HEAVY MOVABLE STRUCTURES, INC.
13th BIENNIAL SYMPOSIUM

Strengthened Bascule Piers for the Newly
Rehabilitated Bridge of Lions

Jian Huang, Ph.D., P.E. and R. Wayne McLennon, P.E.

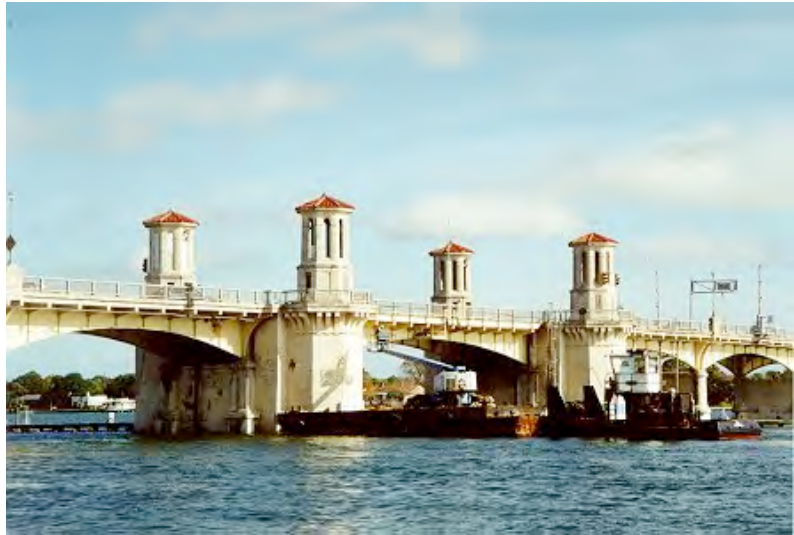
Figure 1 General View of the Existing Bridge of Lions

A general view of the existing bascule span is shown in Figure 1. The newly rehabilitated bridge is exhibited in Figure 2.

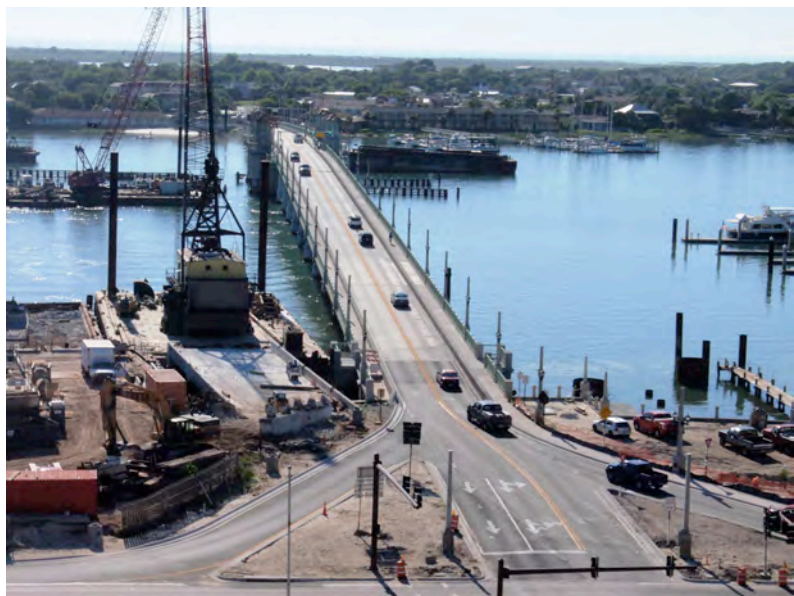
Figure 2 Overview of the Newly Rehabilitated Bridge of Lions

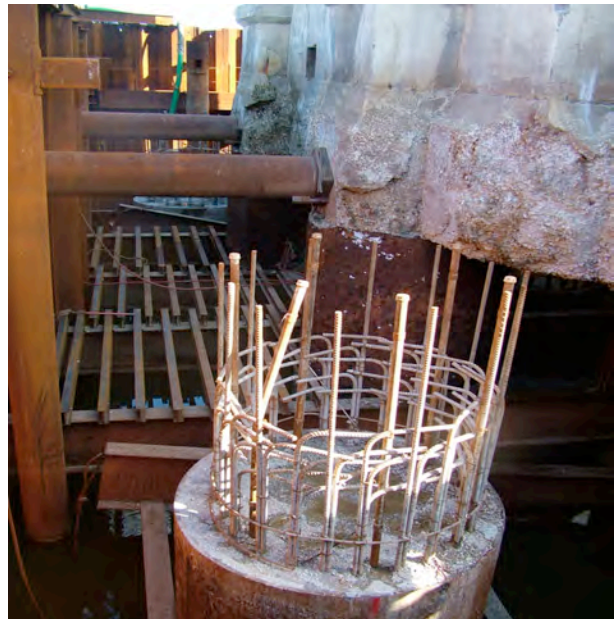
Figure 8 Partial View of Cofferdam

Cofferdams were built to create a dry environment for the new waterline footing construction. As seen in Figure 8, the water level inside the cofferdam only maintain below the falsework for the new waterline footing. There is no seal concrete required for the cofferdam, which eliminates potential environmental issues and saves the construction costs. Also as seen in the figure, the horizontal struts for the cofferdam utilized the existing waterline footing as the support/load transfer members.

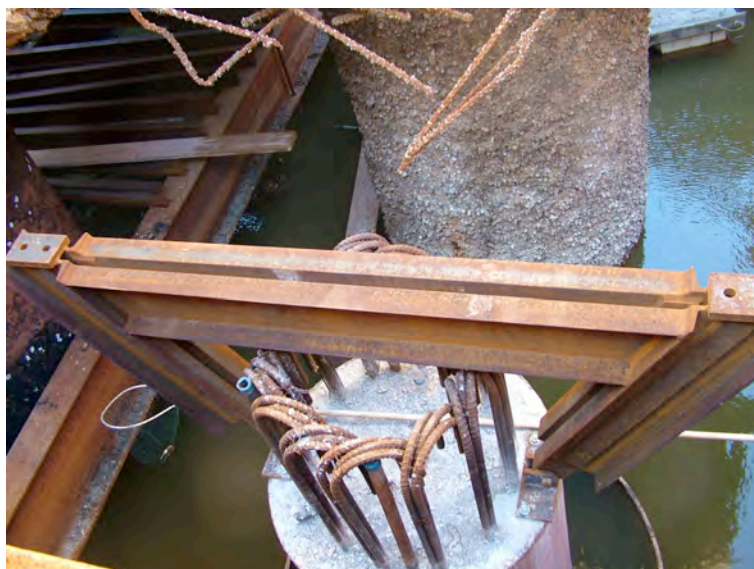
Figure 9 Steel Frame on the Drilled Shaft Head to Support Falsework (Permanently embedded in the new concrete footing)

The falsework for the new waterline footing is supported by the new drilled shafts at their heads, temporary steel pipe piles, and some hangers tied to the existing waterline footing as supplemental supports. Figures 9 to 13 show the concept of this unique falsework.

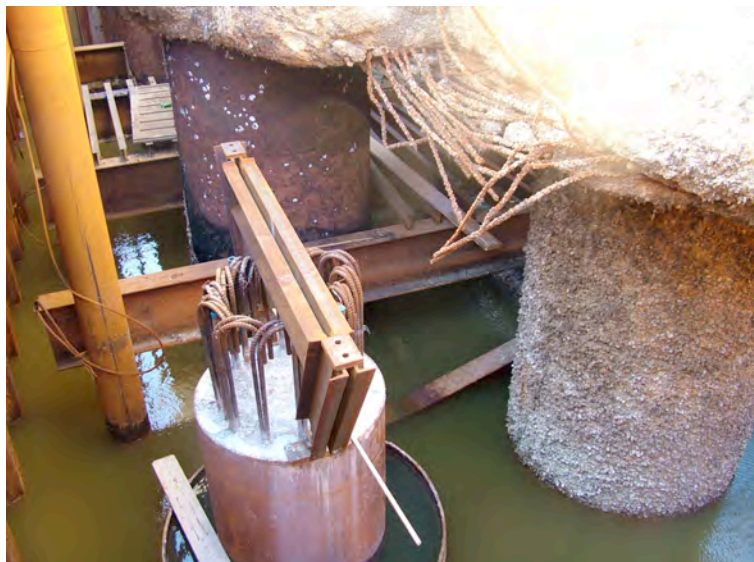
Figure 10 Steel Pipe Pile Supporting the Falsework

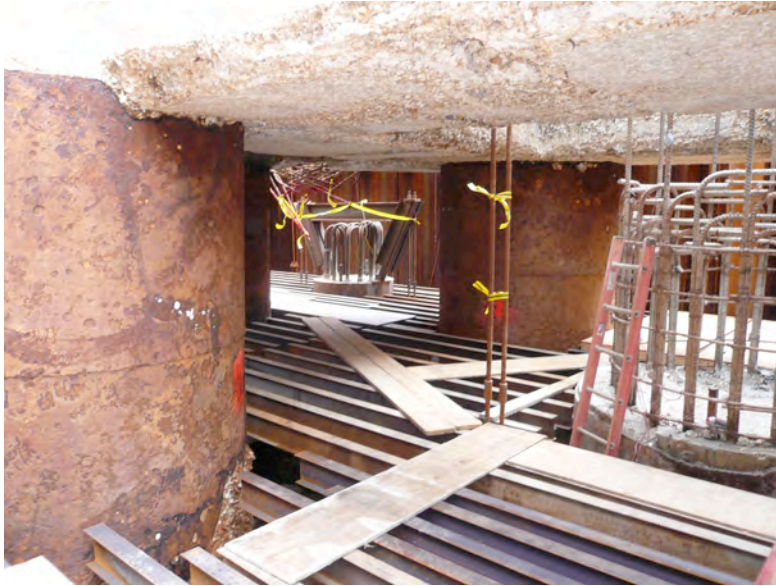
Figure 11 Partial View of Falsework under the Existing Waterline Footing

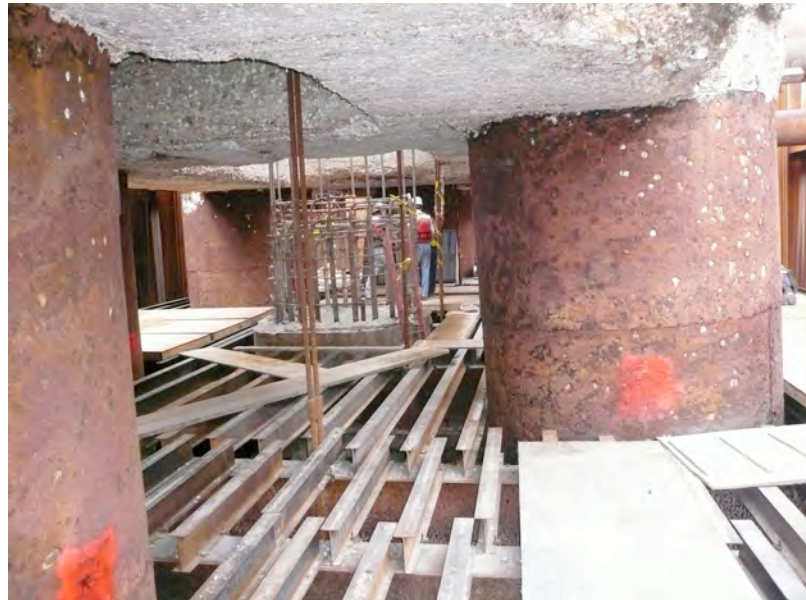
Figure 12 Another View of Falsework under the Existing Waterline Footing

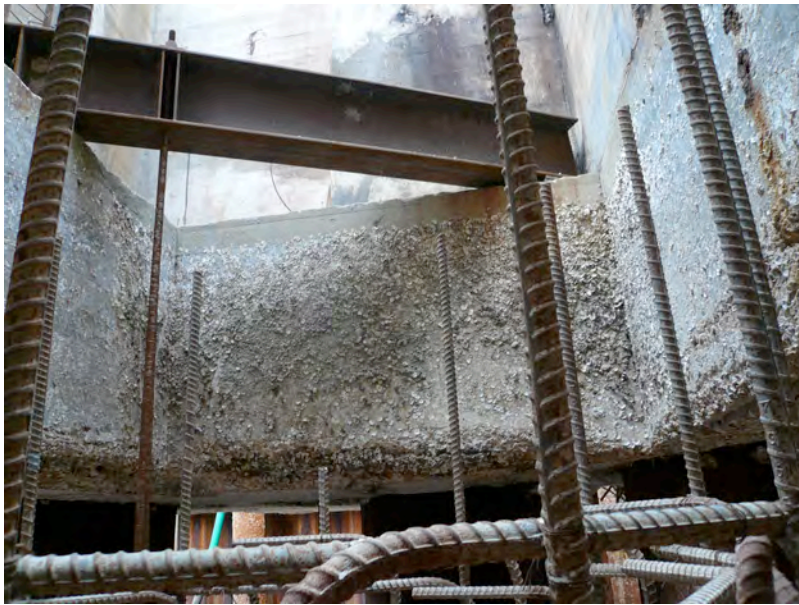
Figure 13 Hangers and Cross Steel Beam for the Falsework at the Opening of the Existing Waterline Footing

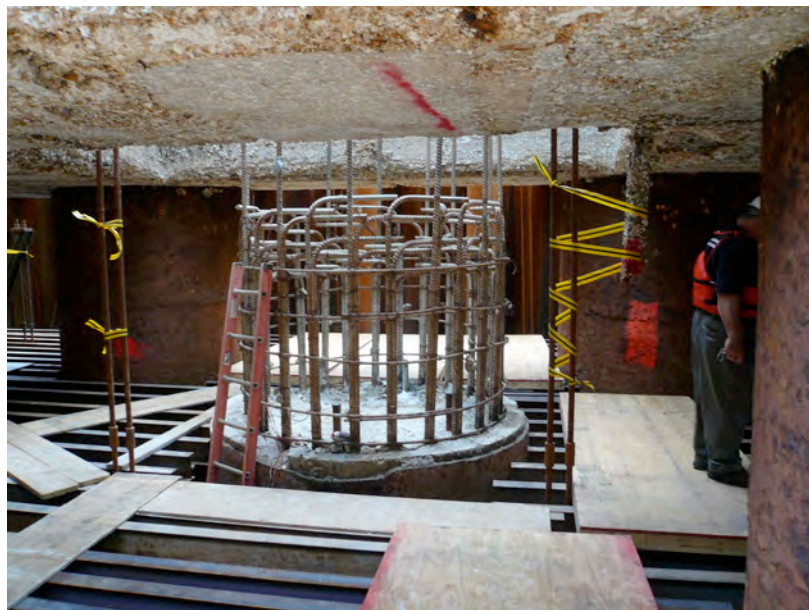
Figure 14 Showing the Falsework Platform at the Middle Opening of the Existing Waterline Footing and the New Drilled Shaft

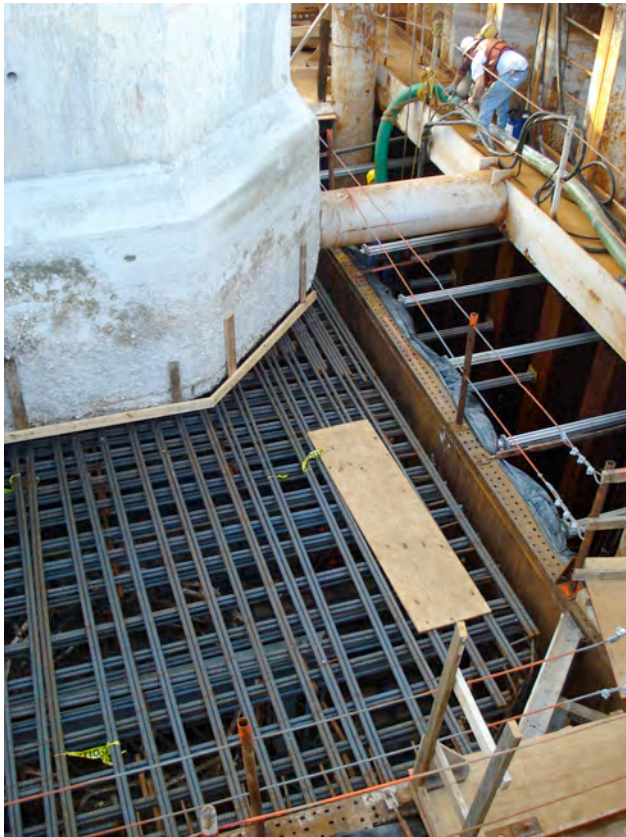
Figure 15 Showing the Top Layer of the Reinforcing Steel in the New Waterline Footing (Back Side of the Pier)

The new water line footing was constructed under the existing waterline footing. In addition, the existing 8' diameter concrete caissons go through the new footing. As seen in Figures 15 to 18, the space is tight for the placement of the reinforcing steel and concrete for the new footing. Both high slump normal concrete and self-consolidated concrete (SCC) were considered for the footing concrete pour. Considering testing results of the SCC concrete and the construction schedule, high slump normal concrete has been used for the new waterline footings at both bascule piers.

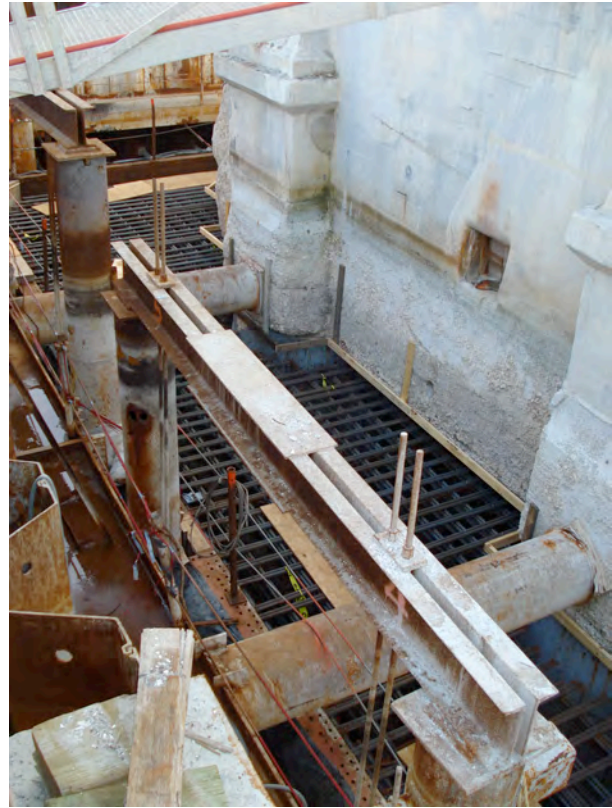
Figure 16 Showing the Top Layer of the Reinforcing Steel in the New Waterline Footing (at a Front/Side Corner of the Pier)

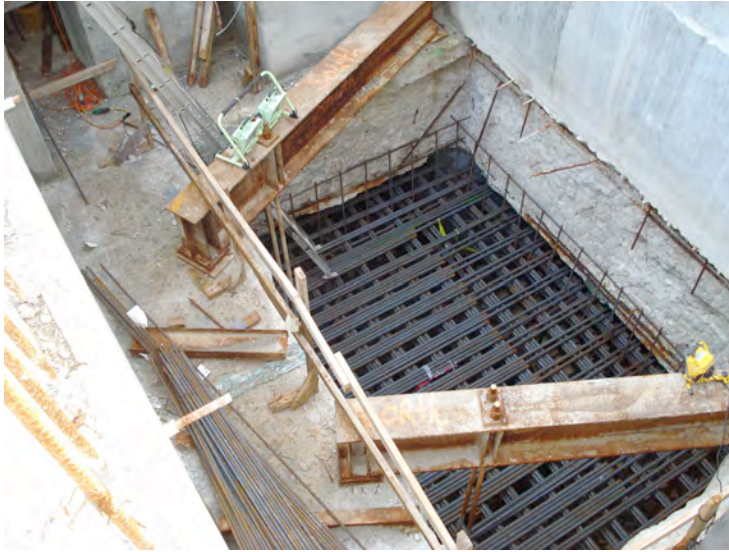
Figure 17 Showing the Top Layer of the Reinforcing Steel in the New Waterline Footing (At the Middle Opening of the Existing Waterline Footing)

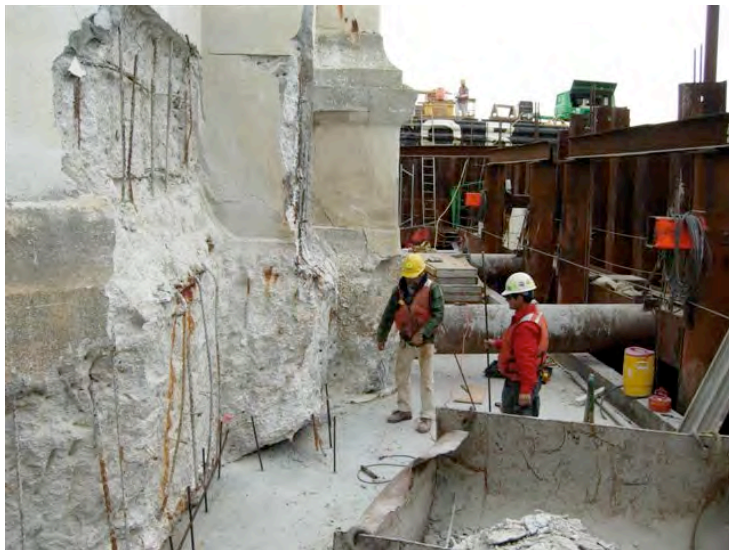
Figure 18 Showing the Newly Poured Waterline Footing and Preparation for Restoring the Existing Bascule Pier Surface

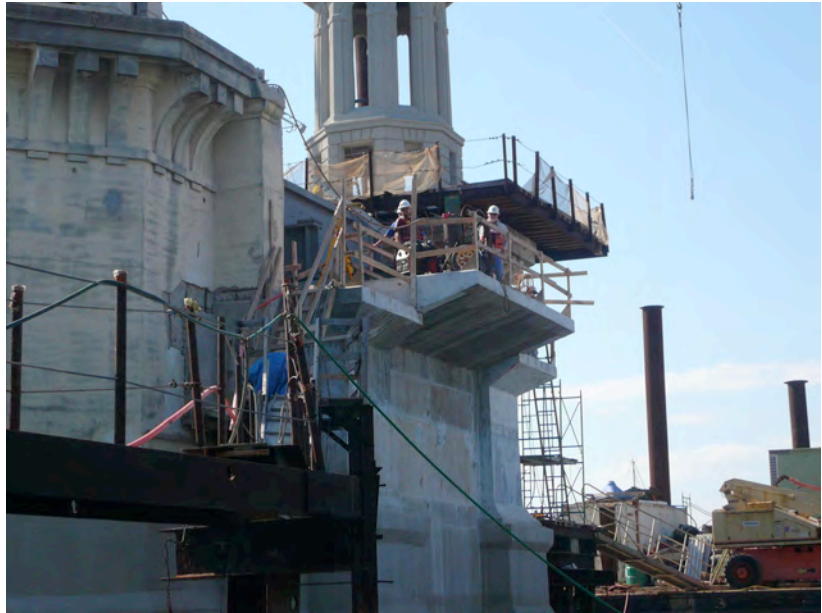
Figure 20 New Machinery Platform Cantilevered from the Existing 18" Wide Backwall

The existing machinery was on the moving bascule leaves. Due to increased size of the new machinery meeting the current design requirements, the new machinery is required to be placed off the moving leaves. New machinery platform have been built above the existing 18" wide backwalls of the piers. The new machinery platforms are also supported at the ends by the expanded columns, which at the meantime support the approach span girders. It should be noted that the actual reinforcing steel in the back wall was significantly less than that assumed during design. Additional reinforcing steel has been added, see Figure 20.

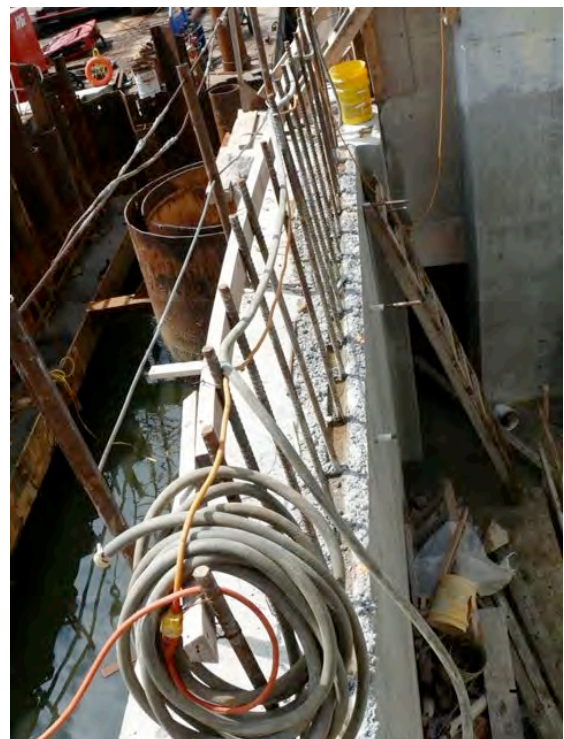
Figure 21 Additional Reinforcing Steel Added by Removing the Back Face of the Backwall

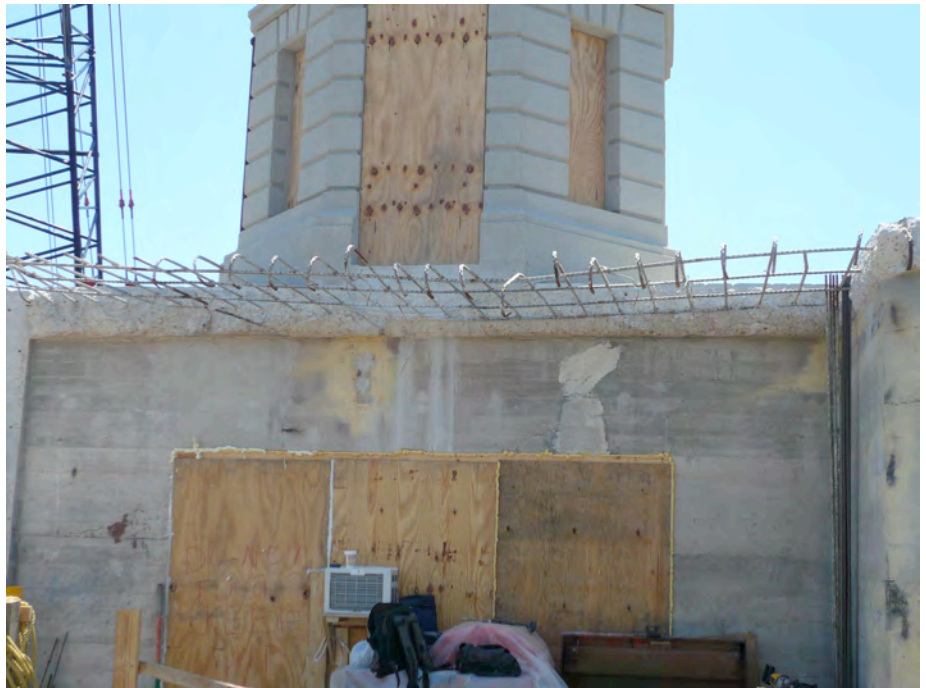
Figure 22 Much Less Than Expected Reinforcing Steel in the Existing Deck

Due to added concrete traffic barrier and carrying portion of the roadway, the existing cantilevered pier deck has been replaced. It should be mentioned that the actual reinforcing steel is also significantly less than that assumed during design. There was only one layer of reinforcing steel and a much larger than expected spacing of the reinforcing steel in the existing deck, see Figures 22 and 23. Additional reinforcing steel has been added.

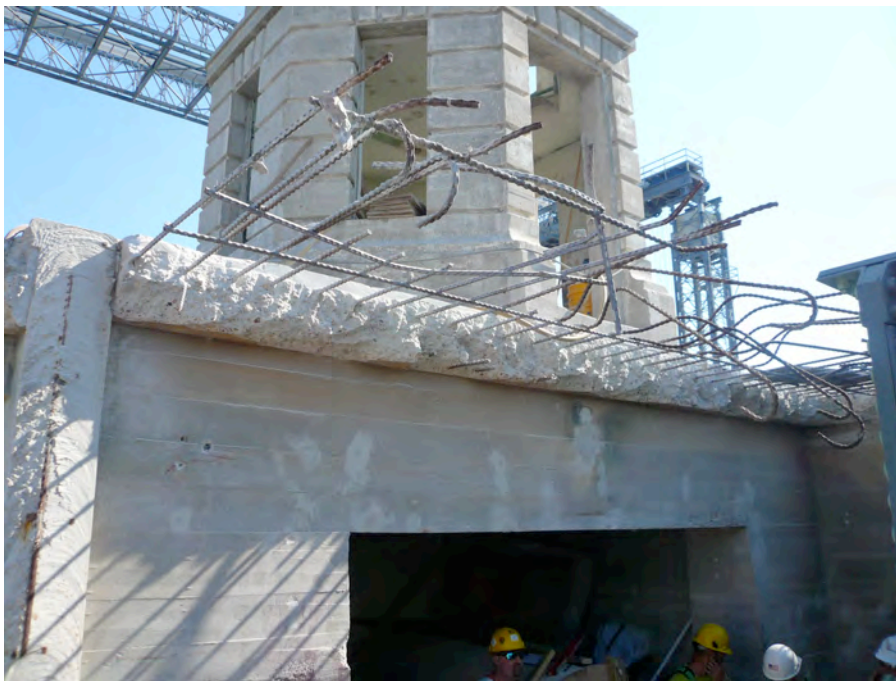
Figure 23
Another View
of the Existing
Reinforcing
Steel in the
Deck
