**HEAVY MOVABLE STRUCTURES, INC.
SIXTEENTH BIENNIAL SYMPOSIUM**

Haystack Bridge: Repurpose of a Bascule

Claus Frederiksen, P.E.
COWI Bridge

John Williams, P.E.
Stafford Bandlow
Engineering, Inc.

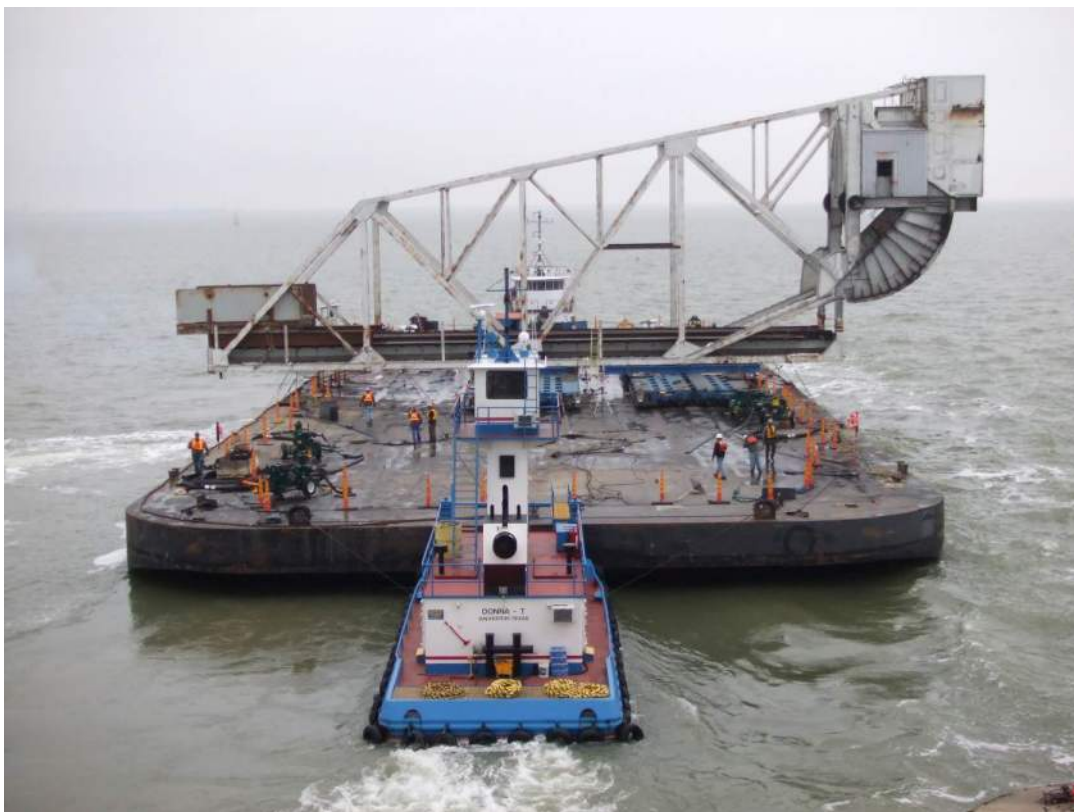
Figure 1 – Removal from Galveston Causeway

During the initial condition assessment of the swing bridge, it was brought to SMART's attention that the Galveston Causeway bascule bridge in Texas was due for replacement. This existing rolling bascule bridge, built and installed in 1986, would be removed from service, replaced by a new vertical lift bridge that increases the channel width at the Galveston site. SMART undertook an initial evaluation and condition assessment of the bascule bridge and determined that for roughly the same cost to rehabilitate the existing swing bridge, SMART could purchase and install the bascule bridge.

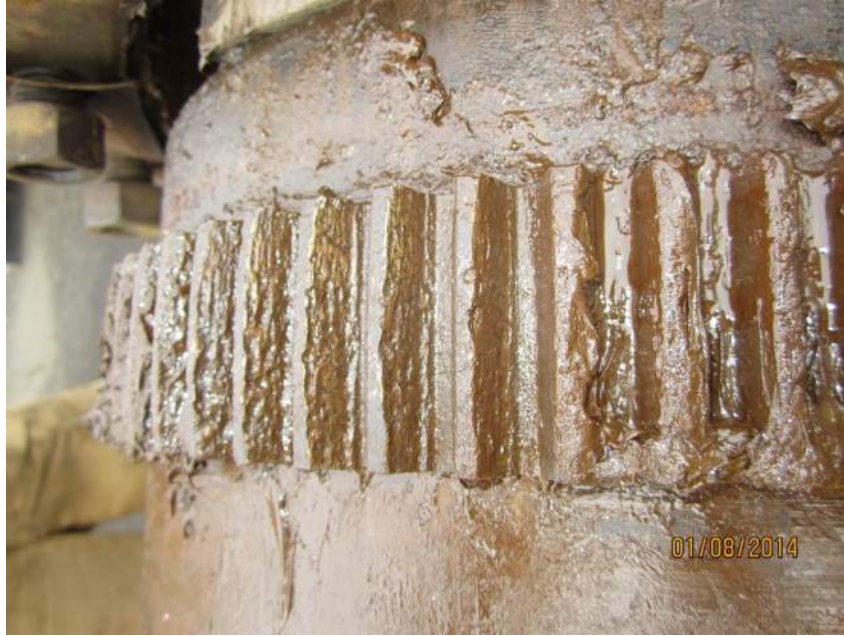
Figure 4 - Gear coupling teeth severely damaged due to corrosion.

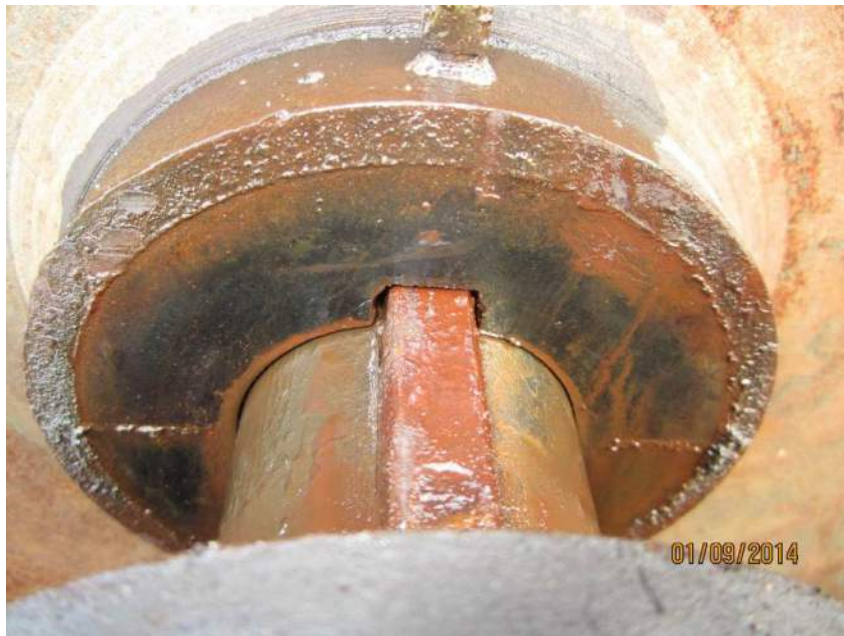
Figure 5 - Gear hub fit with the shaft with excessive clearance.

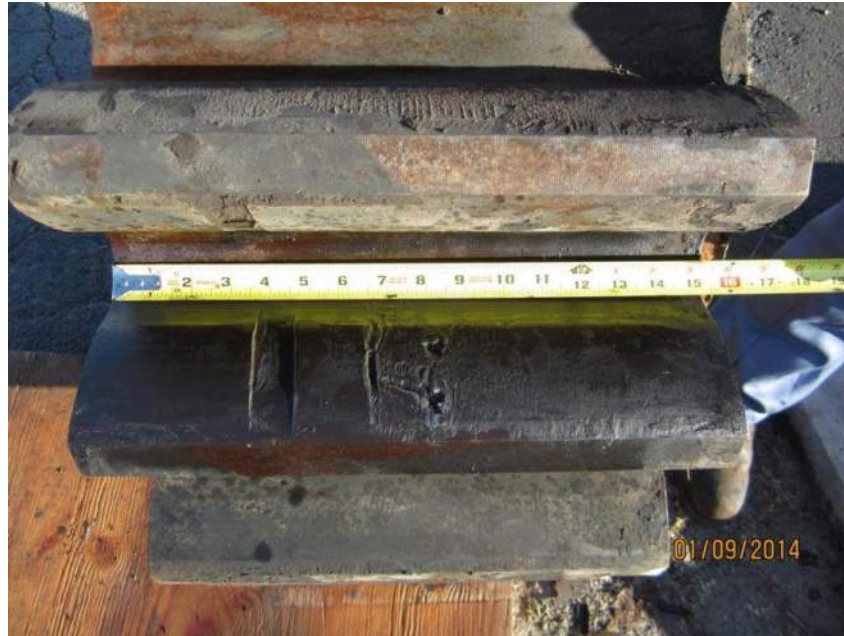
Figure 6 - Gear teeth with isolated damage.

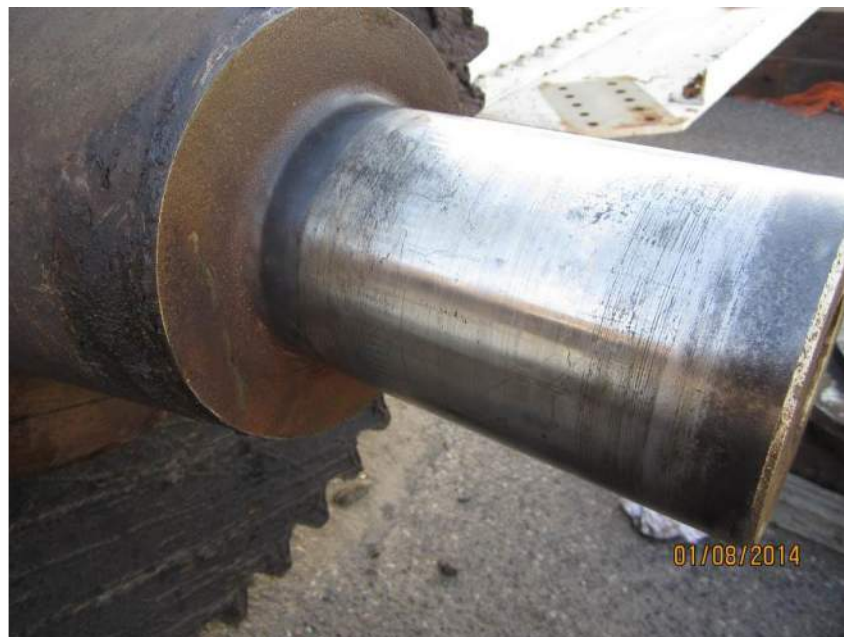
Figure 7 – Bearing journal with moderate scoring and corrosive pitting in the fillet at the shoulder.

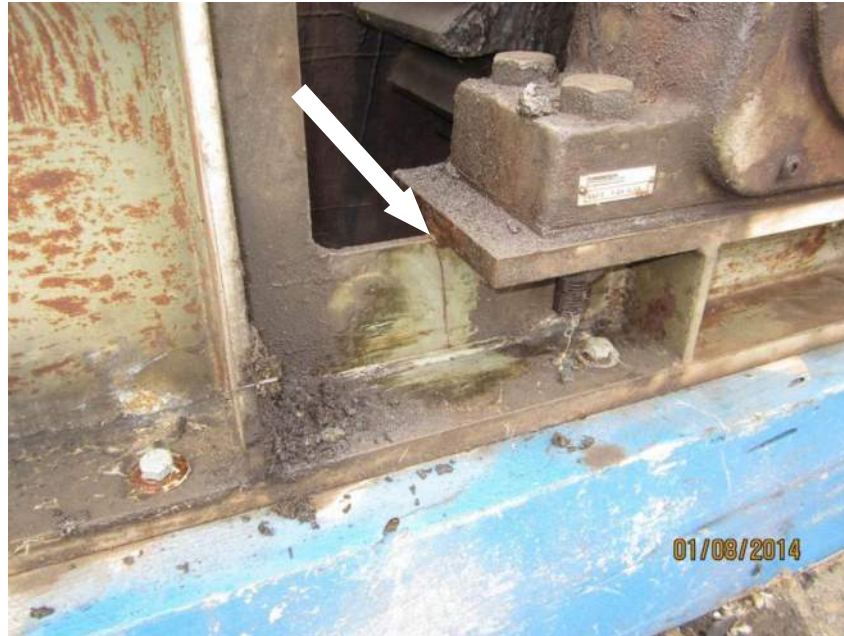
Figure 8 – Open gear frame with a crack the full height of the web.

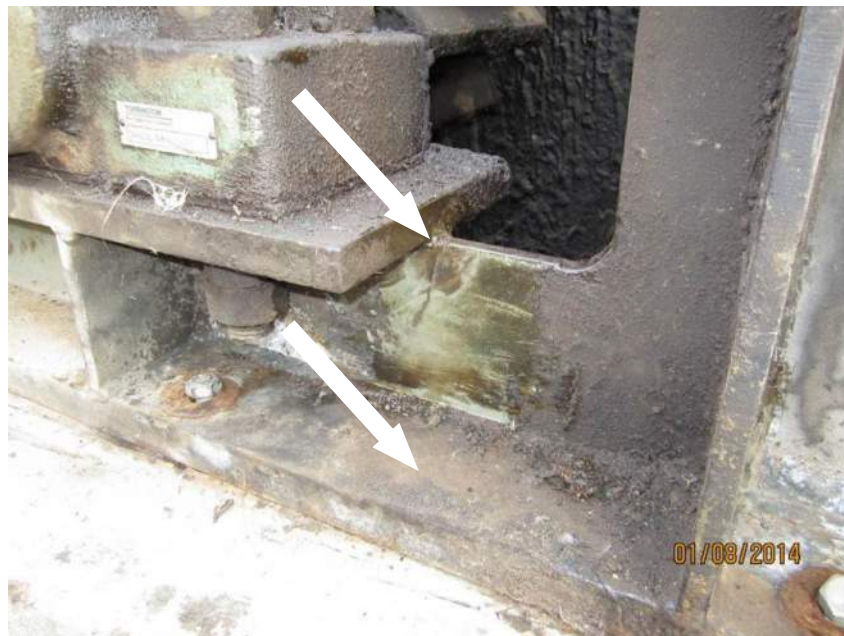
Figure 9 – Different open gear frame with a crack 2/3 the height of the web.

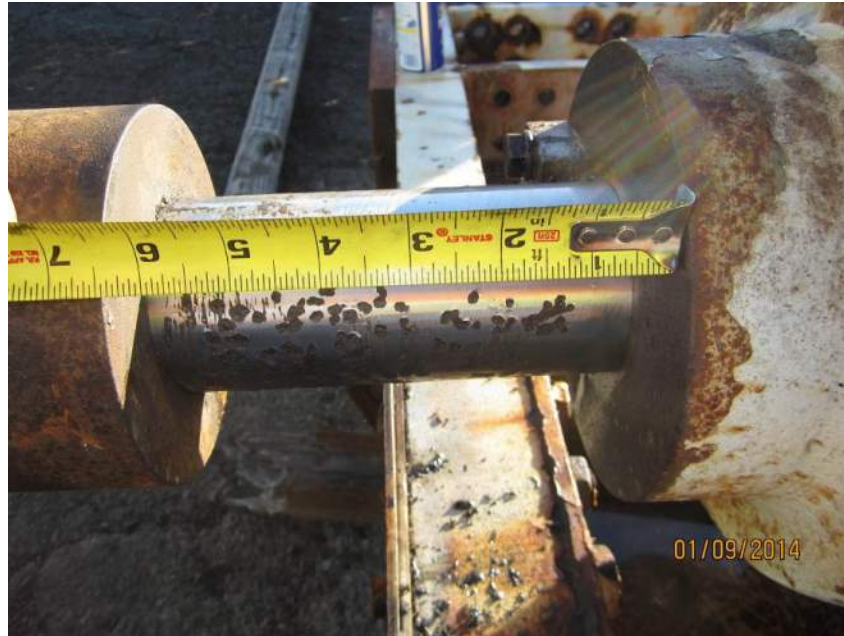
Figure 10 – Air buffer piston rod damaged due to corrosion.

There are two air buffers mounted at the toe end of the bascule span that are used when closing the bridge and two air buffers mounted on the counterweight that are used when opening the bridge to the fully open position. The existing air buffers were installed on the bascule span and counterweight after being disassembled at a shop, rehabilitated as needed and tested in accordance with AREMA requirements to ensure reliable operation.

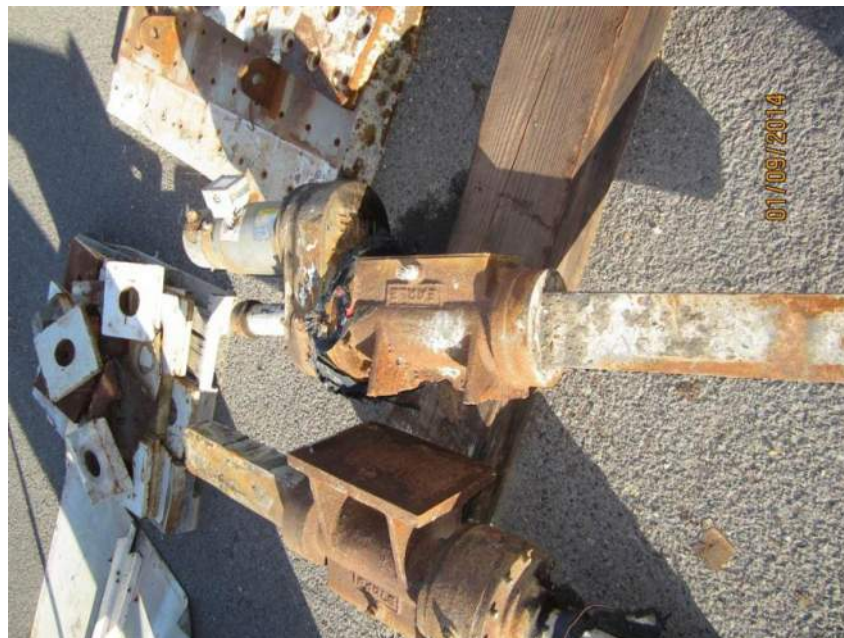
Figure 11 – Span lock operators were found in poor condition and were replaced.

New span lock systems were designed for each truss to hold the span in the normally open position. The open position span lock system was sized for winds loads in accordance with AREMA requirements. For the closed position, the existing span lock system was refurbished and installed at the toe of the bascule span. Once engaged both the open and closed position span lock systems participate in the overall seismic resistance. Under the 100 year serviceability event, minor repairable damage is expected. Under the 500 year and 2400 year event, the span lock systems could suffer significant damage and plastic deformation due to post-yield behavior.

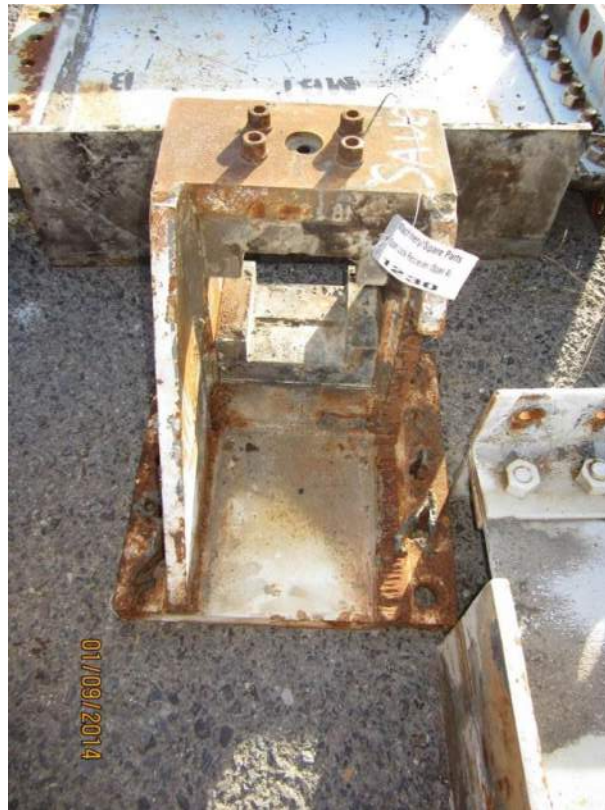
Figure 12 – Both span lock front guides were badly damaged and were replaced. Shoes were salvaged.

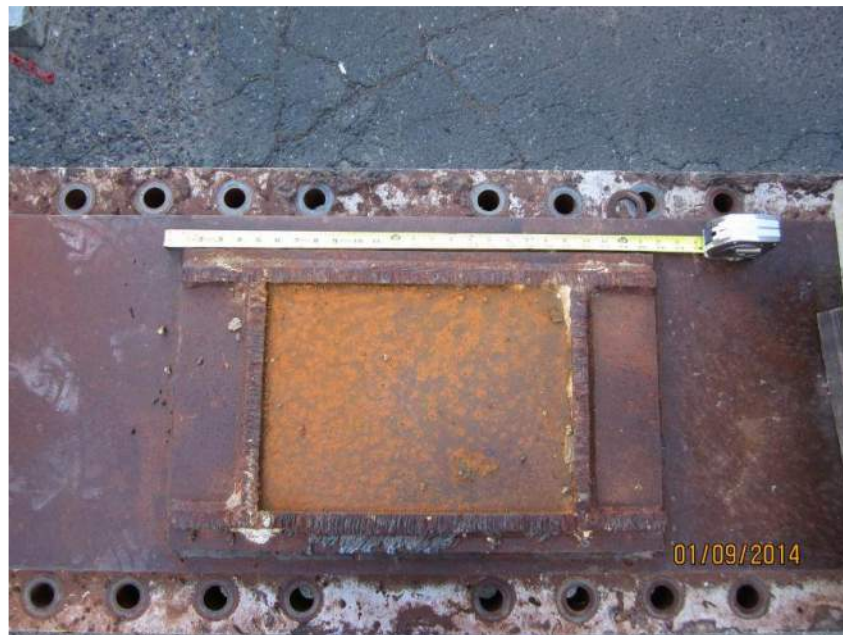
Figure 13 – There is plate welded to the rolling surface of the flat tread that was removed and the surface was repaired.

The bascule leaf support machinery consists of flat and curved tread plate assemblies. The existing flat tread plate assemblies were re-used and installed on new track girders and the existing curved tread plate assemblies were re-used and remained installed on the segmental girders and the connection bolts were re-used to the extent possible. Line bearing of segmental girder on track girder was checked only for the 100-year seismic load combination using 150% of the allowable stresses from AREMA 6.5.35.5 and without dead load impact.

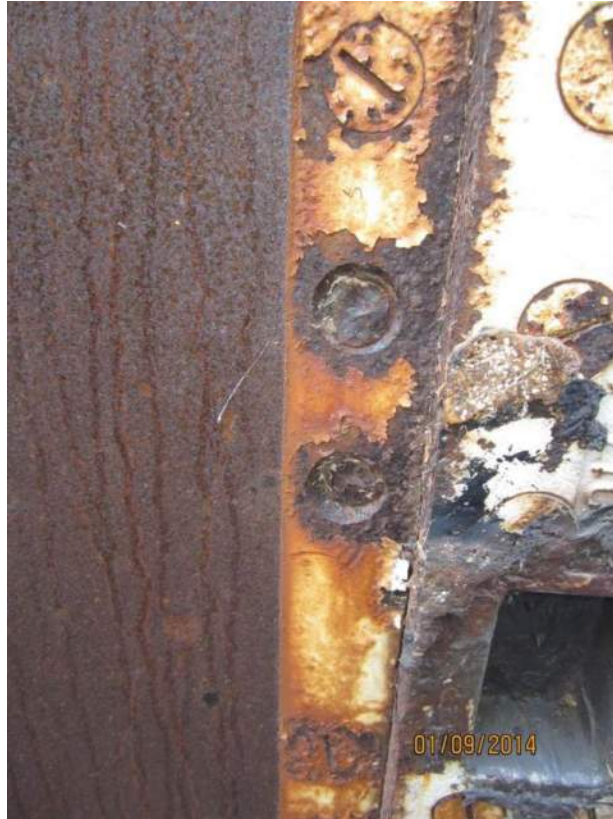
Figure 14 –A few curved tread mounting bolts were found to be damaged or missing and required replacement.

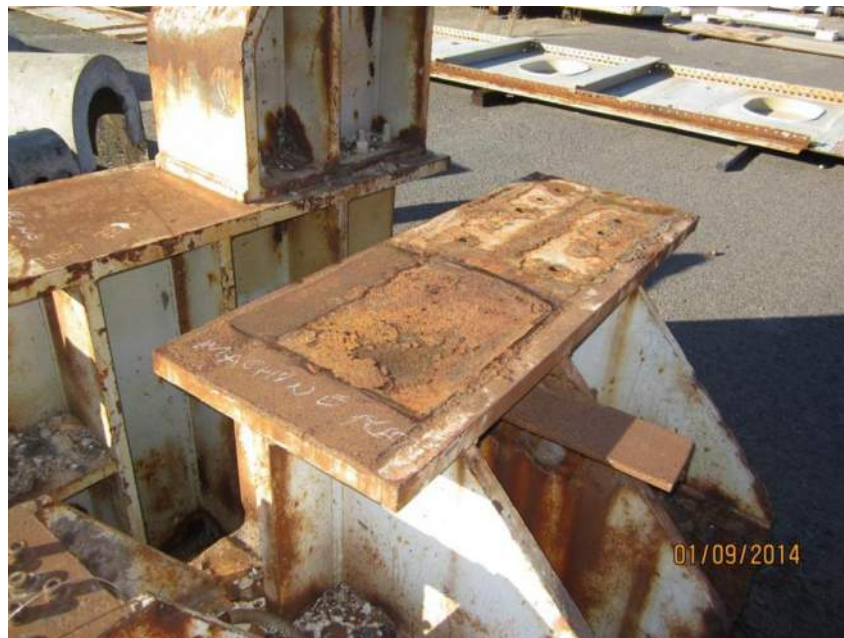
Figure 15 –Live load supports were corroded and were machined to restore a flat surface.

The existing live load supports and centering devices were evaluated, rehabilitated as required and installed in the proper location to support the toe end of the structure and to properly align the structure in the fully closed position.

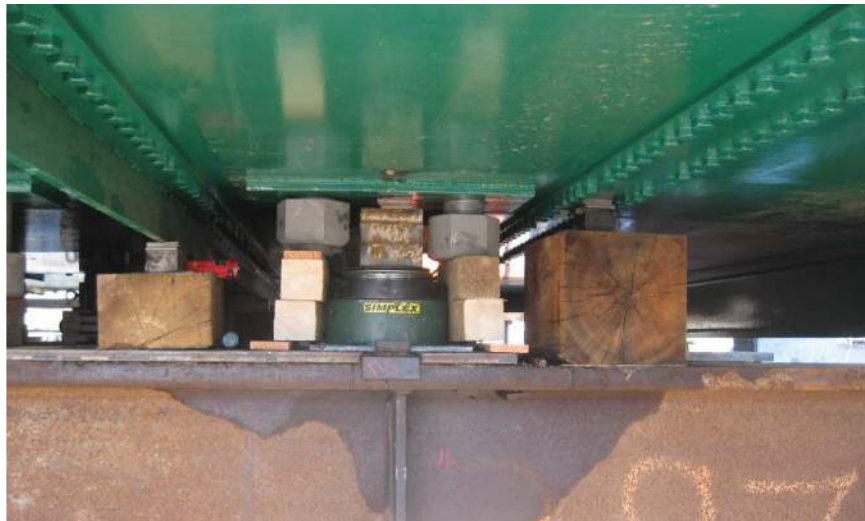
Figure 17 - Counterweight Support Frame

The segmental girders were placed on the rolling girders and then the segmental girders were rolled up to bolt to the counterweight. The counterweight was assembled very close to the final position, and the system was designed to allow for +/- 1-inch vertical adjustment and +/- 2-inch longitudinal adjustment. The adjustment system design incorporated hydraulic jacks on a steel sliding plate with a Teflon sliding surface. This allowed the fine adjustment of the counterweight box for bolt-up with the segmental girders. The photo in Figure 17 shows one of the hydraulic jacks on a sliding plate.

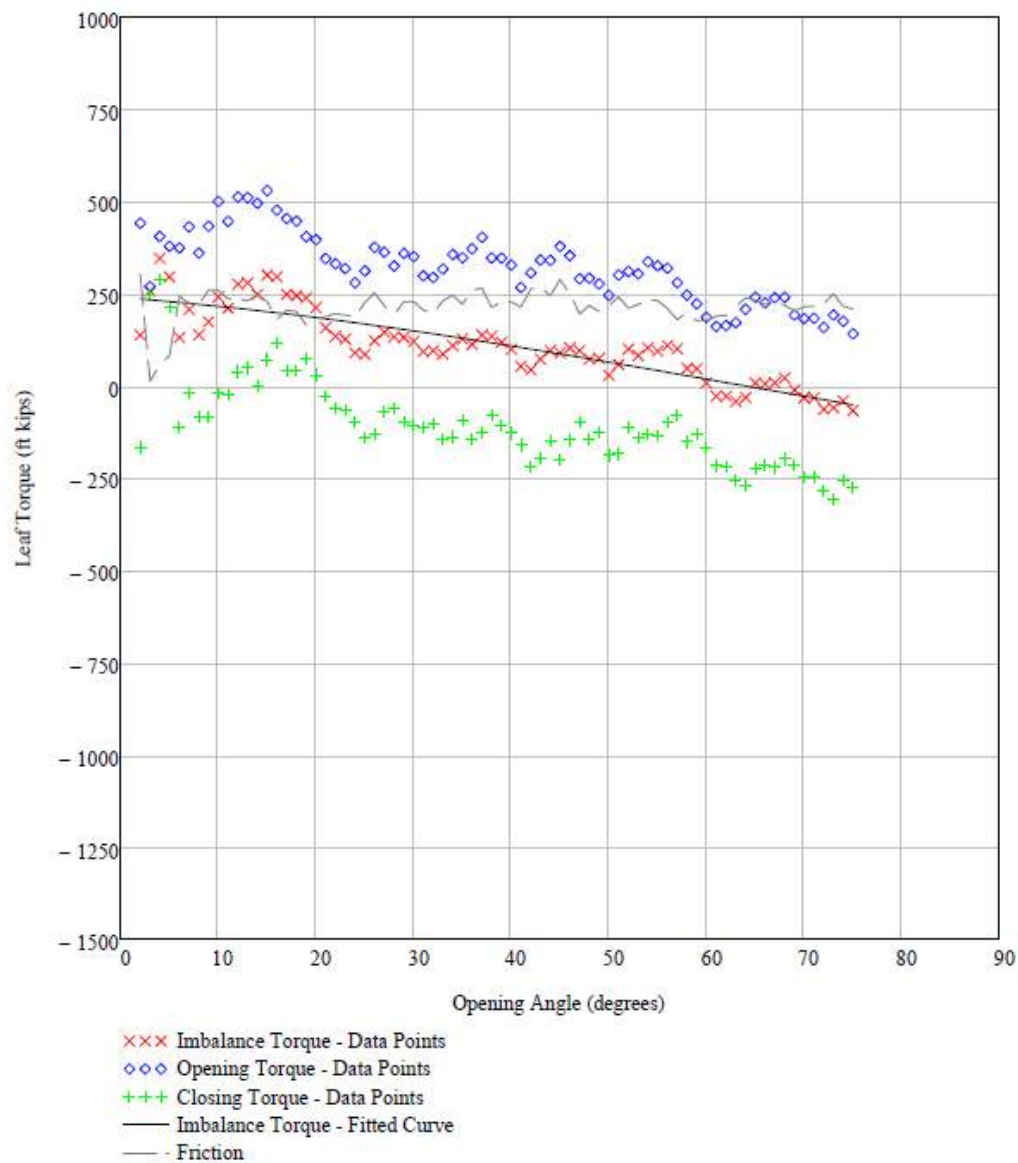
Figure 22 – Strain Gage Balance Testing Graphical Results

Span Balance Curves Imbalance Versus Opening Angle

TEST_DATE = "January 21, 2015"

$\theta_{\min} = 3$

$\theta_{\max} = 76$

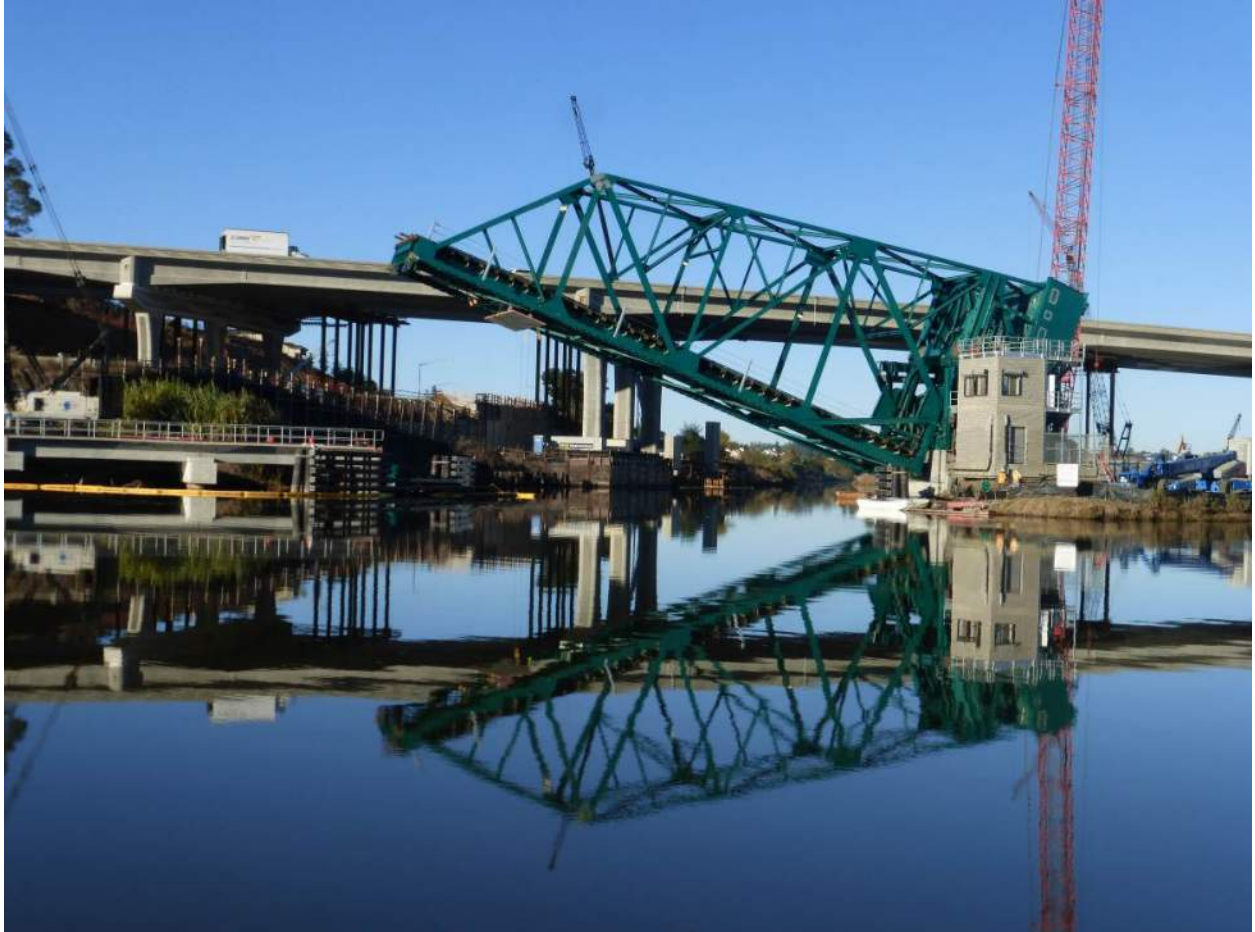
Figure 24 - Initial Closure of New Haystack Bridge
