HEAVY MOVABLE STRUCTURES, INC.
12TH BIENNIAL SYMPOSIUM

NW 17TH AVENUE BRIDGE REHABILITATION
OVER THE MIAMI RIVER
MIAMI-DADE COUNTY

John Low, P.Eng.
Hardesty & Hanover, LLP

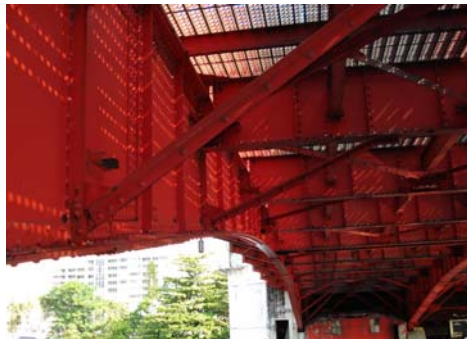
The existing bascule span was a three girder system with floorbeams that support a two level stringer system and an open deck roadway grating with filled concrete grating cantilevered sidewalks. The three girder system was a design developed by Harrington, Howard and Ash. John Lyle Harrington was the former partner of John Waddell –

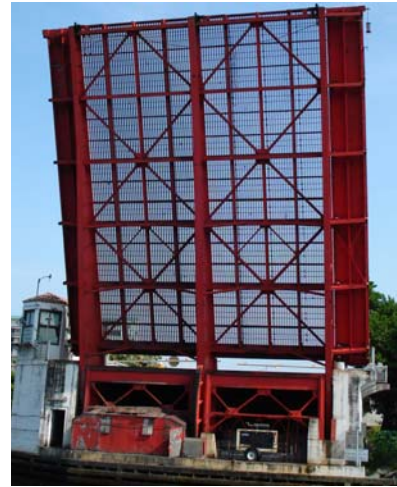
founder of Hardesty & Hanover, LLP. There are only about five known bridges of this type still in existence, four in Florida (one is being replaced currently, NW 5th Street Bridge) and one in New Jersey. The original floor system consisted of transverse floorbeams, longitudinal stringers and transverse timber ties supporting timber planking. The timber portions of the deck system were later replaced with transverse steel substringers (channels) and an open steel grating.

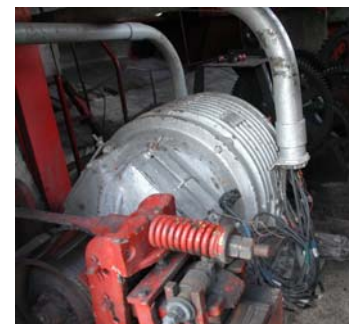
The existing operation was achieved by an electric motor energized to provide torque to the main drive rack pinion through 5 stages of an open gear train. The main drive pinion was fixed to the pier in the shaft sleeve bearings and the pinion engaged with the circular rack bolted to the center bascule girder. The leaf rotated as the drive pinion walked the rack.

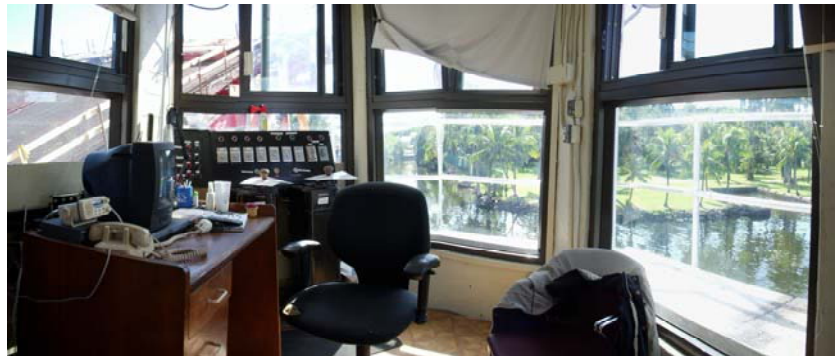
Electrically, the existing electrical system provided speed and direction control of the main span motors and rudimentary safety interlocking with traffic signals and traffic gates. Drum switches in the control console on the observation level of the control house and resistors located at the floor below, limit the current to the motors thereby controlling their speeds.

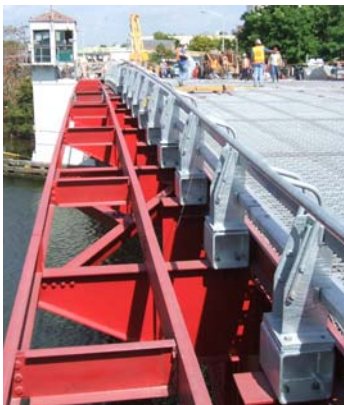
The entire bascule deck and support system, stringers, floorbeams, grating and sidewalks were replaced in lieu of repairs (as per the original contract) due to the severity of the corrosion discovered, to reduce environmental impacts and to expedite construction. The two level stringer system was replaced with a conventional longitudinal single stringer system. The stringers were positioned to ensure that the grating did not have to be supported on the existing bascule girders as per the original design. This enabled the reinforcement of the bascule girder top flanges to be simplified with no interference

from the grating. The concrete filled sidewalks were replaced with an aluminum closed grating which greatly reduced the weight on the bascule span leaves. Bascule span weight was one of the major issues that had to be considered in the design to ensure proper balancing of the bascule span leaves both during construction and at the end of construction. The two new span locks at the toe of the bascule span added a considerable weight to the north bascule leaf in terms of balancing, therefore considerable effort had to be made during design to reduce the weight on the bascule leaves.

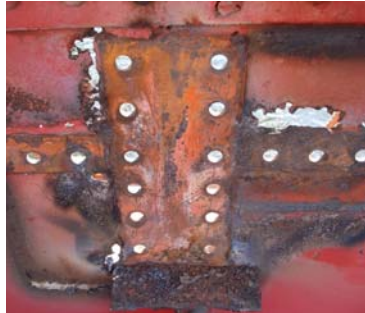
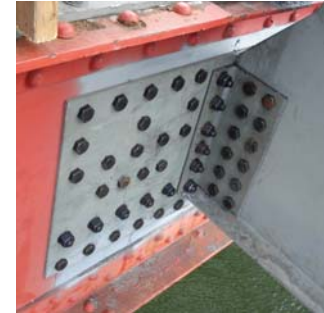
Repairs were also required to the main bascule girders due to deterioration to the girder webs behind existing connection angles for the floorbeams. The web plates had rusted through in many locations and reinforcing steel plates had to be provided to compensate for the section loss.

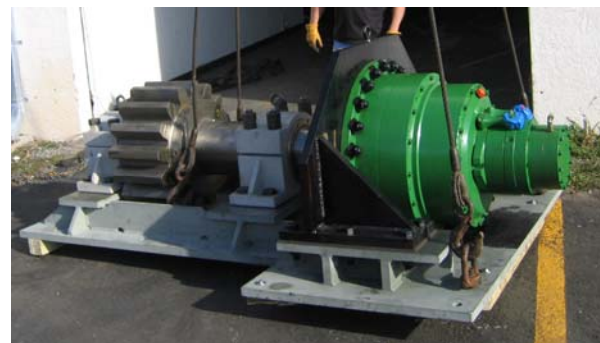
The open gear operating machinery was replaced with a hydraulic gear motor and planetary reducer directly driving the new main rack pinion. To minimize the field installation, the hydraulic motor, pinion/pinion shaft and bearings were all installed in the shop on a steel plate support assembly. This assembly was then positioned in the field on leveling screws and then grouted under the steel plate assembly and held in place with anchor bolts. The Hydraulic Power Units (HPU) were placed under the flanking spans for protection and to maximize space on the bascule piers. The HPU was placed about 10 feet above the

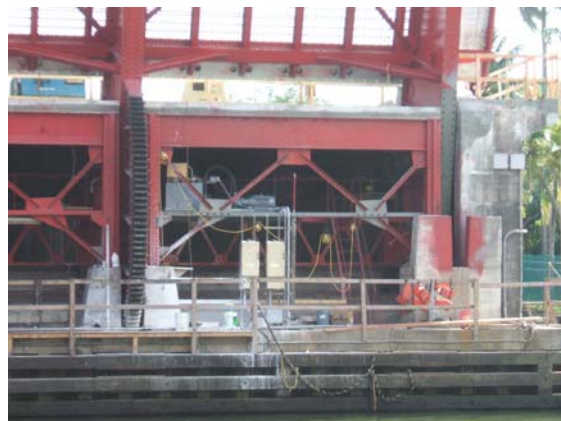
Hardesty & Hanover redesigned the original contract two span lock and center latching mechanism with a two span lock system that is located under the sidewalks for easy accessibility.

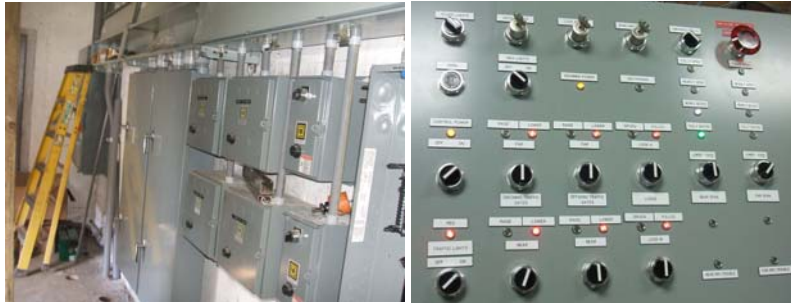
Entire new electrical control and power distribution systems to operate the new hydraulic motors and span locks were also provided for this fast-track project, including a new control desk, limit/proximity switches, relays. The existing traffic gates and lights, warning gongs and navigation lights were integrated into the new control system.
