**HEAVY MOVABLE STRUCTURES, INC.
12TH BIENNIAL SYMPOSIUM**

**Rehabilitation of the Fremont Bridge in
Seattle, Washington**

John Williams, P.E.
Stafford Bandlow Engineering, Inc.

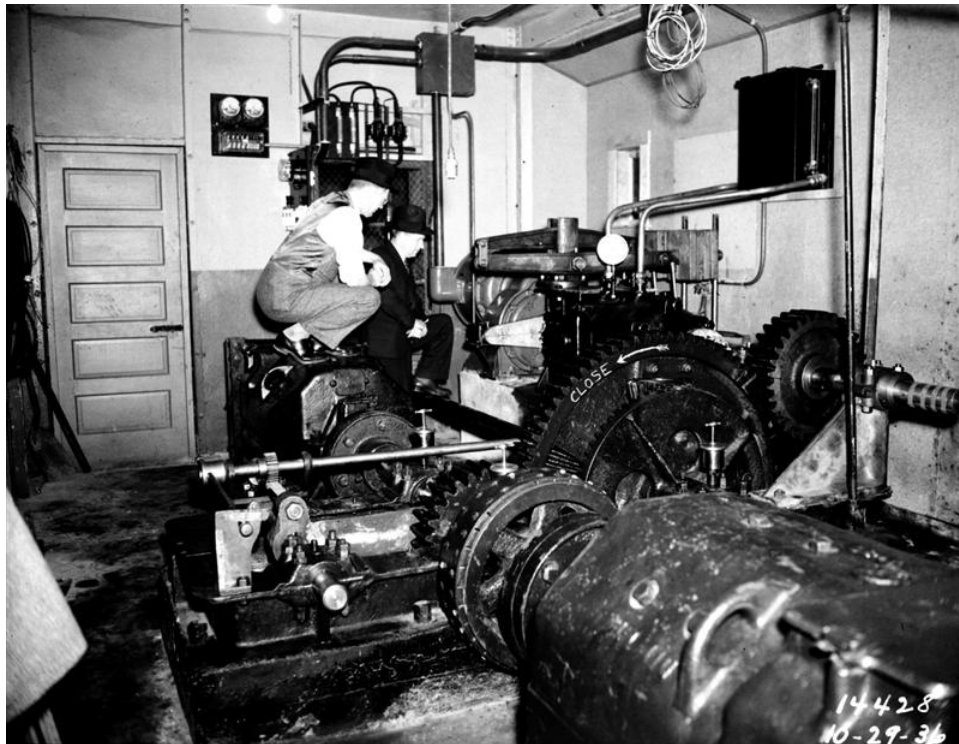
Fremont Bridge original span drive machinery, 1936 *Seattle Municipal Archives
Photograph Collection*

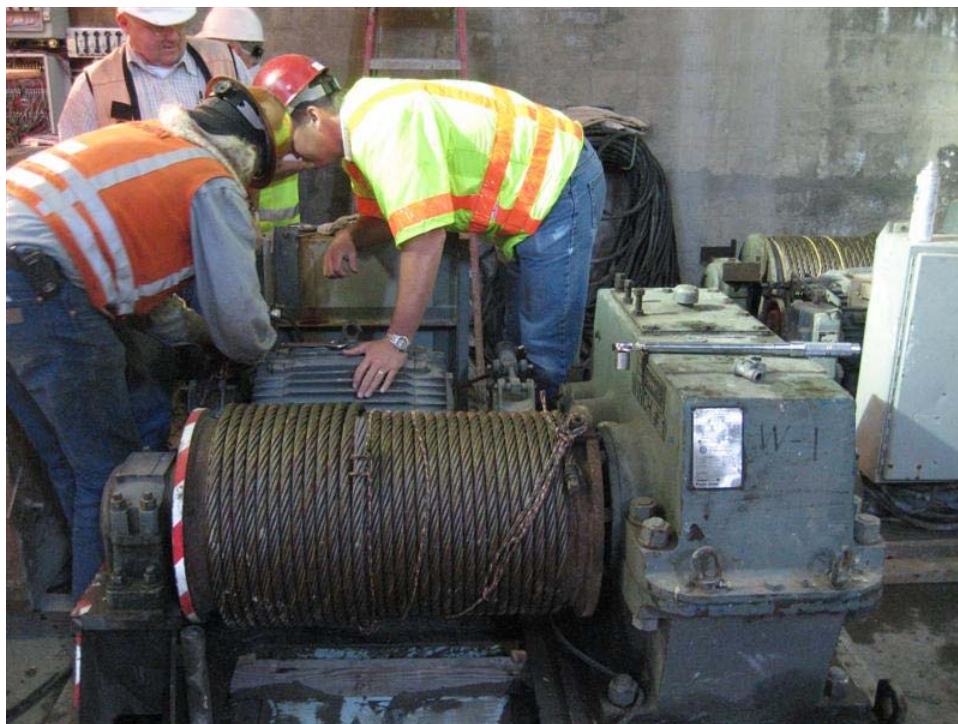
Temporary winch span drive equipment being prepped for installation.

After installation of the winch system, the span drive machinery and electrical control system are removed. Due to the fact that the opening time is increased under temporary winch operation, single leaf openings were used except for three scheduled double leaf openings each day. The time of opening for the temporary winch system is approximately 3 ½ minutes.

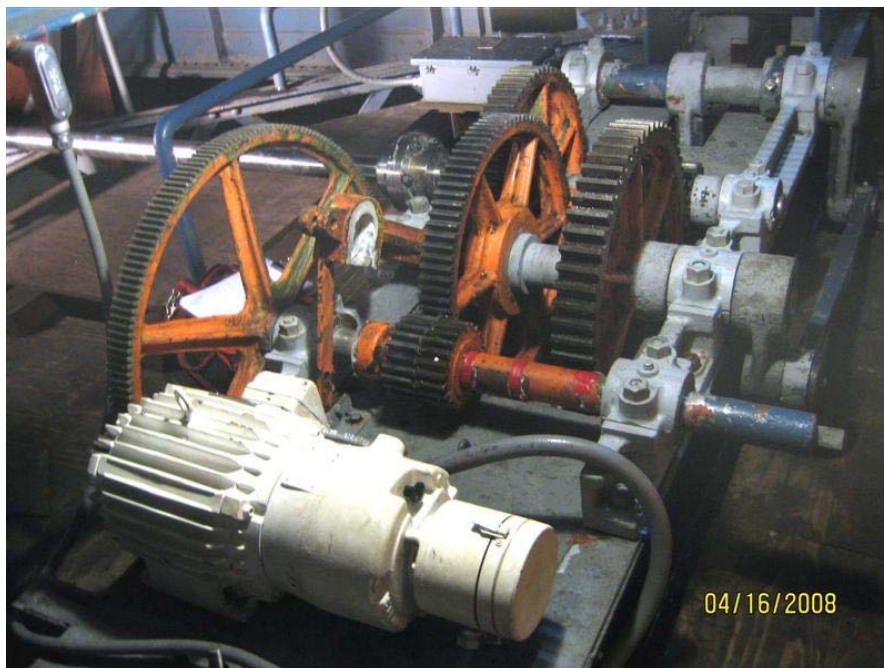
Rehabilitated span lock operating machinery

The original lock operating machinery was rehabilitated as follows:

- The bearing journals were polished
- The bearings were re-babbitted and re-bored
- The cross shafts were replaced.
- The brake-motors and motor pinions were replaced.

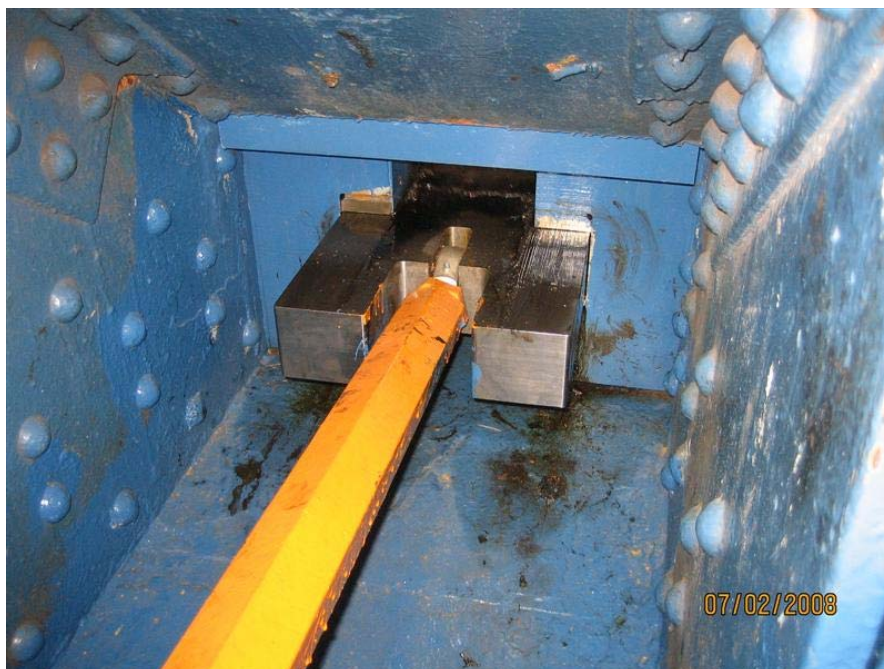
New span lock connecting rod, lock key and guides with bronze wear shoes, shown disengaged.

The only failing of the original design was the lack of the ability to adjust the clearances in the jaw and guides to account for wearing of the parts. A prior rehabilitation modified the guides to incorporate wear shoes, however no such retrofit was possible for the jaws. During the current rehabilitation, the guides and jaws were replaced with a new design that included bronze wear shoes. A similar design was used at the retrofit of the University Bridge and the feedback from the City after 20 years of service was that that design was performing well.

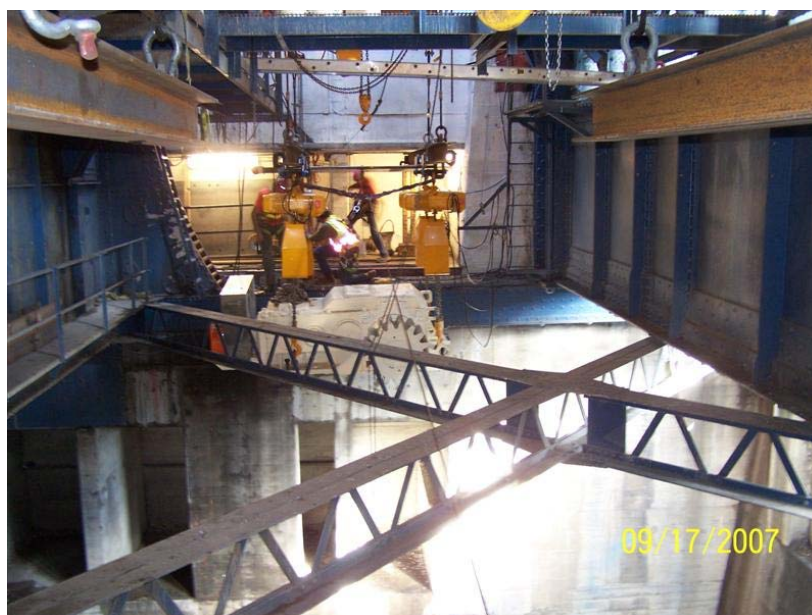
Secondary reducer installation sequence.

In order to install the new secondary reducers and machinery support assembly, the leaf was opened and the reducers were lowered into the counterweight pit. Rigging was then installed to

lift the reducers and machinery support assemblies up to the machinery level where they were placed over their anchor bolts, which had been previously installed.

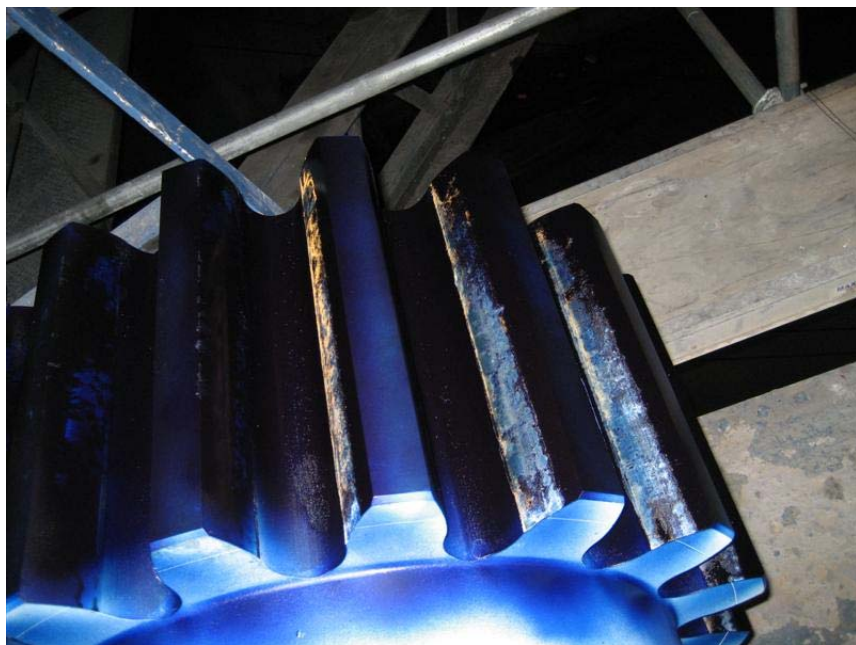
Evaluating rack pinion tooth contact during installation of the secondary reducers.

Once all of the machinery was in position for the North leaf, the secondary reducers were lowered into position so that the rack pinion engaged the rack during a night time closure to vehicular traffic. The leaf position corresponding to the minimum backlash had been previously established based on the “slinky” measurements. The leaf was opened to that position, the pinion was aligned and the reducer secured with the desired backlash and the leaf was opened using the winch to establish the contact pattern on the new pinion and existing rack.

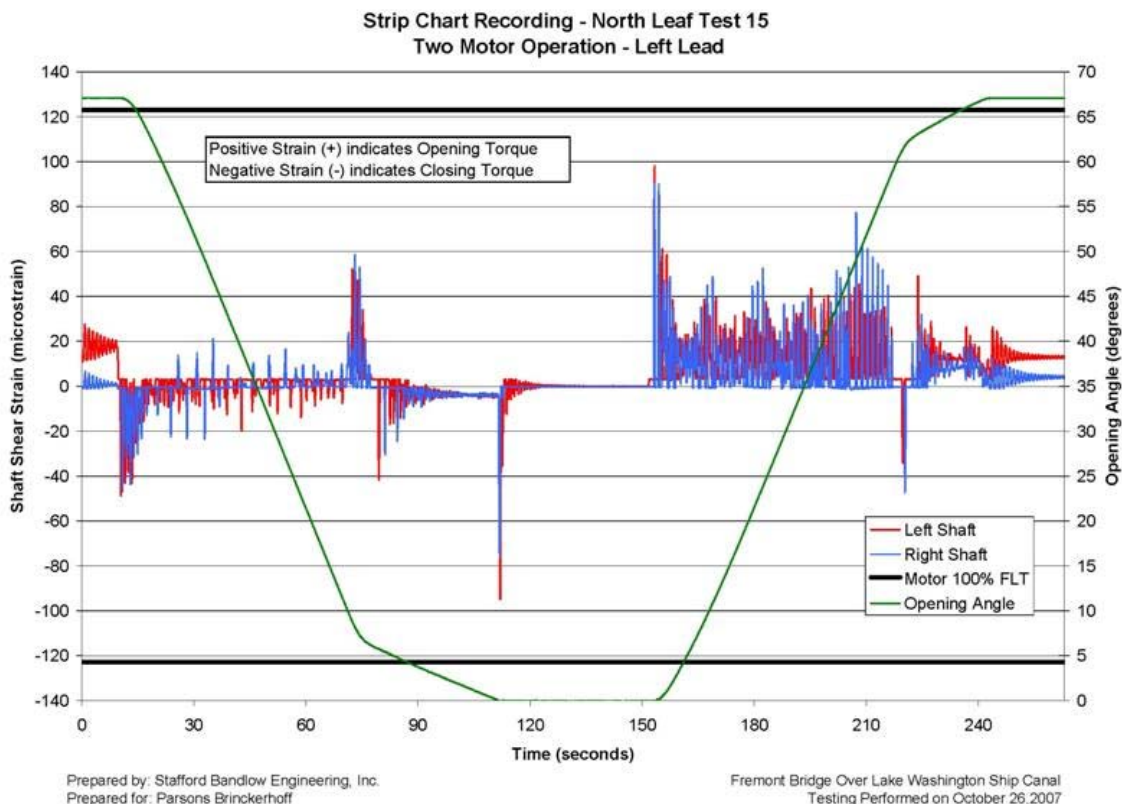
Operational testing of new span drive machinery

Following completion of the anchorage of the machinery, the new span drive machinery and controls were commissioned. SBE performed dynamic strain gage measurements during the commissioning tests for the dual purposes of verifying the electronic load sharing functions of the drives and also for determination of span balance.

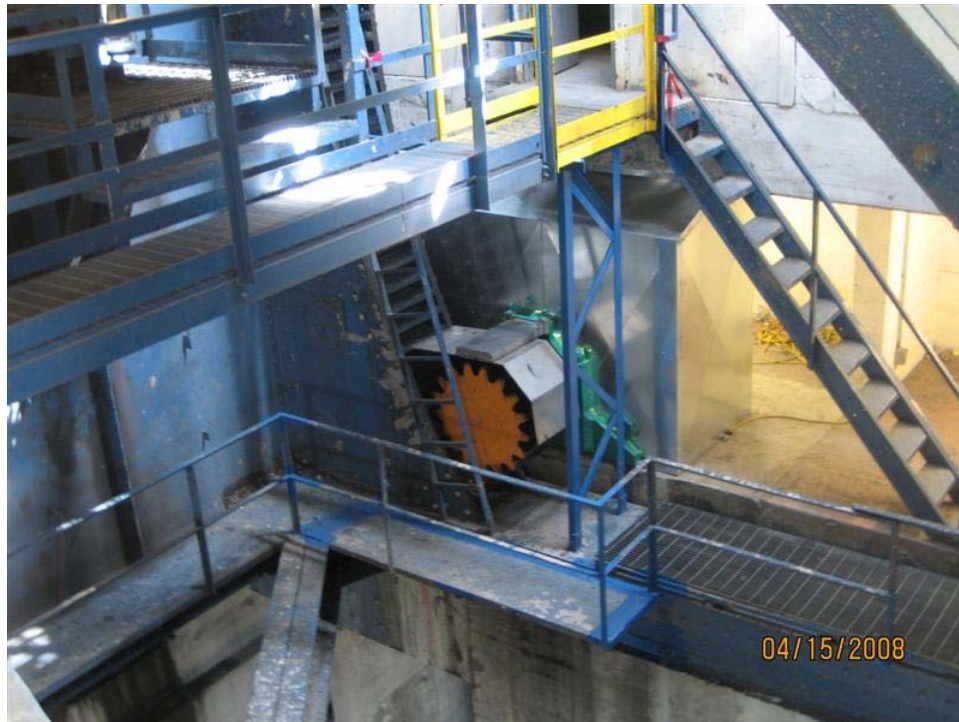
The rack, new pinion and machinery shield viewed from inside the bascule leaf.

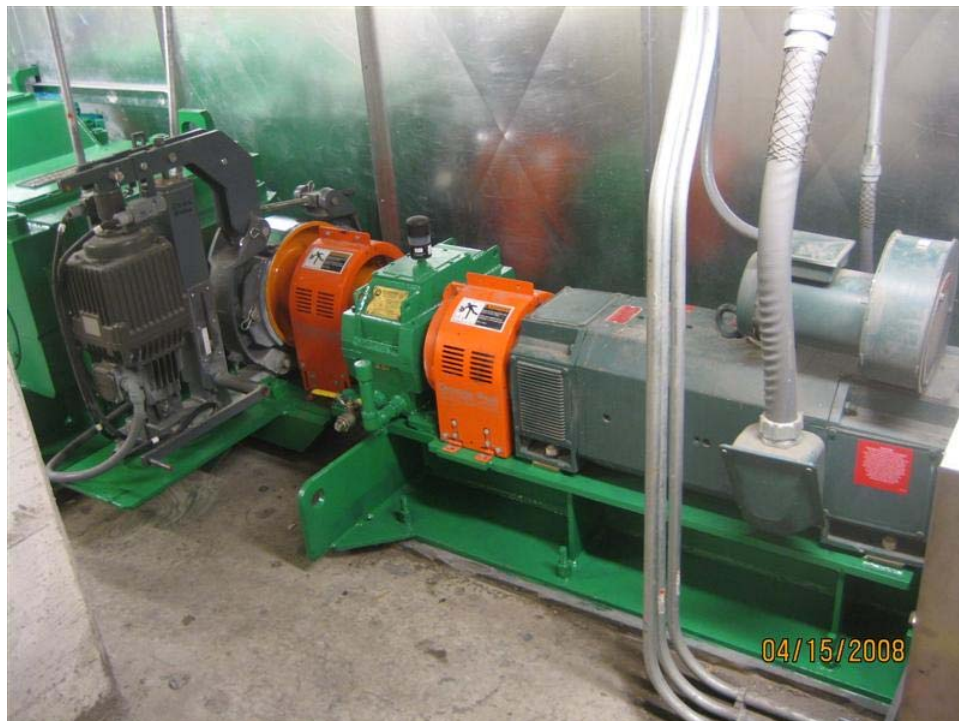
The new span drive motor, primary reducer, motor and machinery brakes viewed from the machinery room.

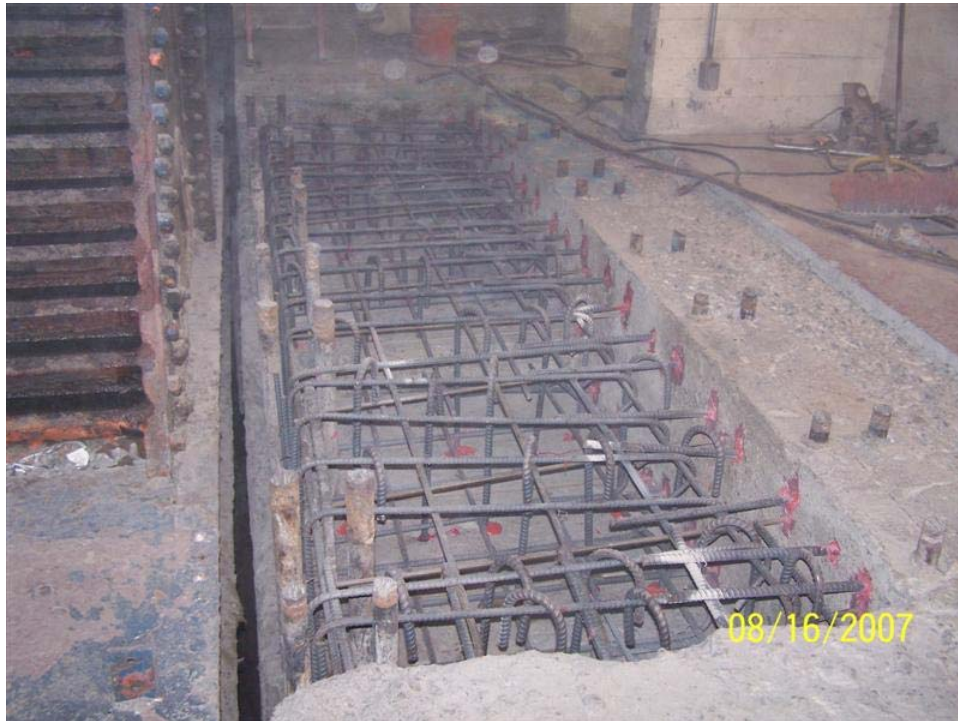
During construction of the temporary winch system it was necessary to anchor sheave brackets to the counterweight box. It was intended that epoxy anchors would be used. During construction large voids and poor quality concrete were discovered. Despite attempts to fill the voids with grout, it was not possible to anchor the sheave brackets and an alternative plan involving welding the brackets to the counterweight box was used.

Machinery anchorage modifications.

Unsound concrete was also discovered during modifications to the machinery floor that the secondary reducers were anchored to. In order to ensure the integrity of the reducer anchorage, the unsound concrete was chipped out, reinforced and re-poured.
