THE SECURITY ASSESSMENT OF CABLE ASSEMBLIES IN MOVABLE STRUCTURES

TIMOTHY W. KLEIN, PE

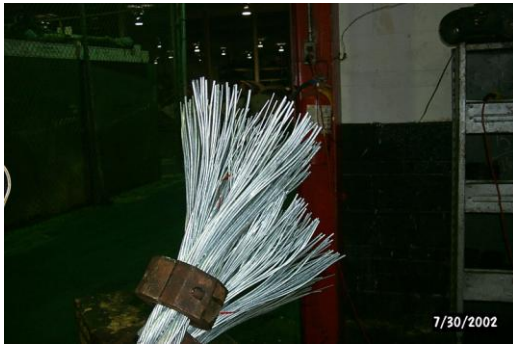
Photo 1

The spltering process requires the individual wires of the cable be separated into a broom configuration as shown in photo 1. The broomed wires are cleaned and inserted into the cone of the termination as shown in photo 2. The socketing medium is cast in to the cavity and allowed to solidify forming a solid composite of socketing medium and wires. The most widely used socketing medium material is ASTM B6 High Grade Zinc. It is an inexpensive product that provides an efficient end termination while protecting the cable from corrosion. The assemblies are proof-loaded to seat the wedge and prove the bond between the wires and the socketing medium.

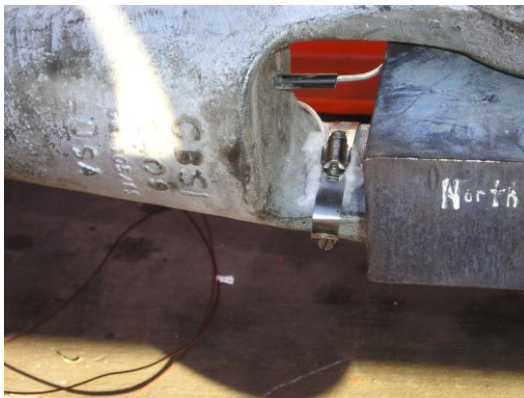
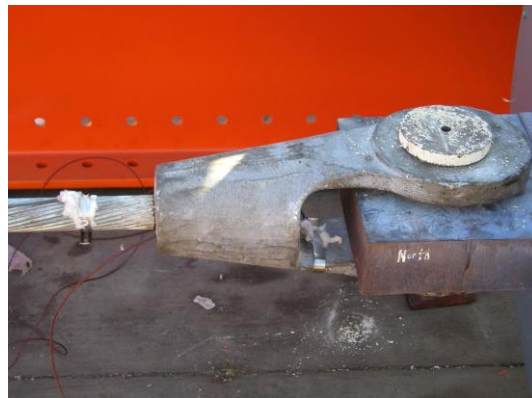
Sample # 1 was prepared with a 1/8" diameter well tube inserted into the socketing material to allow the placement of a thermocouple into the socket basket. The second thermocouple was attached to the inside of the socket ear, see photo 3 and 4.

Photo 3, Test # 1

Photo 4, Test # 1

The results for test # 1 are shown below. The total test time inside the oven was 160 minutes at an average oven temperature of 987.6 F (530.9 C). The socket temperature and well temperature came close to the oven temperature due to the time exposed in the oven. The test was completed at 160 minutes after the strand failed 4" from the base of the socket as shown in photo # 2. An examination of the socket showed no movement of the wires in the socket basket. The strand failure was due to the annealing of the wires. The socketed assembly was exposed to temperatures in excess of 900 F for 150 minutes prior to failure.

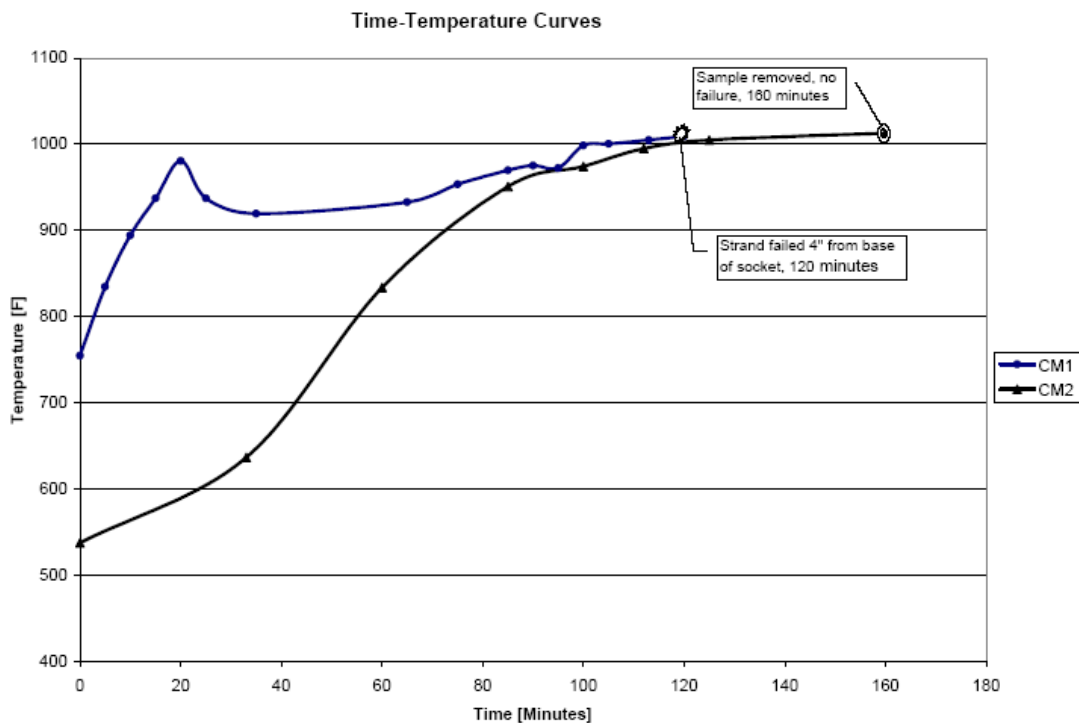
Tests #1 & #2, CM Socketing Material

A graph of test # 1 and # 2 is shown below. The Time-Temperature curves vary due to the time required to heat the oven. Test # 1 was performed in the midday and Test # 2 was performed in the early morning. Both samples were in the 900-1000 F range for approximately 100 minutes prior to terminating the tests. The temperature on the graph is the average oven temperature.

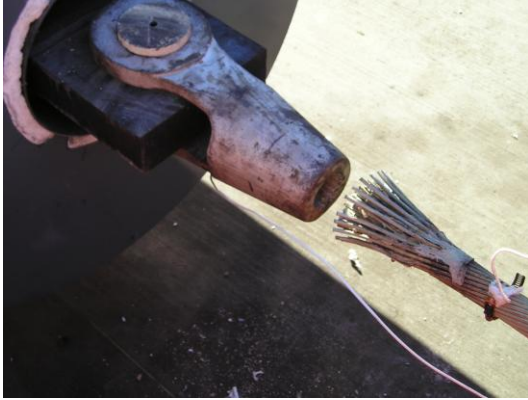
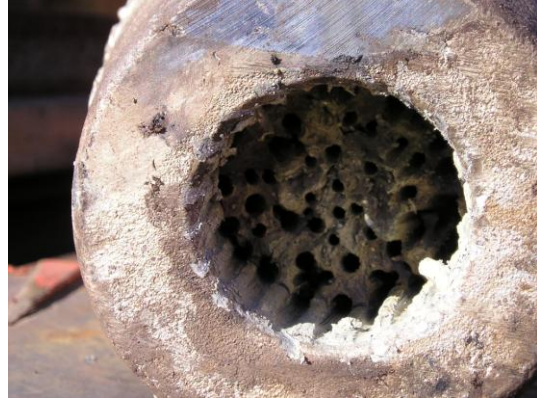
Tests #3 and #4 were performed with traditional socketing material of zinc and resin respectively. The strand for both samples was 1-1/2" diameter ASTM A586 Grade 1 galvanized strand. The target temperature for samples #3 and #4 remained at 1,000 F (538 C). Sample # 3 was socketed with zinc material and failed after 47 minutes of exposure never reaching the desired set point temperature. The zinc partially melted from the socket basket losing the mechanical properties required to maintain the load ultimately releasing the strand. Photos 5 and 6 below show the zinc socket sample after failure.

Photo 5, Zinc Test # 3

Photo 6, Zinc Test # 3

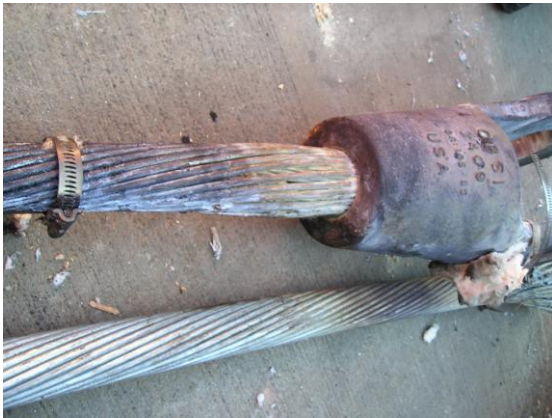
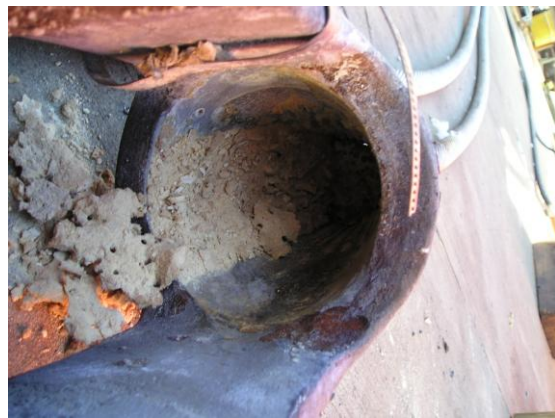
Photo's 7 and 8 show the resin sample after removal from the oven. The strand had slipped approximately 5" from the socket. The resin lost all mechanical abilities turning the socket medium into a fine particle.

Photo 7, Resin Test # 4

Photo 8, Resin Test # 4

Sample # 4 was socketed with resin material and failed after 27 minutes of exposure without reaching the 1,000 degree target. The resin material combusted and began to burn after 15 minutes of exposure in the oven. At the time of failure the socket had only reached 521.6 F (272 C).

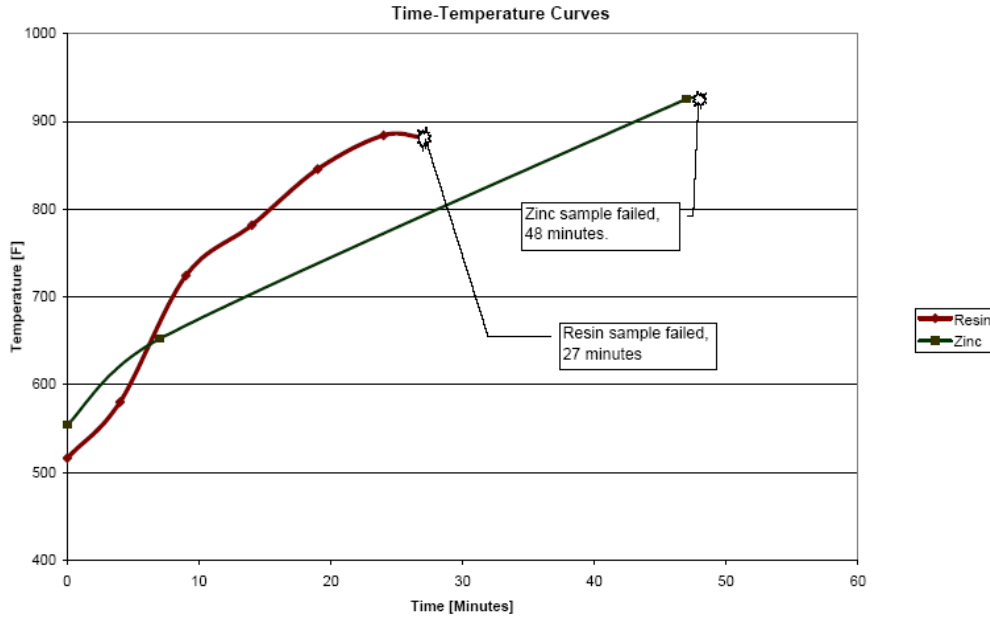
Test #3 & #4, Resin and Zinc Socketing Material

The graph below shows the Time-Temperature curves for test 3 and 4. Neither sample reached the target temperature of 1000 F (538 C) prior to failure. Both tests resulted in failure due to the socketing material weakness. The temperature on the graph below is again the average oven temperature. The temperature of the sockets at the time of failure was significantly less.

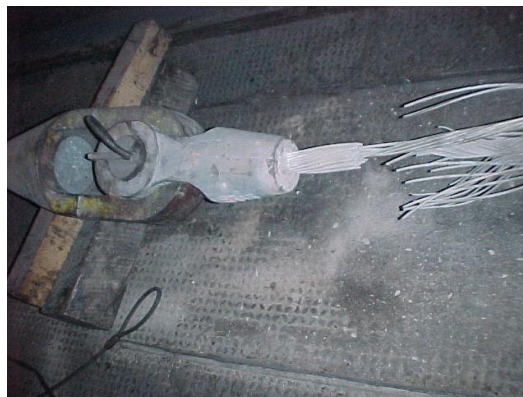
Test #5 was heated in the oven for a total of 100 minutes before terminating the test. More importantly the sample was above 900 F (482 C) for more than 60 minutes during the testing. The sample was removed and inspected. No movement or slippage was measured in the socket basket. The sample was tensile tested with an ultimate tensile strength of 325,395 lbs. This is approximately 75% of the nominal catalog strength of 432,000 lbs. The tensile strength of the structural strand was again reduced due to the heat exposure. The failure occurred approximately 4" from the socket base, see Photo 9. This indicates the ability of the socketed connection to develop the strength of the structural strand after the exposure at temperatures is excess of 900 F for 60 minutes,

Photo #9, Tensile test of sample # 5

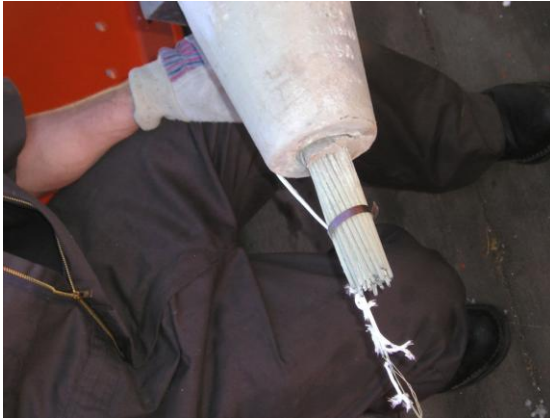
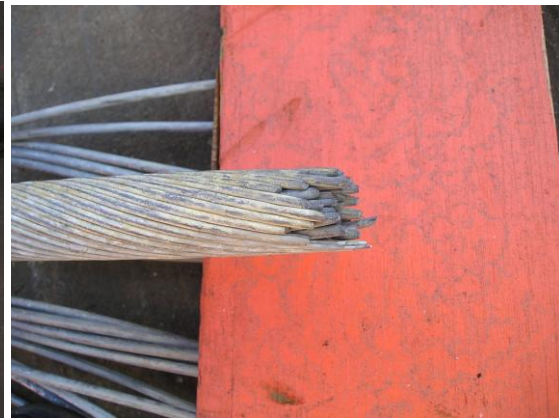
The oven was not capable of heating the sample quickly causing the strand to anneal prior to reaching the target temperature. Photos 10 and 11 below show the failed sample. The high temperature exposure resulted in necking and ultimate failure of the strand.

Test # 6 increased the target temperature to 1,200 F (649 C) for the sample. After 73 minutes in the oven the strand failed 4" from the base of the socket prior to reaching the target temperature.

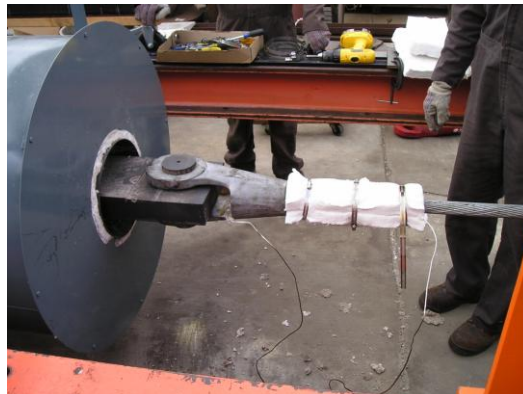
Photo # 12, Test 7

Due to the previous results for test # 6 the strand in test # 7 was insulated to deflect the heat away from the strand. 1" insulation was wrapped around the strand for approximately 12" from the base of the socket as shown in photo # 9. The socket body remained exposed to the heated environment. The strand for test # 7 was 1-1/2" diameter ASTM A586 Grade 1 galvanized strand. The target temperature for sample was 1,200 F (649 C). A static tension of 56,000 lbs. was applied to the sample during the heating.

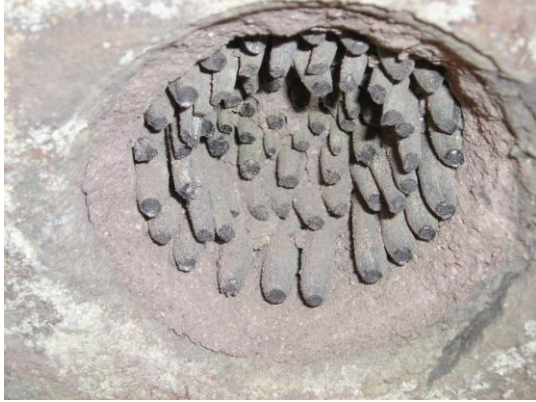
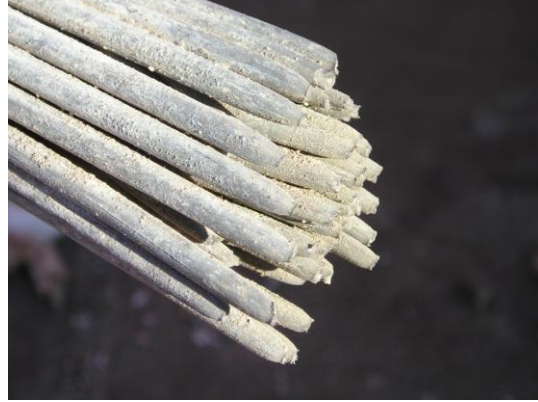
The results of test # 7 showed the materials ability to withstand temperatures up to 1,200 F (649 C) without losing the mechanical properties required to sustain loading of the sample. The total exposure time of the sample was 135 minutes. The total exposure time of the sample in range of the target temperature was approximately 90 minutes. The temperature of the socket body was 1,056 F at the time of failure. At 135 minutes the strand failed at the base of the socket. As before the strand failed due to annealing of the wires. Photos #13 and #14 show the necked condition of the wires at the failed connection. A close examination of the socket showed no movement or distortion in the socketing medium up to the time of failure. An examination of the face of the CM socketing medium showed no cracks or distortion.
