Unique Way Of Replacing Main Counterweight Ropes Burlington Canal Lift Bridge Burlington, Ontario, Canada

**Abbas Khan, P.Eng. & Clare Lamont
Public Works and Government Services of Canada**

HEAVY MOVABLE STRUCTURES, INC.

TENTH BIENNIAL SYMPOSIUM

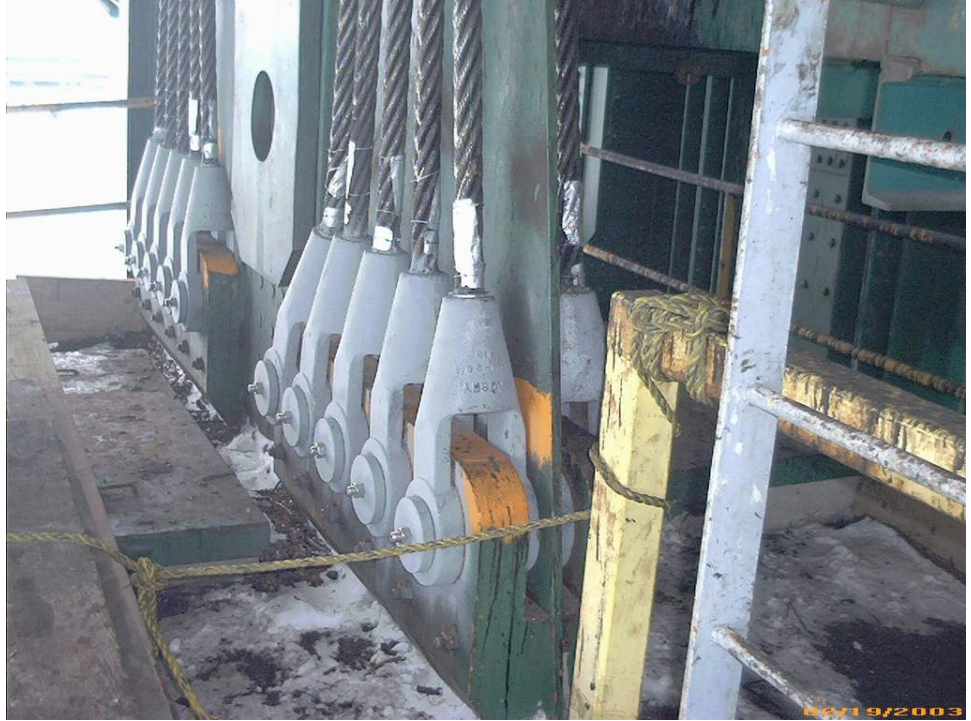
New Ropes Attached at Counterweight

As part of a feasibility study for the project work, it was anticipated that the removal and installation of the ropes would be accomplished by removal of the sheave shroud and panels from the machinery rooms. Cranes positioned off the approaches or on barges from the canal would then lift the new ropes up the tower. However after several proposed schemes, the contractor used very a simple winch and pulley system to remove the existing and install the new wire ropes. A simple trolley system that attaches to a socket at one end of the rope was used (See figures 1, 2, and 3). To protect the new ropes, each rope was partially covered in plastic tubing. Although the process appeared complicated, the contractor worked very efficiently, increasing the number of ropes installed from about 2 per day to 8 per day there by maintaining the contracts aggressive schedule.
