Performance/Construction/Maintenance

Reconstruction of the Third Avenue Bridge over the Harlem River in New York City

**Jay A. Patel, P.E.
Rahul P. Shah, P.E.
NYCDOT, Division Of Bridges**

TENTH BIENNIAL SYMPOSIUM

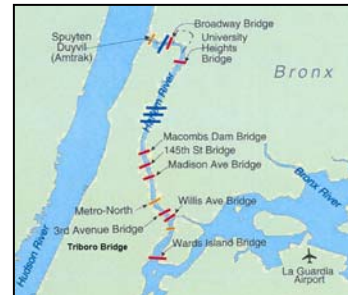
Figure 2: Location of Harlem River Bridges

All Harlem River movable bridges are operated by a six-person “Rolling” crew. This crew can be divided such that two bridges can be opened simultaneously. All Harlem River bridges require four-hour advance notice for marine opening. As per current US Coast Guard Regulations, these bridges can be opened between the hours of 10:00AM and 5:00PM on weekdays. Emergency openings can be performed any time. Figure 2 shows the location of Harlem River movable bridges.

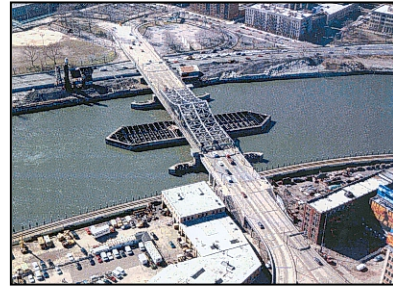
Figure 4: Aerial View of the Third Avenue Bridge

The existing Third Avenue Bridge connects the boroughs of Manhattan and the Bronx and crosses the Harlem River Drive, the Harlem River and the Oak Point Link Railroad. This structure consists of through-truss movable swing span, 29 multi-girder approach spans and 1 reinforced slab approach span. The total length of this structure is 1,269 ft with skew angles of various piers varying between 0 – 4 degrees. The curb to curb roadway width is 58 ft and there are two sidewalks, which are 7'-3" wide. There are four traffic lanes on the bridge with speed limit posted at 30 MPH. The bridge is also posted for vertical clearance of 13'-10" at the portals of the swing span through trusses.

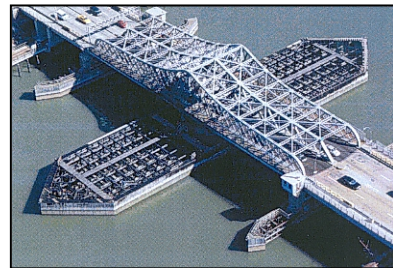
Figure 5: Swing Span of the Third Avenue Bridge

The movable span over the Harlem River is a swing-type bridge and is located between the Madison Avenue Bridge to the north and the Willis Avenue Bridge to the south. The present bridge carries four lanes of traffic from the Bronx into Manhattan. It also carries two sidewalks. This structure spans over the Harlem River Drive, the Harlem River and the Oak Point Link railroad.

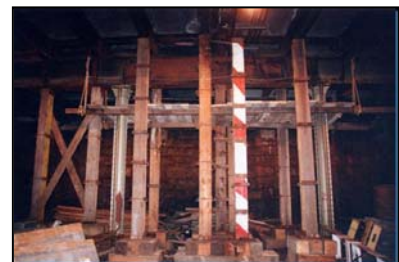
Figure 7: Temporary Shoring supporting the superstructure steel

For the swing span, some of the diagonal members of the outer truss exhibited slightly buckled angles. The lower chord members, below the roadway deck, exhibited significant section loss and heavily deteriorated rivet heads. Floorbeams exhibited deterioration in the bottom six inch portion. Superstructure steel in both the Manhattan approach and the Bronx approach spans is in marginal condition. Superstructure steel of the Bruckner Boulevard Ramp, which was built in 1956, is in poor condition.

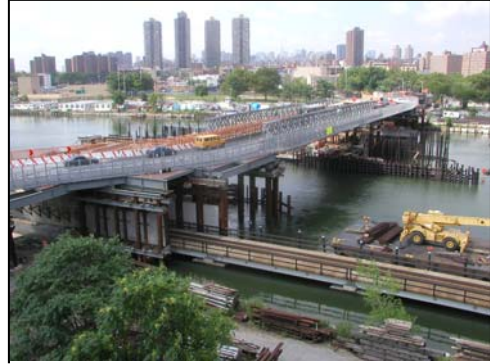
Figure 12: Temporary Bridge over the Harlem River

In order to maintain two lanes of traffic during the replacement of the swing span, it was necessary to construct a two lane wide temporary bridge (fixed span) to the north of the swing span. As a result, a permit was obtained from US Coast Guard to deviate from the regulation for bridge operation for taller vessels to pass underneath. The temporary bridge would be dismantled after the new swing span is constructed and commissioned to carry the traffic.

The employment of a temporary bridge was necessary to maintain two lanes of Manhattan-bound traffic at all times for approximately 6 months, because the demolition and replacement of the swing span could not be performed with traffic on the span. The alignment of the temporary bridge is immediately north (3 meters fascia to fascia) of the alignment of the Third Avenue Bridge, with two reverse curves that connect the new approaches.

The temporary bridge was a series of temporary approach spans made from steel girders and steel deck that were connected to the two main river spans. The river spans are fixed spans by Mabey Bridge and were assembled off site in Brooklyn NY prior to delivery to the Harlem NY site. Upon the completion of their use on the Project, they will likely be recertified by Mabey and reemployed by another owner at some later date. The approach spans will be dismantled and materials will become the property of the Contractor after demolition. The spans are supported by pipe piles and a series of steel bents, and the wearing surface is 2 – 3 inches of bituminous concrete top course.

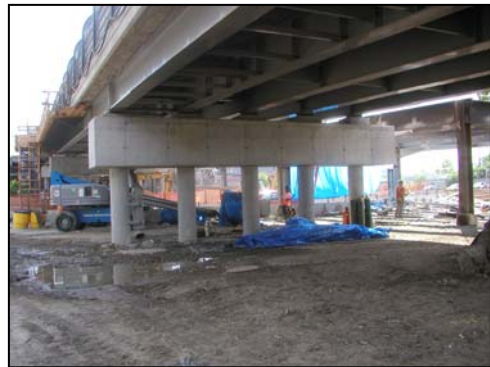
Figure 13: Typical Pier Configuration for the Approach Spans

The Third Avenue Bridge is an online replacement of the swing span and the approach spans. All substructure elements were replaced on the same alignment as that of the existing structure. Foundations for the piers in the Harlem River consisted of 6 ft diameter reinforced concrete Drilled Shafts. These shafts were approximately 100 ft long and are socketed into the bed rock. Foundations for approach spans consisted of 2 ft diameter Cast-In-Place Pipe Piles. The above ground portion of these piles would eventually act as the columns of these piers. These columns will be connected with a cast-in-place concrete cap beam. In addition to the 2 ft diameter Pipe Piles, the approach substructure also included H-Piles and Mini-Piles at some locations.

Land approaches employed h-piles, open ended pipe piles, and mini-piles, designed for seismic conditions. The foundation types varied from pier to pier, with h-piles being the most straightforward to drive. Open ended pipe piles, 2-feet in diameter, also doubled as above grade columns that aesthetically protrude from the ground to a cast-in-place pile cap that support the concrete deck spans. Care was necessary to avoid a "piping" condition when driving the open ended piles. Piles sometimes required immediate concrete placement upon excavating and placement of reinforcement, to avoid lost stability from quick conditions of soil below land piers that are close to the river edge.

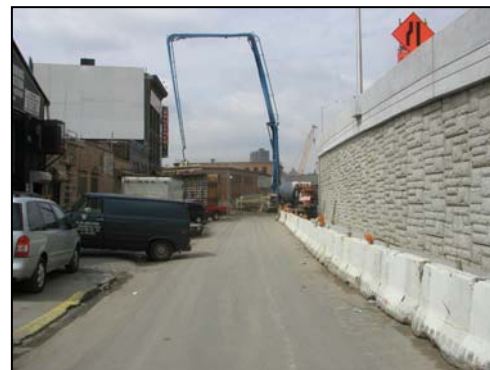
Figure 14: MSES Retaining Wall

All approach ramps were designed to be Mechanically Stabilized Earth System (MSES) retaining walls. This precast system was selected for rapid construction,

minimum disruption to the local community, and minimum impact to the surrounding/infrastructure.

The roadway embankment approaches were constructed with little encroachment of properties outside of the City's ROW. To work outside the ROW in the City of New York involves detailed multi-agency coordination that could have delayed the Project's commencement. One method of avoiding the need to encroach the ROWs was through the employment of Mechanically Stabilized Earth Systems (MSES) walls as retaining walls that encapsulate the fill for the inclined ramps in both Manhattan and the Bronx. These walls are a matrix of interlocking precast members held in place by the gravity of the earth behind them as it bears on metal straps that protrude into the earth perpendicular and attached to each precast wall panel. The wall strength is developed from the earth bearing on the straps and the interlocking character of the vertical panels. This eliminated the need for larger spread footings that would have caused damage and interruption to the use of New York City Parks Department property in Manhattan, and local streets in the Bronx. As an added feature, the walls are aesthetically pleasing and provide a finished product that is context sensitive.

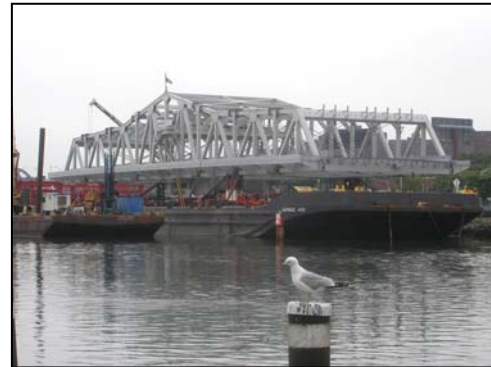
Figure 15: New Two-truss Swing Span

The new swing span consists of two Warren trusses connected with top and bottom lateral bracing. The new swing span will carry five lanes of traffic between the trusses and one sidewalk on outer side of each truss. The flooring system consists of floorbeams spanning between the trusses and multi-girders, which are framed into the floorbeams. The final roadway consists of a concrete filled steel grid deck system with 2" overfill with light weight concrete. The truss members are welded box members with bolted connections.

The entire dead load plus impact forces associated with the operation of the swing span is transferred to the pivot pier through Spherical Roller Thrust Bearing. This bearing has a capacity to safely support nearly 6 million pounds of service loads and one million pound of horizontal forces during an seismic event. The span drive machinery is mounted in the control house at the center of the span. The end lift machinery is mounted directly on top of the rest piers and will lift each corner by 1" to ensure positive contact. The turning machinery's main motors are rated at 150 HP and are located in the control house. The horizontal shafting extends the drive train from the differential reducer output shafts through the control house walls to engage bevel gear boxes that are positioned in-line with each of the trusses. The vertical shafting extends down from bottom of bevel gear boxes through the plane of the truss and engages the main reducers mounted to the underside of span floor system.

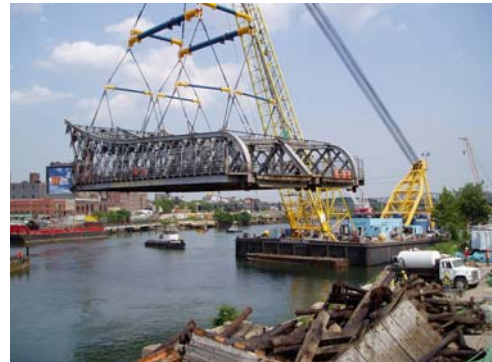
Figure 17: Demolition of Existing Swing Span

A procedure was submitted and approved for the dismantling of the existing swing and flanking spans and lift them out of position with the crane, *Chesapeake 1000*, rated as a 1000 ton crane that is mounted on an ocean worthy barge. The sections to be removed included:

- Manhattan Flanking Span – First Section.
- Manhattan Flanking Span – Second Section.
- Bronx Flanking Span.

- Manhattan Draw Span (1/2 of the existing swing span).
- Bronx Draw Span (1/2 of the existing swing span).
- Center Pier Girder System.

Of the six sections, all but the Manhattan Flanking Span – second section were removed over a five day period between June 28 and July 2, 2004. On July 28 – June 1, sections of least stability were removed, because NYCDOT allowed 15-minute traffic stoppages on the temporary bridge between the hours of 10am and 3pm, and it was mandated by the Resident Engineer that the picks be made with no traffic on the adjacent temporary bridge span, during the period of time when the load was transferred from its at-rest position on the piers to the crane. The temporary span fascia is approximately 3 meters away from the fascia of the existing swing span. Kiska plans to remove the remaining portion of the Manhattan Flanking Span through conventional methods with one of their larger yard cranes.

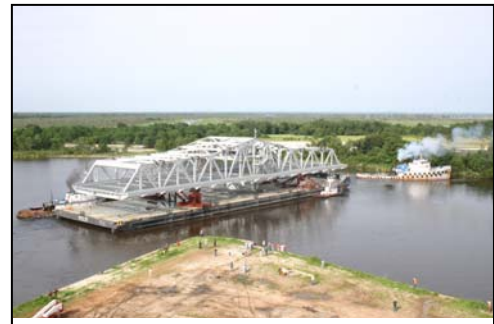
Figure 18: New Swing Span leaving Alabama

The Contractor’s specialty contractor, Mammoet, was employed to move the truss from its erection site on land, to the ocean transport barge in an adjacent berth. This involved the use of a their custom made “transporter”, which is a multi-axle flatbed, controlled with a joy-stick type control pad, that lifted the entire truss and “walked” it on to the transport barge. This process took approximately 6 hours. The truss was then sea-fastened to the Marmac 400 barge (100 ft x 400 ft) and set sail for New York City on June 27, 2004. It arrived at Ambrose Light, approximately seven miles from Sandy Hook NY, on July 6, 2004, and arrived in Harlem on July 8, 2004.
