Miller Park – Pivot Bearing Replacement

**John A. Gimblette, P.E.
Hardesty & Hanover, LLP**

HEAVY MOVABLE STRUCTURES, INC.

TENTH BIENNIAL SYMPOSIUM

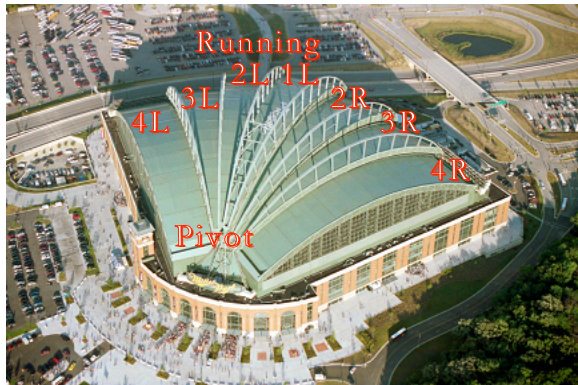
Photo 1: Roof panels shown in the closed position.

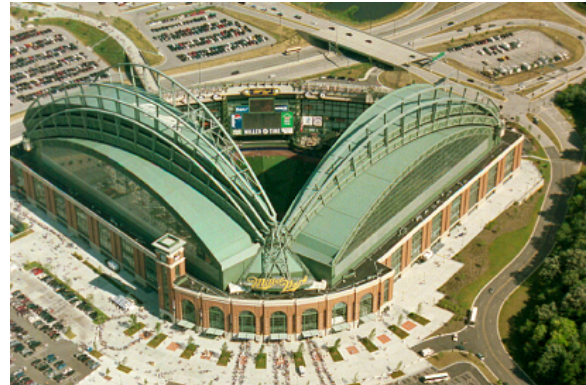
Photo 2: Roof panels shown in the open position.

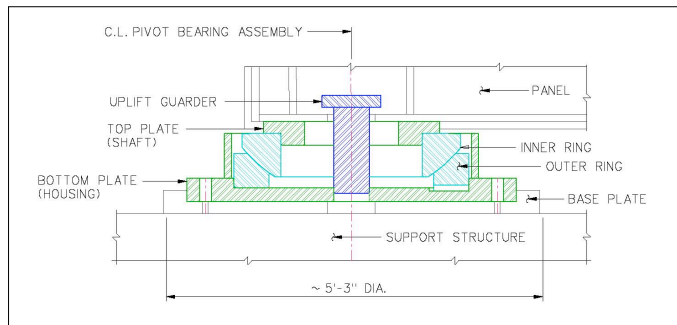
The original pivot bearing assemblies were made up of (4) four major components, the top plate (shaft), spherical plain thrust bearing (SPTB), bottom plate (housing) and base plate. Given the design details, it was our understanding that fabrication and assembly occurred as follows:

- The top plate (shaft) was welded to the underside of the roof panel's pivot end (tub)
- The top plate (shaft) was machined after welding and stress relieving
- A lube retainer and uplift guarder post were welded to the bottom plate (housing)
- The bottom plate was machined after welding and stress relieving
- The base plate was machined and prepped for field welding

Figure 1: Original pivot bearing assembly with spherical plain thrust bearing - steel on steel.

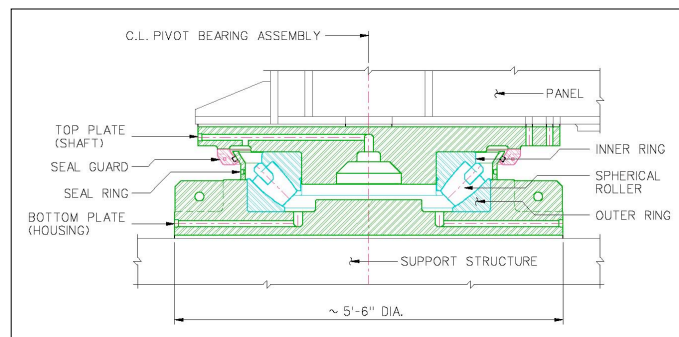
During design, an extensive coordination effort was spent with the selected bearing manufacturers to ensure that adequate stiffness of the supporting elements of the bearing was achieved. Because the details of the existing structure that dictated load paths, such as bearing stiffener locations could not be changed, development of details to ensure even distribution of load to the bearing rollers was not straightforward. Ultimately, housing details were developed that met bearing manufacturer requirements for load distribution and worked within the constraints of the existing structure.

Figure 2: Replacement pivot bearing assembly with spherical roller thrust bearing.

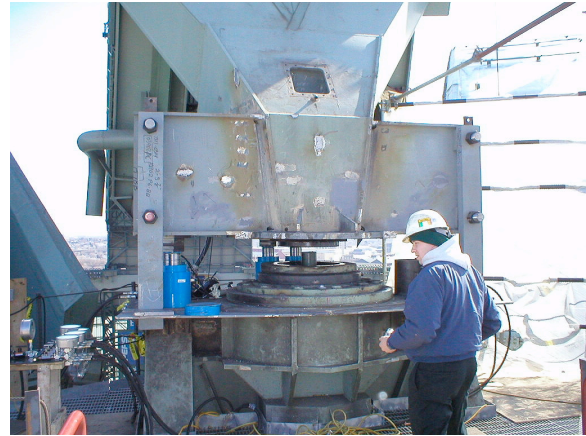
Photo 3: Panel 1L, pivot end shown in the raised position prior to removal of original bearings.

In order to successfully remove the original assemblies, LZA designed a plan where the roof panels were secured in their “jacking” position, working platforms were fabricated and installed at each pivot location and jacking brackets were fabricated and welded to the fixed and retractable roof structures. The jacking brackets enabled hydraulic jacks to lift the retractable roof panels, transferring associated roof loads from the original assemblies to the brackets. The load at the pivots ranged from 1,400,000 lbs to 2,000,000 lbs (or 1,400 kips to 2,000 kips). With the brackets properly positioned, secured, tested and loaded, the original assemblies were removed by machining through the welds used to secure the top and bottom plates to the roof panels and support structure, respectively. The assemblies were removed carefully so as to minimize the surface damage to the existing structure, which would be the mounting surface for the replacement assemblies. The original assemblies were also immediately crated and preserved for forensic testing at a later date.

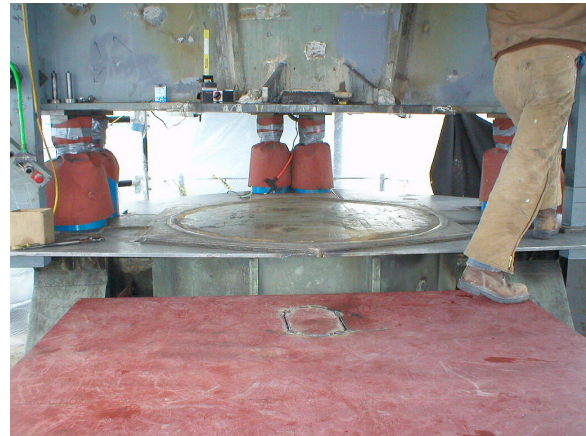
Photo 4: Panel 1, pivot end shown in the raised position after removal of original bearing.

With the original assemblies removed and the roof panels supported by jacks, the top surfaces of the fixed structure were measured for levelness and flatness and bottom surfaces of the roof panels were measured for flatness. The goal was to install the replacement assemblies so that the majority of the bearings misalignment capacity would be utilized during panel movements rather than during installation.

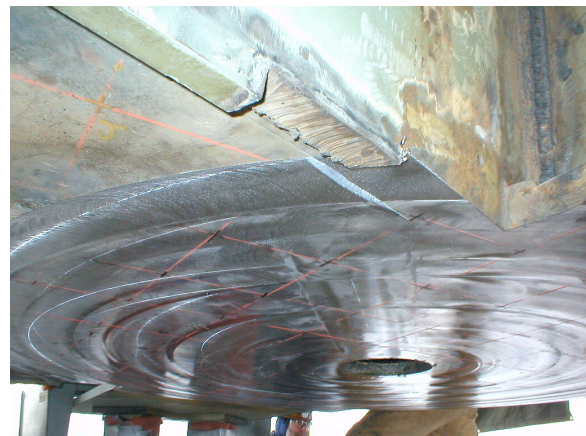
Photo 5: Panel 1L, bottom surface of roof panel after field machining.

Having measured the top surfaces of the fixed structure, a “best fit” plane was determined in order to field machine the existing mounting surface flat to within 0.010-inch by removing a minimal amount of material. The machining effort allowed for a tapered lower shim plate of equal flatness to mate with the field machined surface and provide a level mounting surface for the replacement assembly. Based on the measurements of the bottom surface of the roof panels, a “best fit” plane was determined in order to field machine an area larger than the existing mounting surface flat to within 0.010-inch by removing a minimal amount of material. Because the

replacement assemblies upper housing was significantly larger than the original, this machining effort was necessary to allow for proper mating with the roof panel.

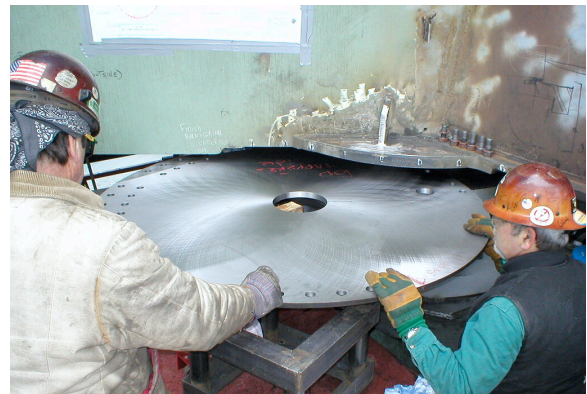
Photo 6: Panel 3L, installation of upper shim plate.

With the upper shim plate fabricated and delivered to the site, the roof panel was raised, transferring load back onto the jacks. The shim plate was installed and the roof panel was lowered just shy of the shim plate. At this point the upper housing plate was verified as being properly centered with the roof panel. The roof panel was then lowered, allowing the load to transfer from the jacking system to the replacement assembly. The vertical distance between the upper and lower housing plates were measured a final time at the same radius along its circumference to verify the bearings position. With the bearing position accepted, the upper shim plate position was secured and the panel was raised, allowing the replacement assembly to be removed for the last time. The pre-drilled upper shim plate was used as a template to drill and tap mounting holes in the roof panel for permanent fasteners. With the drilling and tapping complete, and surfaces cleaned free of machining debris, the replacement assembly was repositioned back into alignment for final securing and testing.

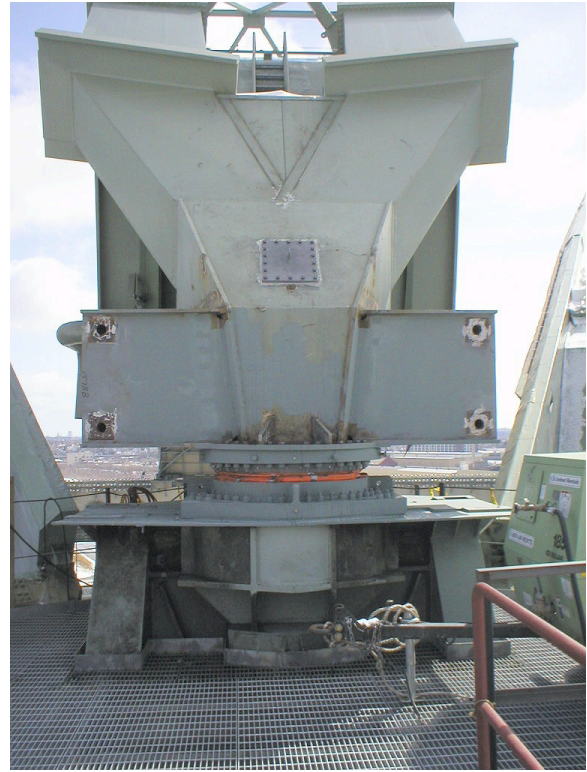
Photo 7: Panel 1L, installation of replacement bearing completed.

Unlike the original assemblies, which were welded to the fixed and retractable roof structures, the replacement assemblies were secured by means of high strength fasteners. This feature minimizes the fieldwork that would be required for any future inspection, rehabilitation or replacement work of the bearings. With remarkable coordination efforts between the owner, the engineers, the contractors and suppliers, workers were able to successfully design, fabricate, install, test and make operational five new pivot bearing assemblies in just 6-months, meeting the projects goal of having the retractable roof panels operational before the first exhibition game on March 28, 2003.
