## **Repair And Redesign of the Spokane Street Bridge Lift / Turn Cylinders**

**A.C. Johnson, Jr. P.E.  
KPFF**

**James M. Phillips, III, P.E.  
E.C. Driver & Associates, Inc.**

**TENTH BIENNIAL SYMPOSIUM**

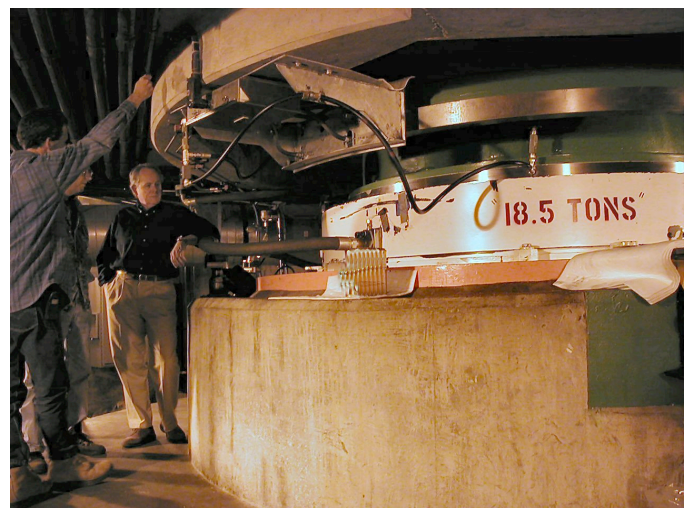
Lift-turn cylinder installed under pivot shaft

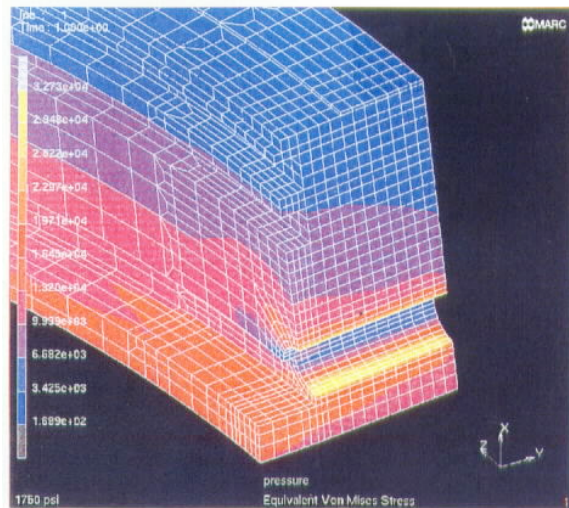
Finite element analysis (FEA) of the original design indicated that principal stresses at the through-barrel hydraulic ports likely exceeded allowable fatigue stresses for an acceptable number of cycles and the barrel material's nominal metallurgy. Calculated principal stresses determined by FEM were found to be significantly larger than stresses estimated using normal stresses modified by published stress concentration factors.

Stress map from forensic study

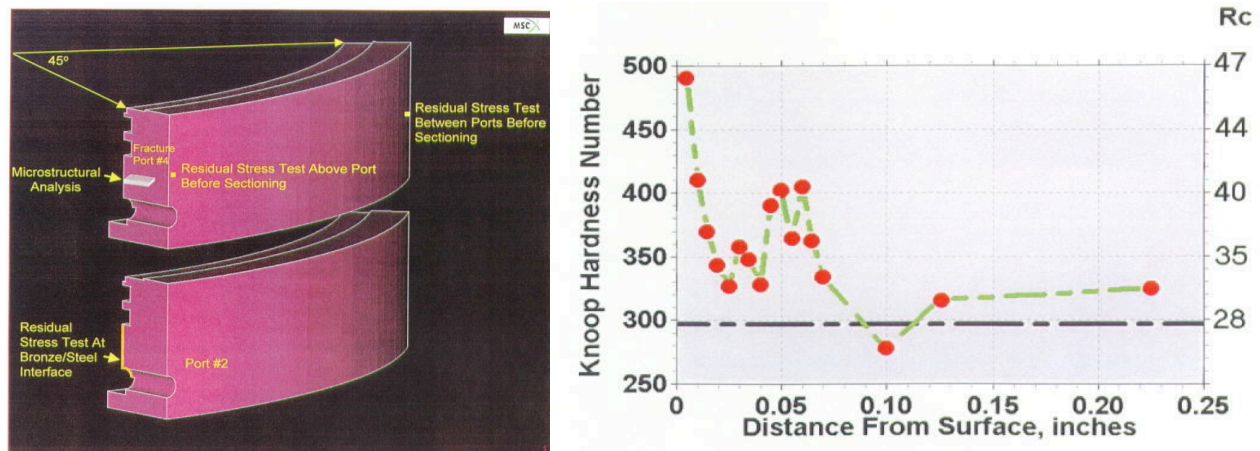
The sliding bearing interface between the cylinder piston and barrel is chrome on bronze. The piston OD is hard chrome plated and the bronze barrel ID was overlayed with bronze by means of a weld overlay process. It is documented that the overlay welding process was problematic from the beginning and that the process was modified over the course of producing three usable barrels. What was not recognized or documented at the time was the creation of large residual tensile stresses at the steel / bronze interface. Testing on the failed part found under-bead stresses as high as 35 ksi. Because these are tensile stresses, they added directly to load-induced stresses caused by normal operation.

Illustrations from forensic analysis indicating high residual stresses in the under-bead heat affected zone

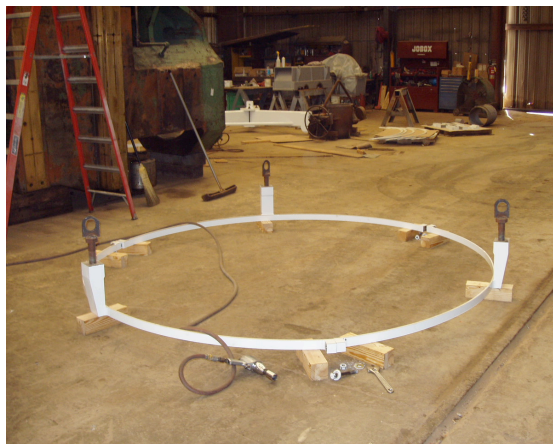
- ❑ A lifting ring - used to lift the barrel or lift/turn cylinder assembly without requiring holes tapped into the barrel as was the case with the original tooling.
- ❑ Piston installation tooling – for use in controlled lowering the piston into the barrel.
- ❑ Lifting Frame – for use in lifting the lift/turn cylinder assembly or major components such as the piston, barrel, or bottom plate.

Lifting Ring

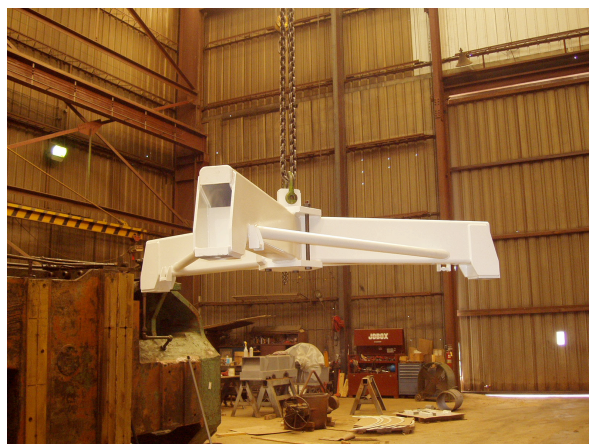
Lifting Frame

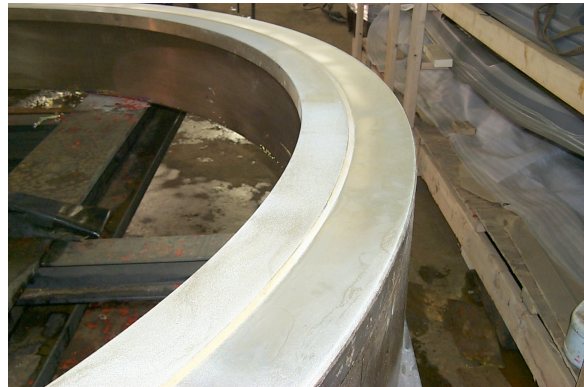
Empire Hard Chrome of Chicago, Illinois performed the barrel chroming. As it turned out, applying hard chrome to the bottom of the lift/turn cylinder barrels was every bit the difficult challenge anticipated. The first barrel assembly had to have the chrome machined off and reapplied. All three barrel chrome surfaces ended up having some degree of indications. Two of the barrels were accepted with minor indications after the indications were inspected in detail and determined not to be harmful or indicative of a systematic problem. However, the third barrel chromed required corrective action for some dime-sized indications. The chrome flaws were repaired using a brush plating process.

Hard Chrome on Barrel

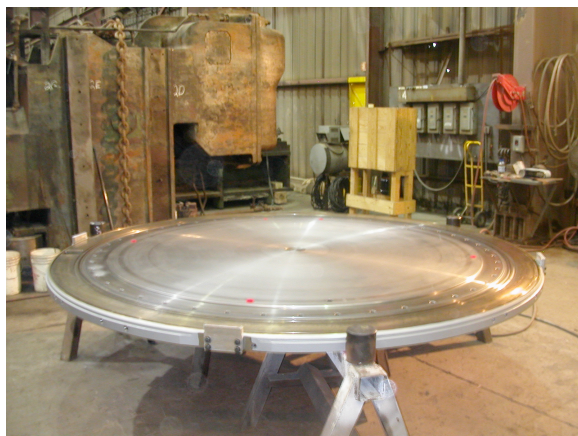
Bottom Plate

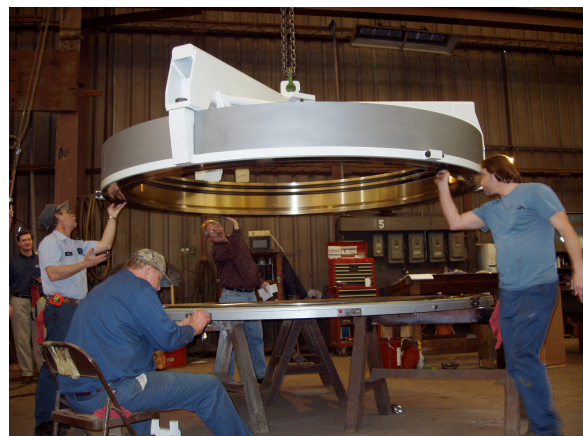
Installing Barrel on Bottom Plate

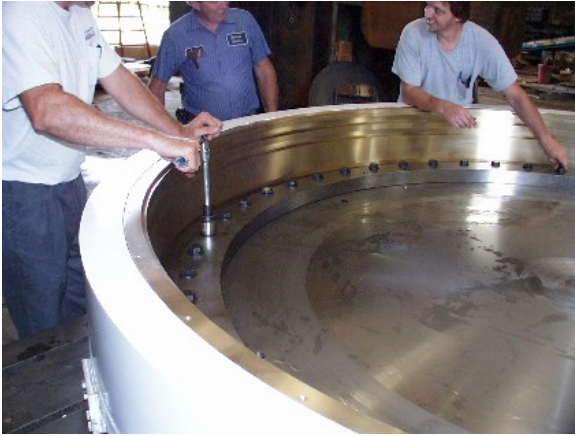
Barrel on Bottom Plate

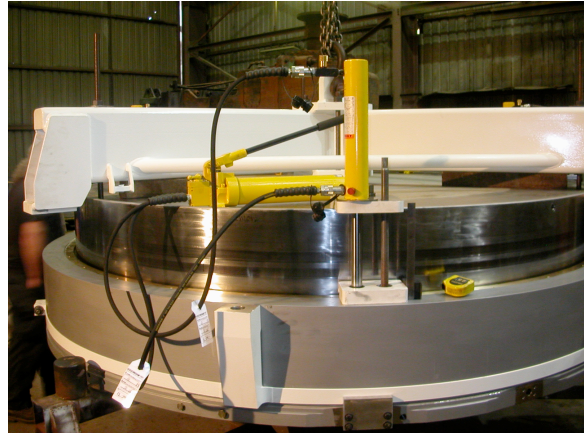
Installing Piston with Tooling
