**HEAVY MOVABLE STRUCTURES, INC.
SEVENTEENTH BIENNIAL SYMPOSIUM**

**Rapid Replacement of
Bayou Sara Bridge Swing Span**

David Knickerbocker, PhD, PE¹;
Kevin Kane, PE²; Israe Zizaoui, EIT¹

1. Henningson, Durham, and Richardson Engineering, Incorporated (HDR)
 2. Brasfield & Gorrie, General Contractors (B&G)
-

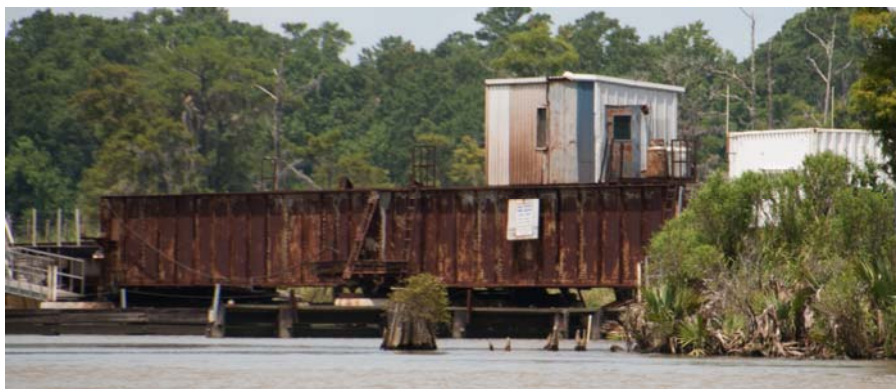
The Bayou Sara Railroad Bridge that was replaced is shown in Figure 2. Built in 1928, it comprised a 162'-2" long steel swing span consisting of built-up riveted steel through-girders, supported on the central concrete pier and two open-deck timber span approach structures of 110'-3" and 104'-2" long, respectively, supported by timber-pile trestles with concrete cap beams. The timber approaches were first replaced in 1958 with new timber approaches, and again in 2008 with concrete box-girder spans.

Figure 2 Bayou Sara Bridge to be Replaced – Built in 1928

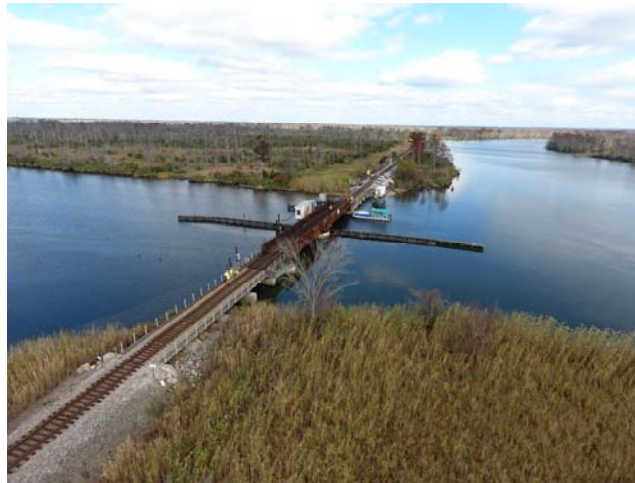
There are some difficulties associated with the site of the Bayou Sara Bridge. The low-lying swampland extending for miles around the bridge site represents an obstruction against consideration for a roadway of any kind for vehicular access. Access to the bridge for local operation, maintenance, inspection, rehabilitation, construction – including material and equipment delivery – is thus limited to marine vessels, and rail-borne passage such as hy-rail vehicles, see Figure 4.

Figure 4 Site Limited Access

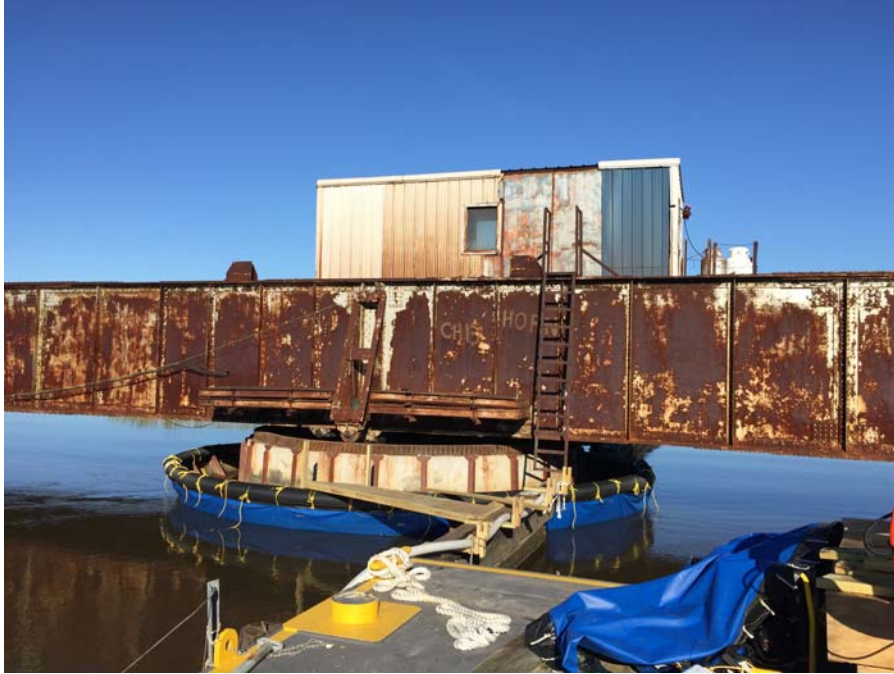
The existing center pier at Bayou Sara was the focal point in planning for the Float-In. A hybrid cofferdam was constructed around the center cap early in the project to provide a working platform 360 degrees about the pier. It utilized a two-stage installation, a synthetic membrane draping the sides, and a small 3" pump to keep water out of the work area as needed. As noted above, approximately 3ft of the existing pier needed to be removed and replaced with a new reinforced concrete cap. Having the ability to access the center pier at all times was crucial. Figure 7 shows the cofferdam setup.

Figure 7 Center Pier Cofferdam

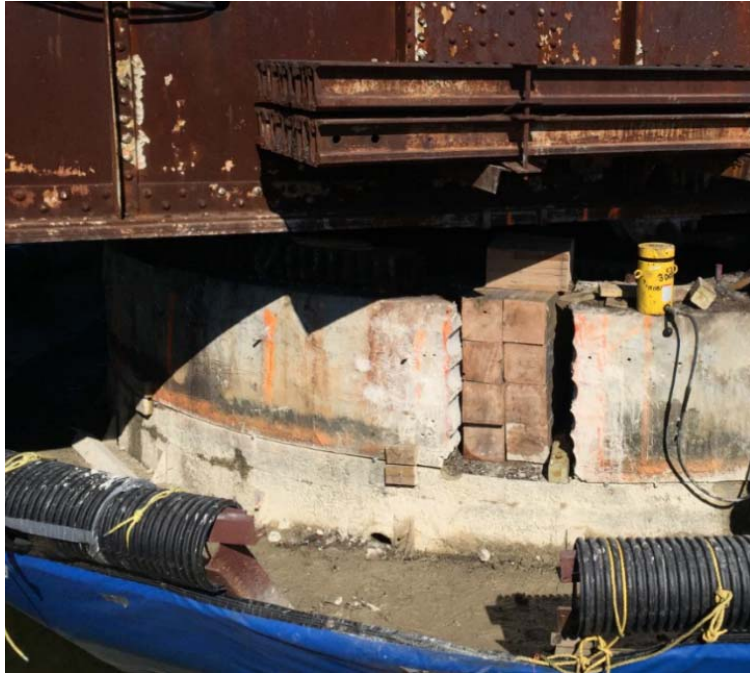
When the outer two thirds of the cap were wire sawed, two 100 ton jacks were used on either side of the blocking pockets to raise the bridge at each support location. Hard timber blocking and a 1" thick steel sole plate were used to support the bridge and lock the blocking in place. The jacking pockets were sealed and secured to prevent shifting under vibrations from live train traffic. The existing bridge was supported for five (5) days prior to the rail outage and monitored daily. This temporary support condition was reviewed by a third-party engineer prior to jacking and blocking the bridge to verify it would not have adverse effects on the existing span. The train speed was also reduced to 10mph during this time as an added safeguard. Figure 8 shows the timber blocking installed just after the span was jacked up incrementally and Figure 9 shows the blocking in its final condition prior to the outage. Note the saw cut line and pilot holes in Figure 9.

Figure 8 Timber Blocking in Pocket

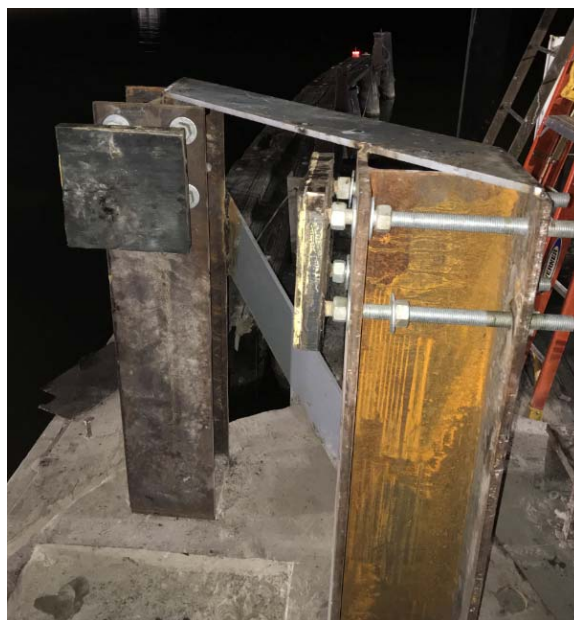
At the rest piers, the new wedge seat anchor bolt holes were cored prior to float-in as the new bridge was four feet wider than the existing bridge. The rest pier concrete at each wedge seat location was also chipped down and smoothed. Steel shim pack bases were installed and epoxied in to provide a level surface for installing supplemental shims up to the bottom of wedge seat elevation. To accelerate horizontal bridge alignment during the float-in, bridge stops were also installed at the back corners and a threaded extension plate was used to align the horizontal positions prior to float-in. Four bridge position stops were installed, but three were utilized, leaving room to float the bridge in and position into one corner (see Figure 10).

Figure 10 Bridge Stops at one Corner

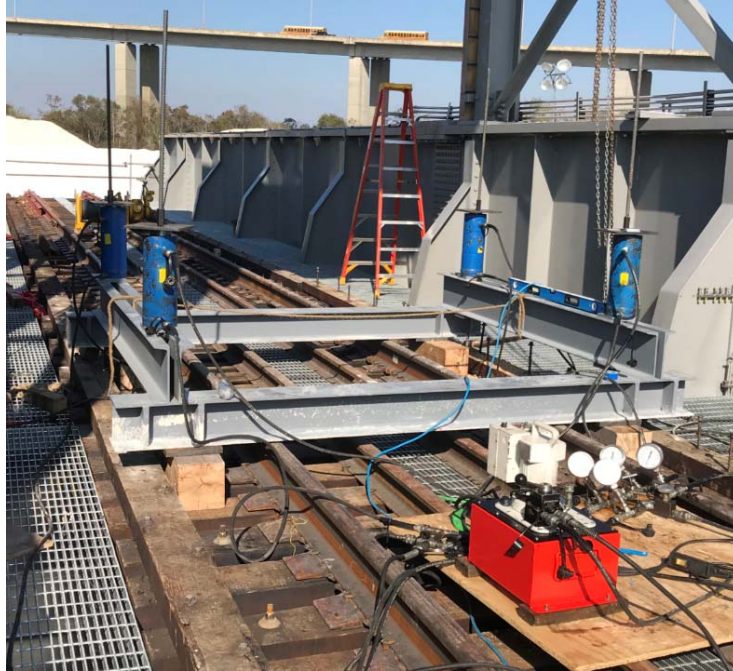
With incorporating the grillage concept, one major concern was machinery alignment and the ability to adjust after the bridge was set in place. B&G opted to perform an alignment check prior to float-in to verify rack flatness and the construction of the grillage frame. When the grillage arrived at the erection site, the bridge was positioned over the grillage using self-propelled modular transporters (SPMTs), which helped accelerate grillage installation. Threaded rods and a jacking frame on the trackside of the bridge (see Figure 11) was used to raise the frame into its initial position. A combination of portapowers, come-alongs, and the jacking frame on the trackside was used to position the grillage and machinery rack in place. A third-party measurement company was used to check the rack flatness and horizontal alignment relative to the center of the bridge and pinion motors. Once the rack was in place, the jacking frame and threaded bars were locked into place, blocking was placed between the balance wheels and machinery rack, and several come-along and ratchet straps were used as cross bracing to limit the grillage movement during the span transport and float-in (see Figure 12).

Figure 11 Grillage Jacking Frame

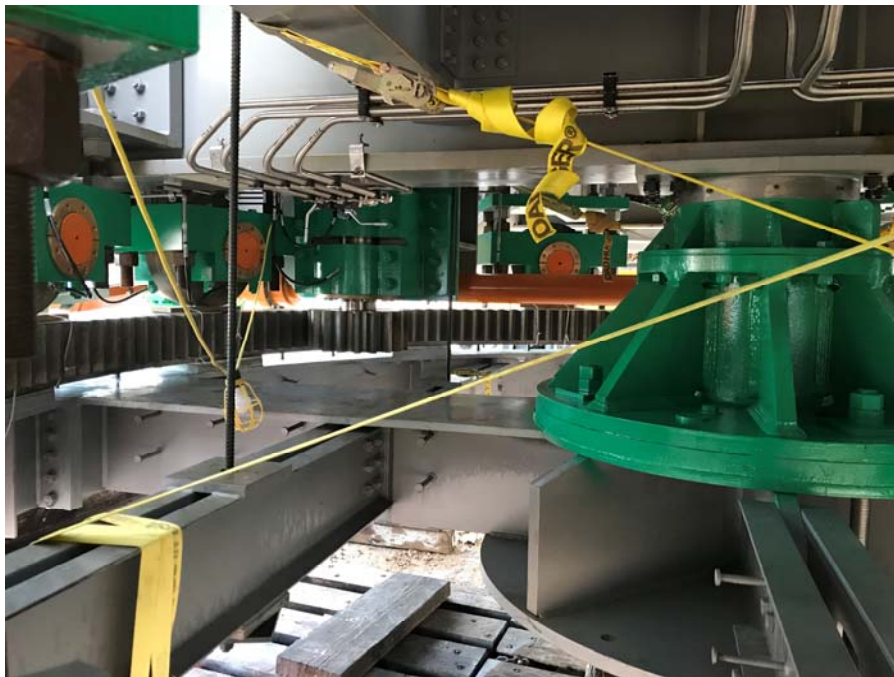
Figure 12 Grillage Frame and Machinery Aligned and Secured Prior to Float-In

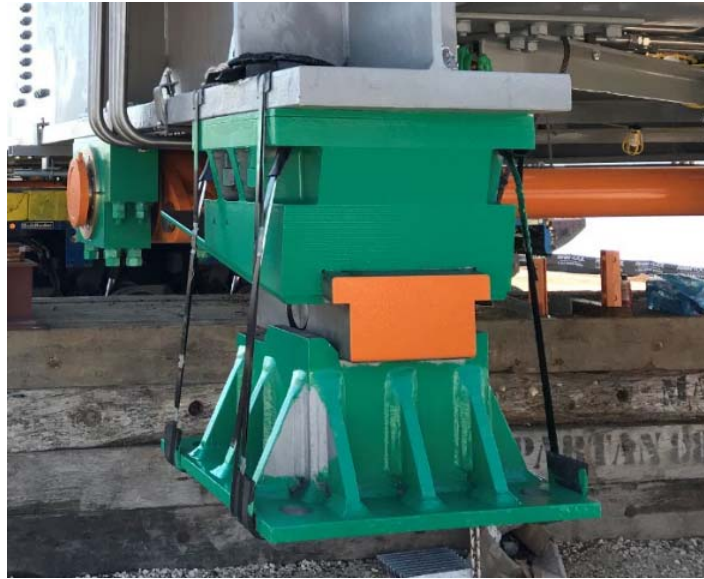
Another key pre-float-in activity was the end wedge seat installation. These seats were over 800lbs and it was not feasible for a crane to set the seats during the float-in due to site logistic and time constraints. Installing the seats on the existing rest piers prior to the float-in was reviewed, but upon laying them out, the existing wedge seats conflicted with the new location by approximately 4 inches. It was then determined that the seats would need to be transported with the span during the float-in. The plan to achieve this was to secure the seats to their respective wedge locations using banding, come-alongs and a backup shackle and cable to secure the seat in the event it fell off prior to or during the float-in. Refer to Figure 13 for a typical configuration.

Figure 13 End Wedge Installation Prior to Float-In

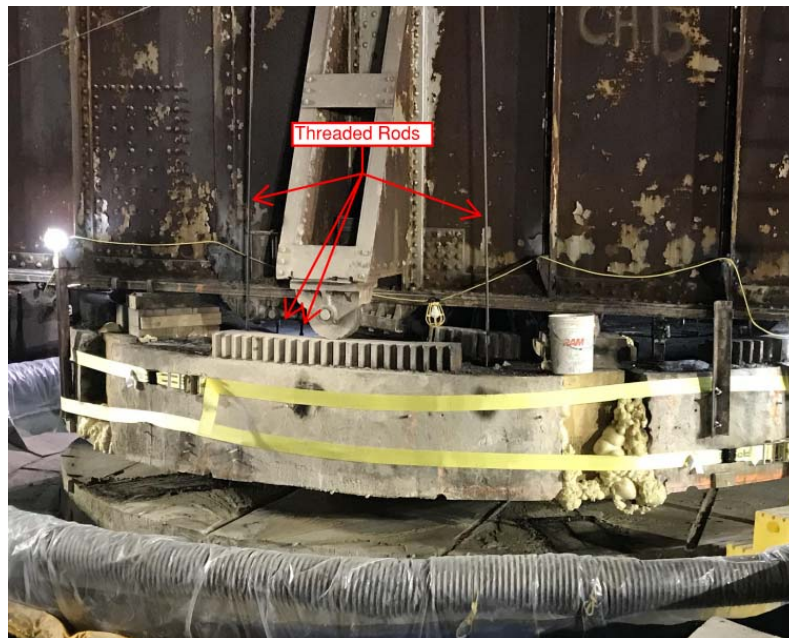
When the float-in began, the center pier crew installed the top support tube steel for the outer rods, coupled the threaded rods together, and welded the couplers in place to lock them in. Two large ratchet straps were also used to provide lateral inward pressure on the cap to help resist major fatigue cracking. As the existing span was raised, the existing cap rose with it in one piece as planned (see Figure 16).

Figure 16 Existing Center Pier Cap Removal

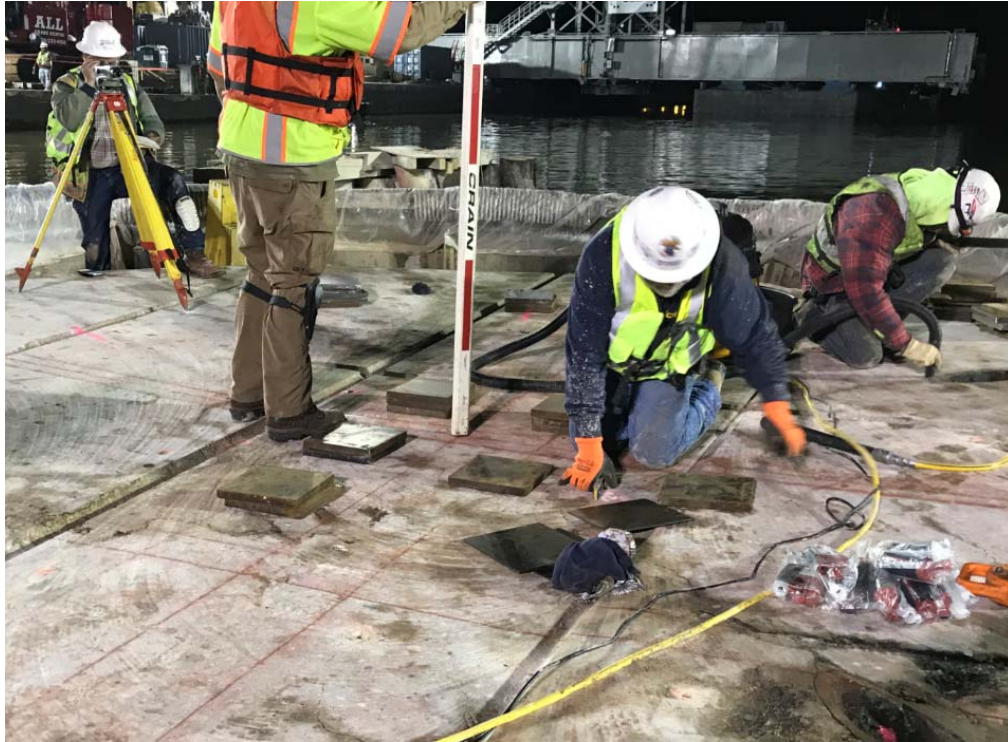
The concept of the grillage frame allowed the dead and live loads to be passed directly through the frame to the center pier. To achieve this, the grillage needed to be supported by steel shims to transfer the load. When the existing bridge and cap were removed, the B&G team immediately began to clean the center pier and prep for shim installation, as shown in Figure 17. A robotic survey instrument was utilized to quickly layout the grillage frame, anchor bolt, and rebar dowel locations on the pier relative the center of track. A level instrument was used to quickly verify elevations as shims were installed. Anchor bolt and rebar dowel holes were drilled during this time as overhead clearance would be limited after the span was set. Multiple hammer drills were used so that coring for dowels and anchors could be done simultaneously in each quadrant to minimize time spent on prep work. Shims were placed in the center pivot and center wedge seat footprints for the grillage to be set directly on them. Fast setting epoxy was used to secure the shims so that shifting would not occur while setting the bridge.

Figure 17 Center Pier Prep Work Prior to Float-In

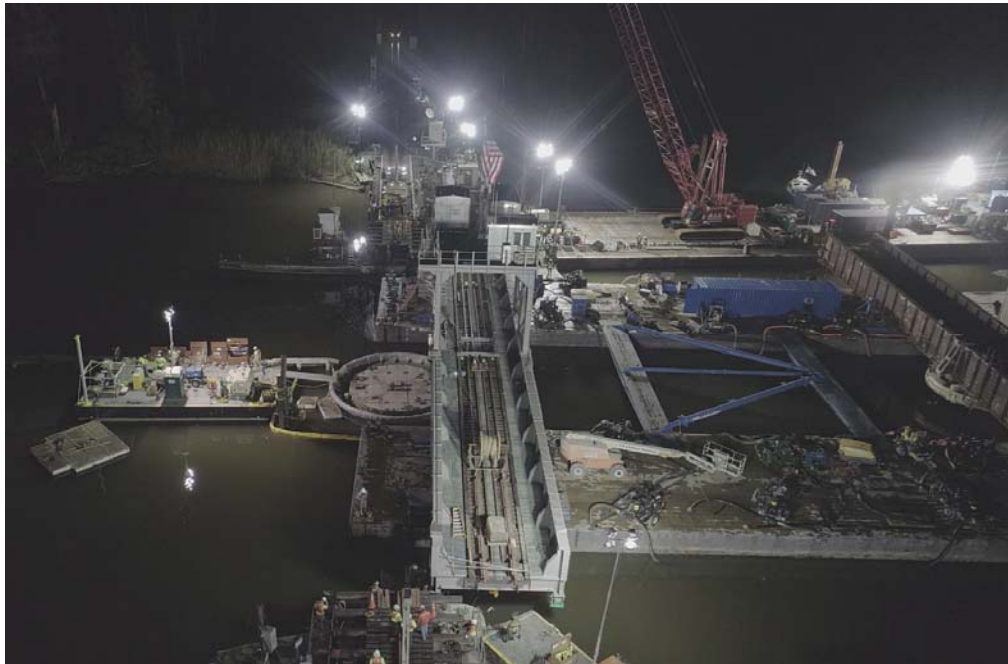
When all anchor and rebar holes were drilled and shim elevations confirmed, the bridge was then floated over the piers – see Figure 18 and 19 – and water was pumped into the barges to lower the span. The pumps were controlled individually, and the span was lowered slowly. When the bridge was roughly aligned horizontally, come-alongs connecting the barge and rest pier on each rest pier side were used to move the span horizontally in lieu of using push boats. Multiple survey points were taken using the robotic survey equipment to verify placement periodically as the span was lowered. When the span was within ¼” of the final elevation, the horizontal alignment was checked at four locations and then lowered into place.

Figure 18 Bridge Float-In Over Existing Piers

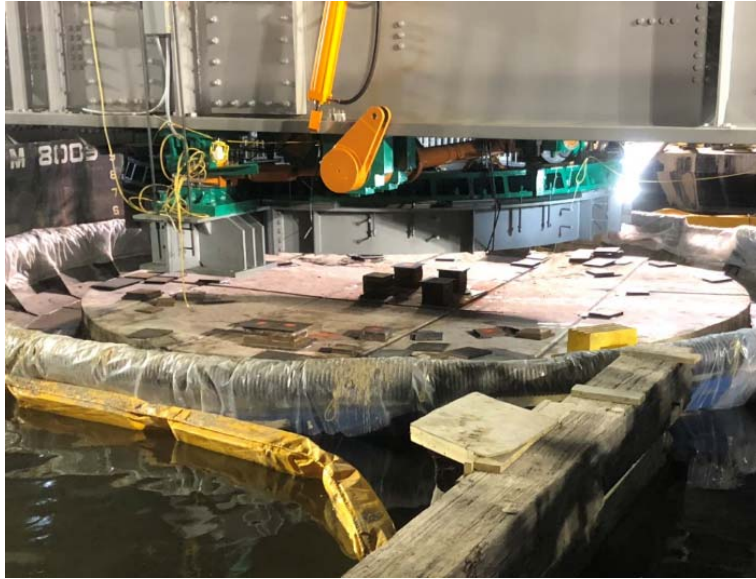
Figure 19 Grillage Alignment Over Center Pier Shims

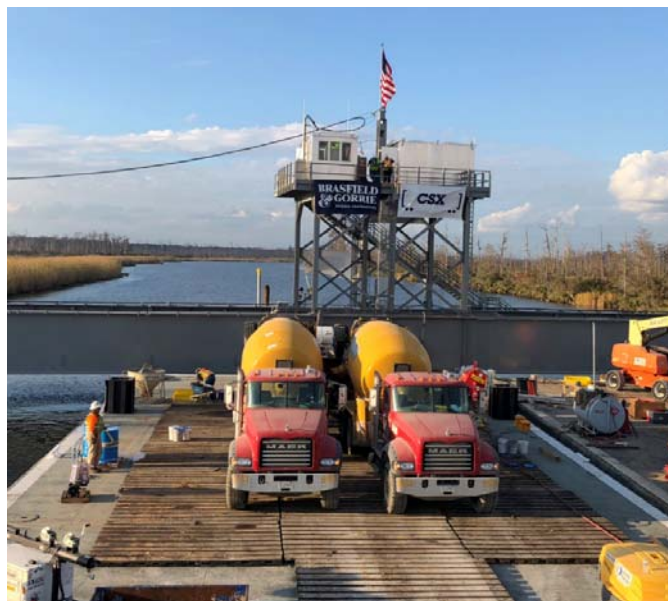
After completing the outage, formwork and reinforcing installation began. Preparations were also made for loading concrete trucks at B&G's offsite erection yard. The pour was approximately 38 CY and the travel time from the plant to the bridge site was approximately one hour. Two barges were used, each holding two trucks and a line pump (refer to Figure 21). The concrete placement required another short rail outage to allow the concrete to setup and cure. CSXT also requested that the concrete mix be high early strength to allow train traffic to resume approximately 6-8 hours after concrete placement was completed. Prior to the pour, B&G had the concrete supplier develop a temperature curve correlating heat of hydration to compressive strength. The curves were then uploaded to a job specific database that could be accessed via a mobile phone app. Temperature sensors were installed within the pour to take real-time temperature readings. Within 3 hours of completing the concrete placement, the theoretical strength approached 1500psi. The 1-day cylinders for the first and second batches broke at 3,700psi and 2,450psi respectively. The temperature sensors indicated similar readings between 2,200psi and 3,200 psi. It should be noted, that the first batch of concrete used had a significant amount of accelerant which caused the mix to setup faster than expected and posed workability issues. The accelerant dosage in the second batch was reduced and workability was improved.

Figure 21 Barge and Concrete Truck Setup
