**HEAVY MOVABLE STRUCTURES, INC.
SEVENTEENTH BIENNIAL SYMPOSIUM**

**Innovative Temporary Systems
for Florida Vertical Lift Rehabilitations**

Henri Sinson, PE
Amaka Amalu-Anderson, PE
Hardesty & Hanover

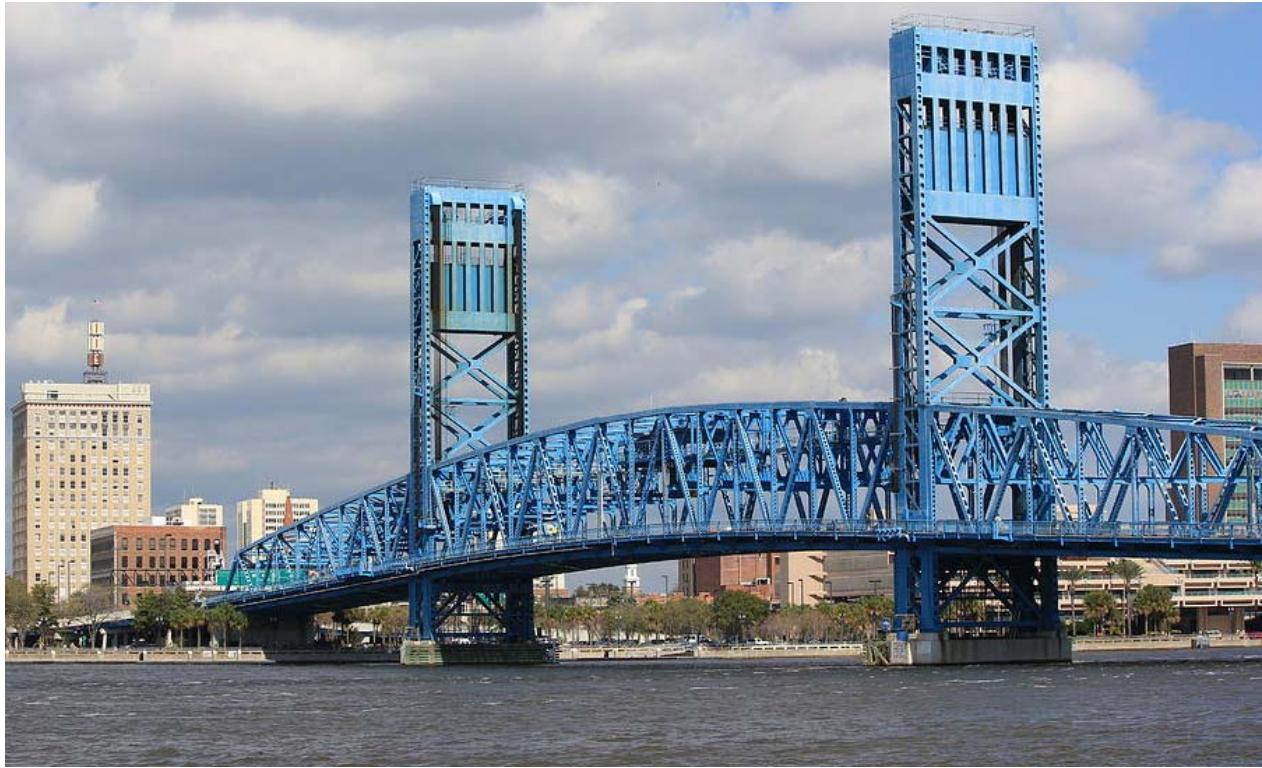
FIGURE 1: Main Street Vertical Lift Bridge

Constructed in 1941, the Main Street Bridge is a 3,000 kip through-truss, Waddell-type bridge, with a 365-foot span and 46-foot truss-to-truss width. It carries four general purpose lanes and two sidewalks with a vertical clearance of 138 feet when opened and 40 feet when closed.

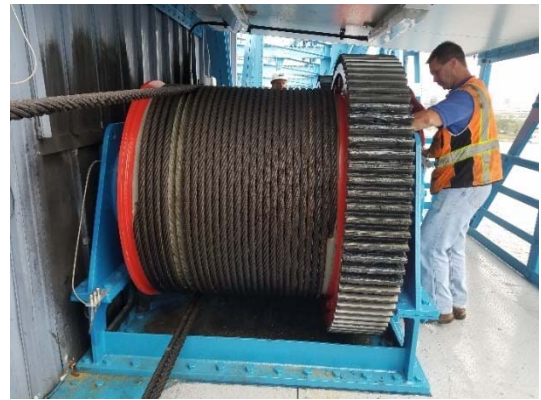
Each operating drum assembly consists of two uphaul and two downhaul operating wire ropes attached to opposing ends of the cylindrical drum. The system is arranged so that during operation of the lift span, equal amounts of each wire rope are pulled or played off the drum as the span operates. A double helix

rope groove is machined into the circumferential surface of the drum, upon which the operating ropes are wrapped around.

FIGURE 5: Operating Drum Assembly

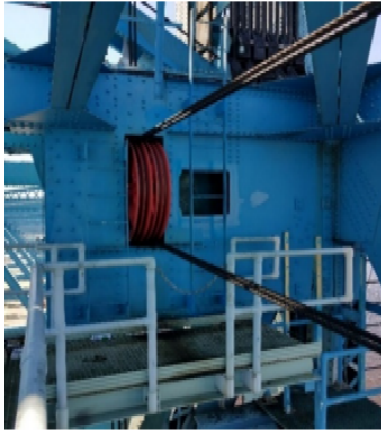
FIGURE 7: Operating Ropes Through Deflector Sheave

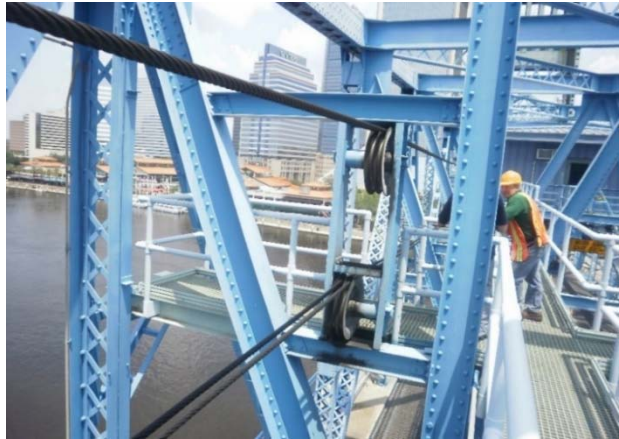
FIGURE 8: Operating Ropes Through Idler Sheaves

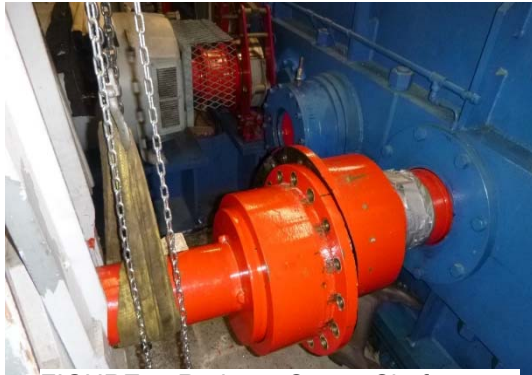
FIGURE 5: Reducer Output Shaft
Coupling Disconnected

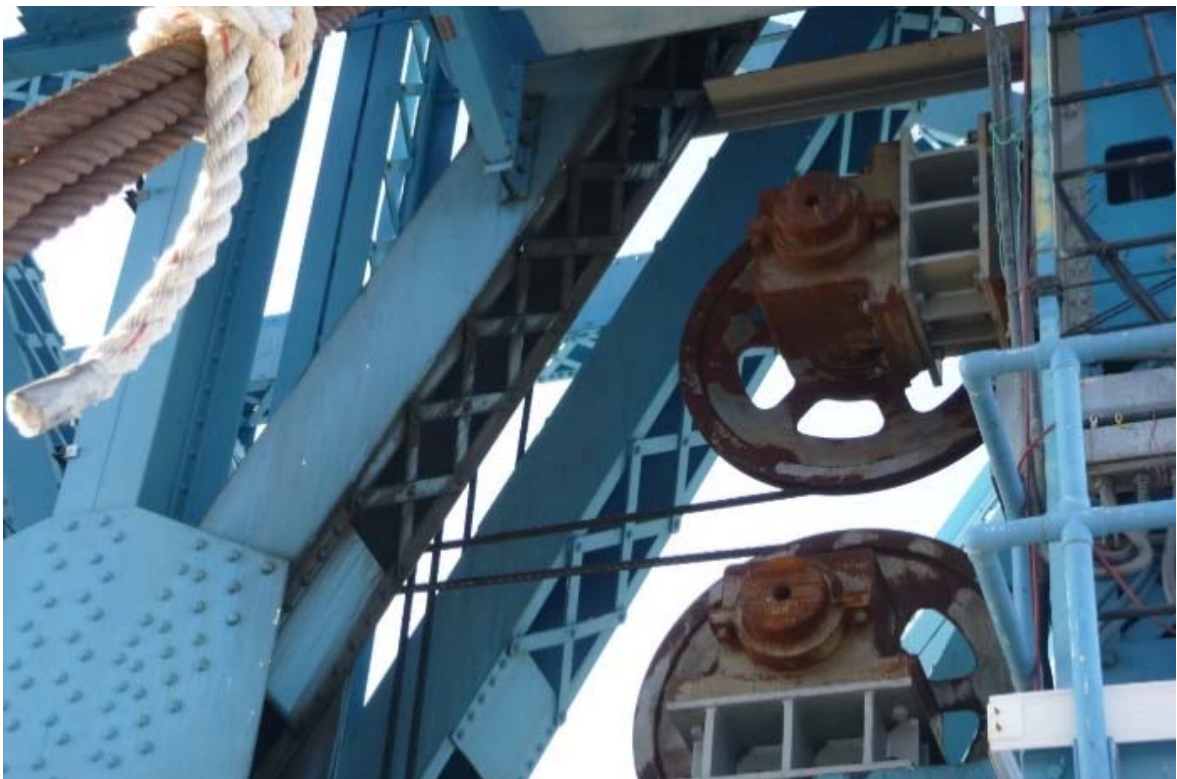
FIGURE 12: Upper and Lower Temporary Sheaves

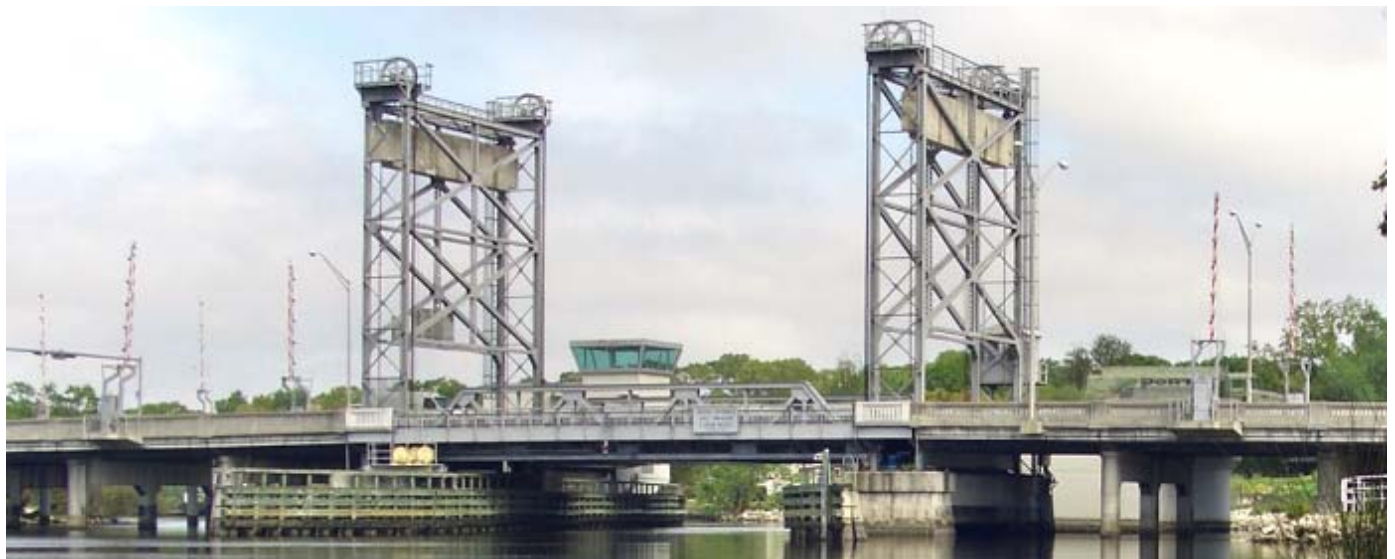
FIGURE 20 - South Elevation

Built in 1939, the historic Hillsborough vertical lift comprises a 93.5 feet Warren steel pony truss lift span at the channel crossing, five 33-foot concrete fixed spans to the west, and three 33-feet flanking to the east. Extending 53.5 feet above the roadway, four steel H-section columns spaced at 43 feet 8 inches transversely, and 7.5 feet longitudinally, carry the tower loads to the foundation. Columns are tied together

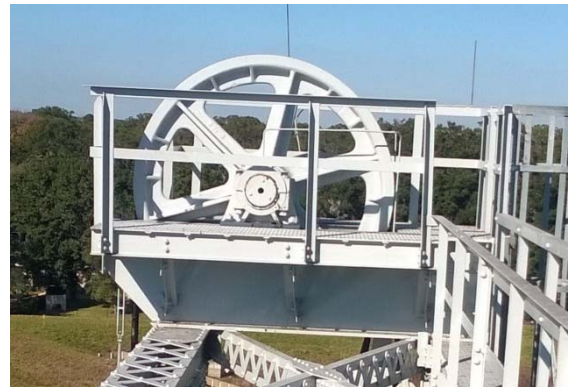
Steel wire counterweight ropes connect the span to the concrete counterweight that hung from two sheaves between the tower columns. The sheaves are supported by trunnions, which are in turn supported by a pair of sleeve bearings. These bearings are carried by W-shape steel sheave girders which are connected to the tower columns.

FIGURE 21 - Original Sheave Assembly

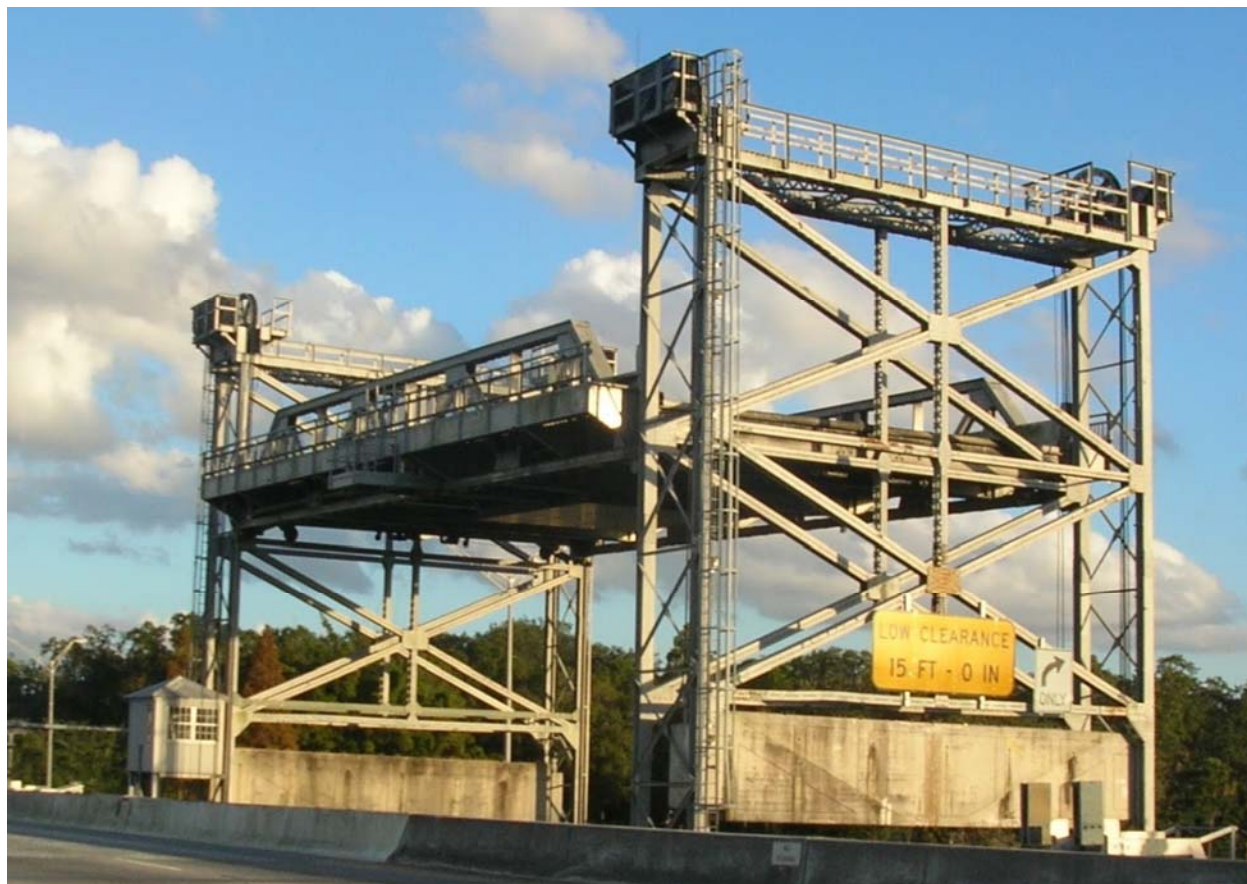
In December 2013, the bridge experienced an operational failure, which resulted from the lift span being out of horizontal plane and binding against the tower guide rails. Continuous driving in the bound condition snapped an operational cable. For the bridge to be lowered, the remaining operational cables were removed, a large onsite crane lifted the lift span to free it from the bound condition and then lowered it to the fully closed position. Operating ropes replacement activities resulted in one night of bridge closure for the eastbound traffic and four-month closure for navigation traffic.

FIGURE 21 - Span Stuck in Open Position

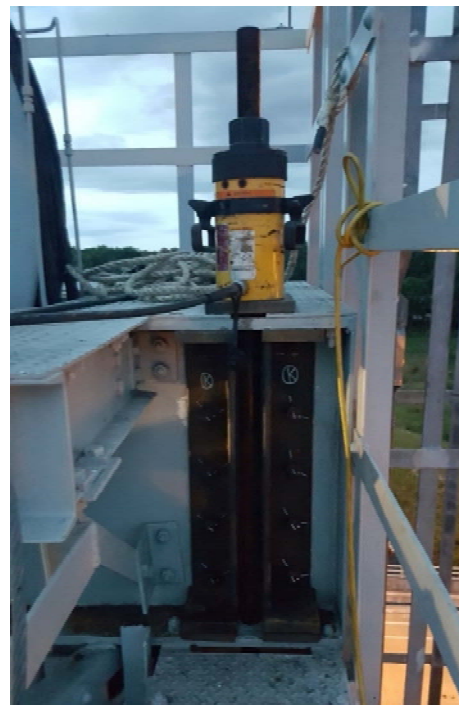
The rods were threaded into high-capacity screw jacks that bore on the top flange of the sheave girders. With the span in the fully closed position, the jacks allowed the counterweight to be raised slightly, relieving any load and elongation in the ropes.

FIGURE 23 - Screw Jack with Tie-Rod and Stiffeners

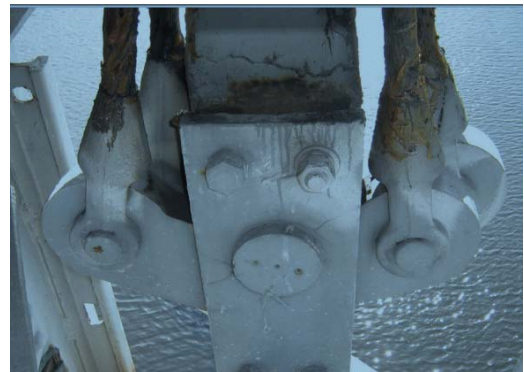
The counterweight connection assembly consisted of a new link plate connecting the existing eye bar that was embedded in the counterweight concrete. The link plate connected to two equalizer plates through a hanger pin. The existing arrangement had substandard open spelter socket connection diameters. In addition, the available space for the new equalizer was dictated by the size of the existing system. The new equalizer plates had vertically-offset rope connection pin locations that accommodated the new galvanized forged steel open spelter socket connection diameters to the four ropes.

FIGURE 25 - Original Counterweight Connection Assembly

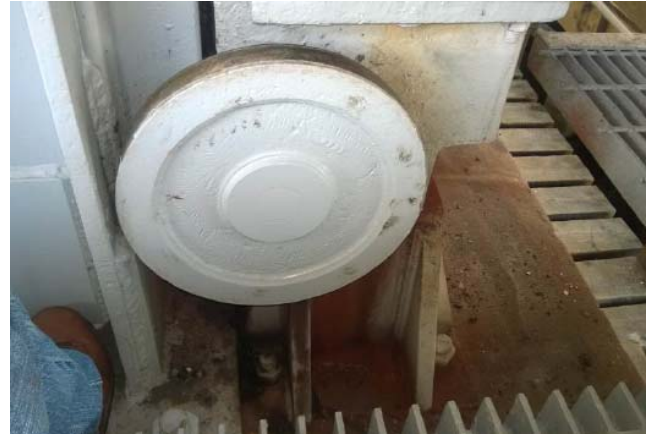
FIGURE 29 - Original Span Guide System
