**HEAVY MOVABLE STRUCTURES, INC.  
NINETEENTH BIENNIAL SYMPOSIUM**

**Noteworthy Aspects of the East Michigan  
St. Hydraulic Rehabilitation**

Kevin Ciampi, PE  
Travis Kimmins, PE  
Hardesty and Hanover

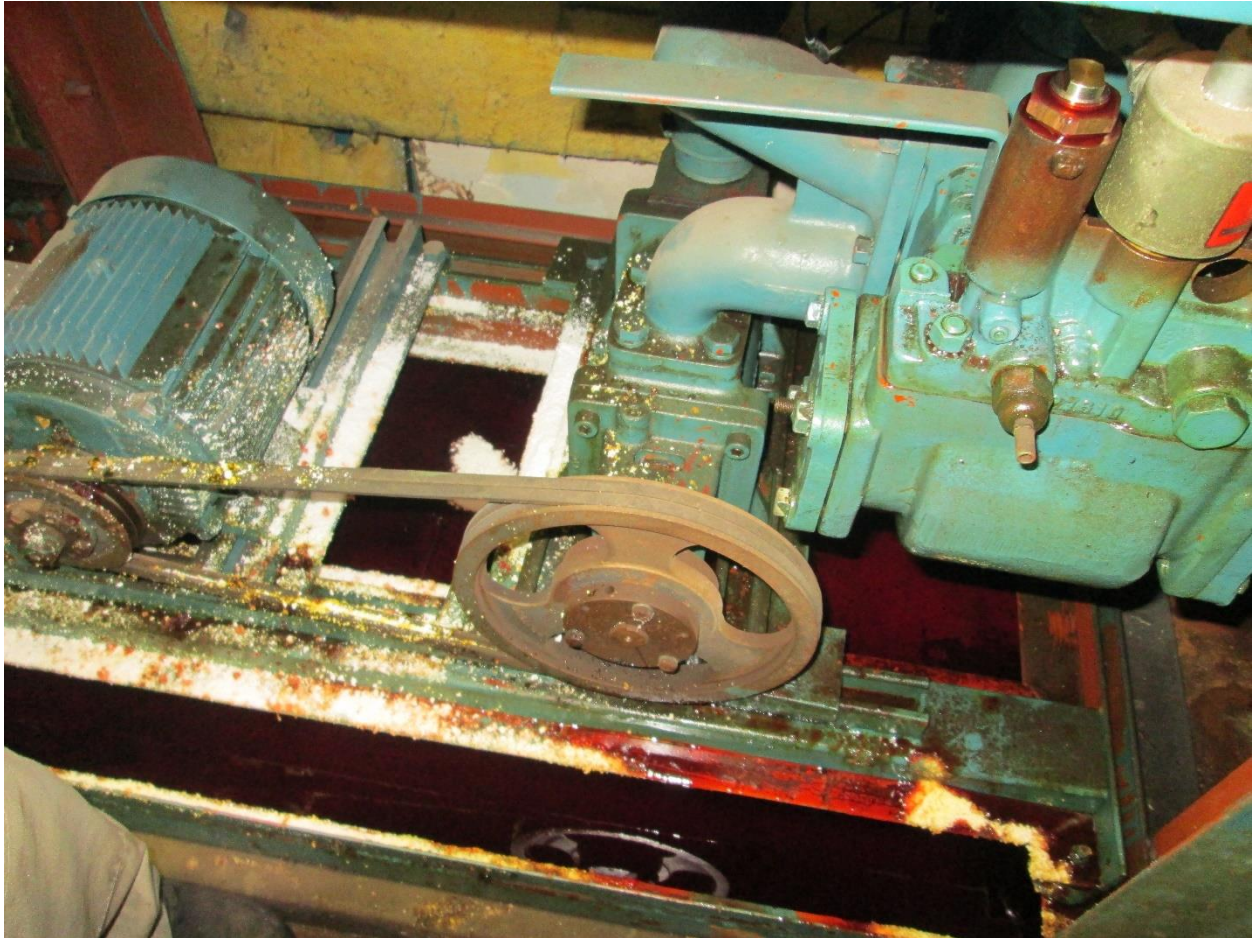
There were numerous leaks in the existing system including at the pumps, valves, cylinders, and threaded pipes joints, many of which had become severe. The system pressure relief was designed to be set at 465 psi for the 400psi rated cylinders, however the system operated at 600psi. Although the cylinders did not require hoses due to the use of ball joints for flexibility and the use of the cylinder rods motion to transfer oil to and from the span, the system did not have cylinder manifolds with valves to lock of the cylinders in case of a pipe failure which does not meet the requirements of current revisions of AASHTO. While many items could be considered grandfathered there are certain safety requirements which should not be overlooked. AASHTO section 7.5.12.5 states “Cylinder Circuits shall include a cylinder manifold mounted directly to each cylinder used for span operation. Manifolds shall contain pilot operated check valves or similar means to hold fluid in the cylinder when the cylinder is not intended to be in motion. Manifolds shall also contain cylinder relief valves for limiting pressure to both ends...of the cylinder.” In addition to the deficiencies present in the system, the hydraulic system was approximately forty years old and had significantly exceeded the predicted life for all components based on table 2.9.1-1 of the AASHTO Inspection Evaluation and Maintenance Manual.

Photo 6: Leaks at the existing Hydraulic Power Unit

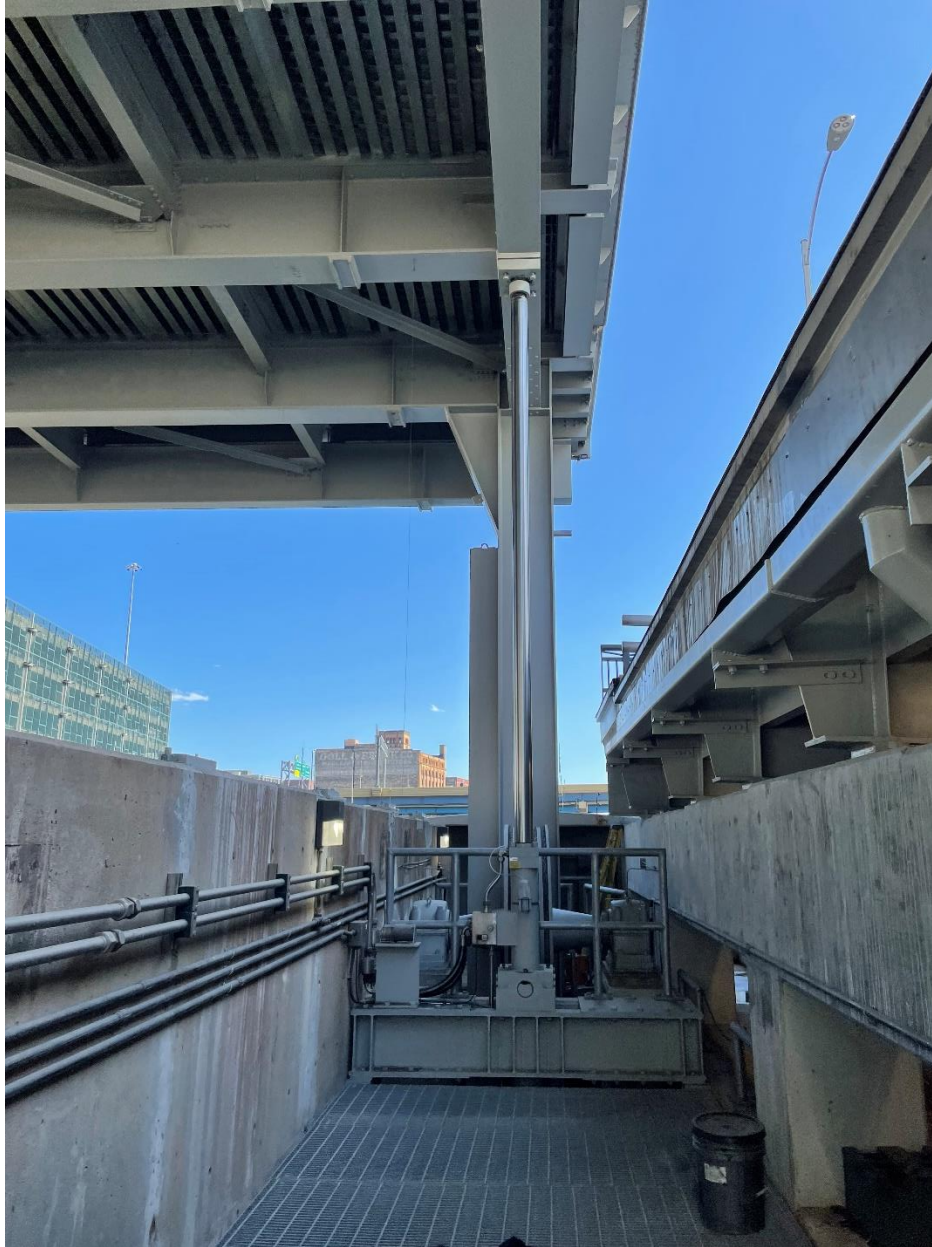
**Photo 11: Hydraulic Cylinder with the Span in the Fully Open Position**

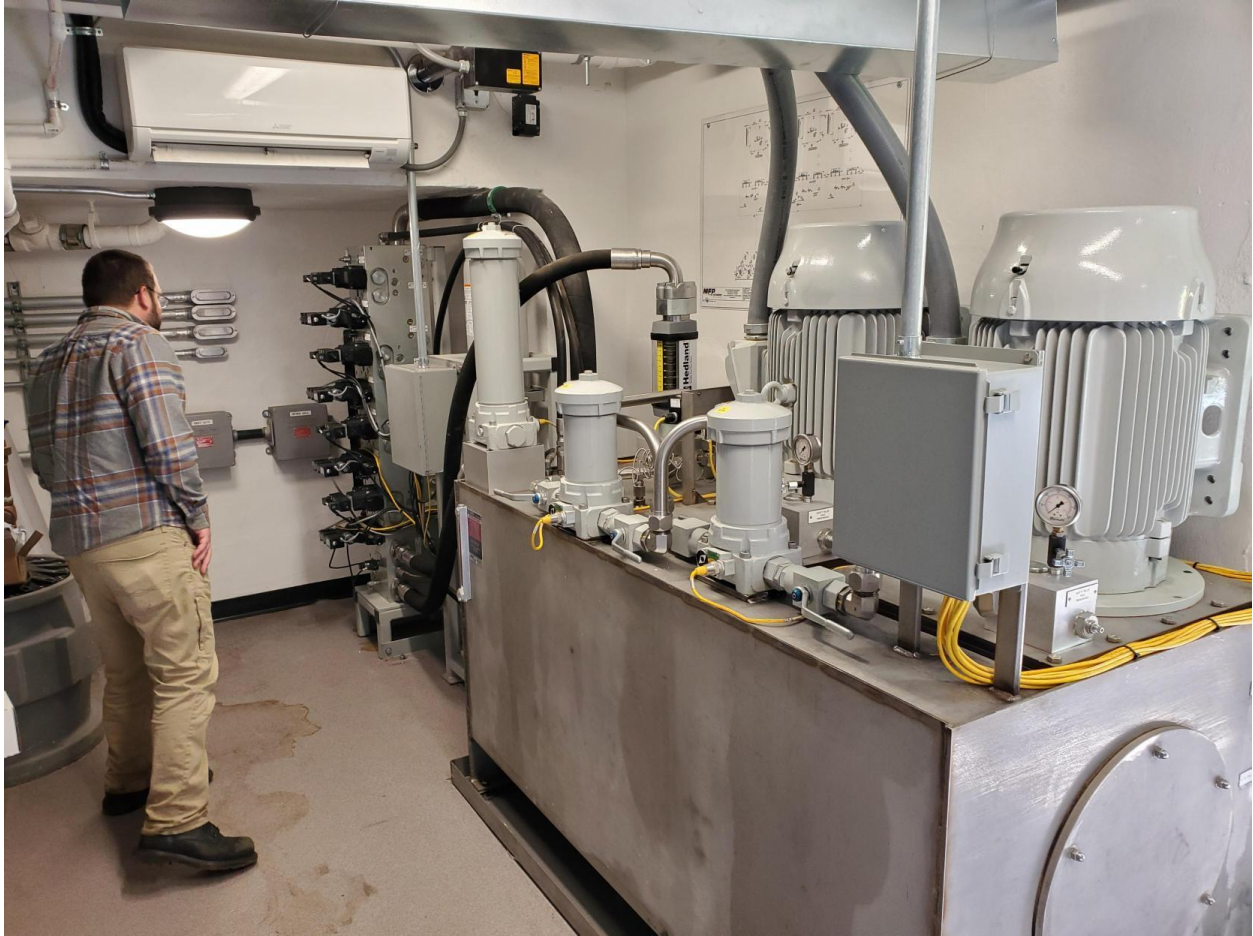
The hydraulic power unit consists of a JIC-style stainless steel reservoir, with two gear pumps mounted internal to the reservoir. The reservoir is 300 gallons. Practically speaking, that is the largest reservoir that would reasonably fit in the hydraulic room, but the reservoir was able to meet the size requirements of AASHTO, mainly due to the reduction in flow rate allowed by the regeneration circuit.

**Photo 14: Hydraulic Power Unit**

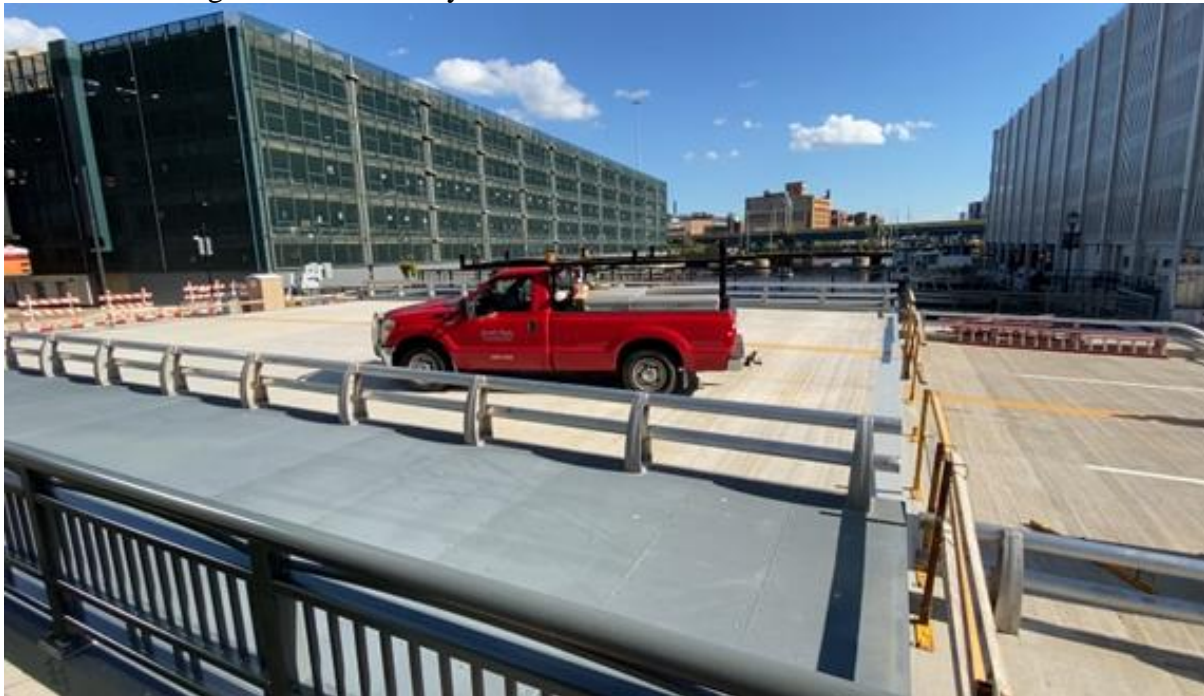
Since limited shop testing was performed, all the required testing had to be performed in the field. Once the Contractor had finished grooming the system and had it running reliably under ideal conditions, it was decided to test the system using unequal loads. To avoid having to partially disassemble the piping system to install valves to simulate uneven loading, the Contractor elected to test the system for uneven loading by parking a work truck on the span, favoring 1 corner. The system operated as intended with no skew issues. Tabletop vertical lift bridges by their nature do not really help cylinders stay synchronized. Given that the span was able to stay synchronized with large uneven loading demonstrates that proportional control can provide a sufficient level of control, not only for tabletop vertical lifts, but also for the majority of movable bridges and other heavy movable structures.

Photo 20: Field Testing Uneven Cylinder Loading with a Truck Parked on the Span
