**HEAVY MOVABLE STRUCTURES, INC.
NINETENTH BIENNIAL SYMPOSIUM**

**Support Machinery Replacement:
Modifications vs. In-Kind and Lessons
Learned from Two Projects**

Hardesty & Hanover and SLSMC

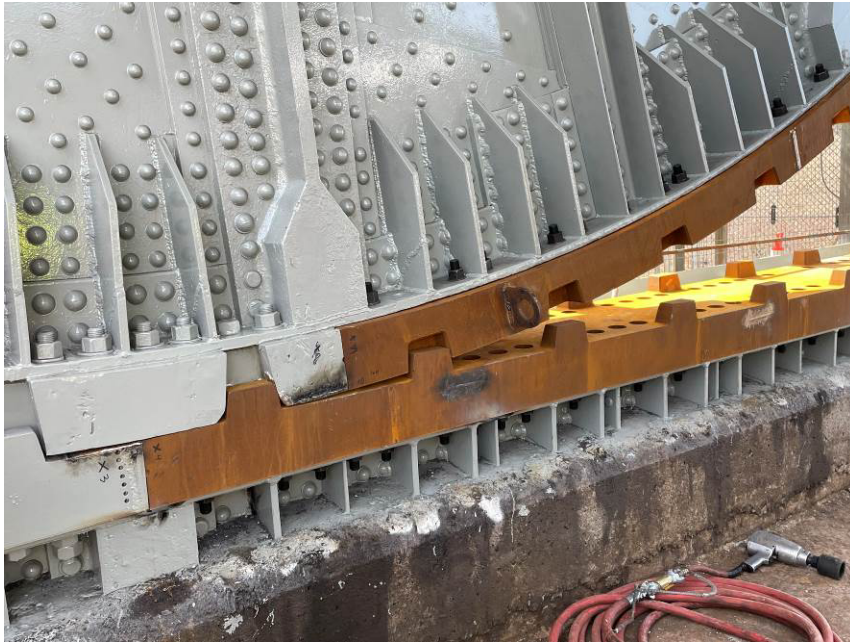
CAPTION: New rear tread and track (unpainted) installed during adjacent to the old tread and track segments (painted grey). Note the modifications to the new tread pockets and the modifications required to old pockets for temporary operation.

- *Part new and part old tread and tracks, operation and sequencing – since the new tread and track are thicker, there was a need to ramp the old plate rolling surface to meet the new plate surface for operation.*
-

1. *Engagement of old lug and pocket under temporary operation required field modifications to the old tread and tracks*
2. *Final engagement of old lug and pocket*
3. *Sequencing and alignment criteria had to be established before any shutdown of the bridge was granted and the existing tread and track plates removed from the bridge.*
4. *Aside from all these details for construction and scheduling, it is essentially a replace in kind, so innovation and changes are limited to “methods” versus designing an entirely new device to accomplish the function as you will see in the next case study. But innovations of the methods and accomplishing this retrofit proved to be challenging and require excellent teamwork.*

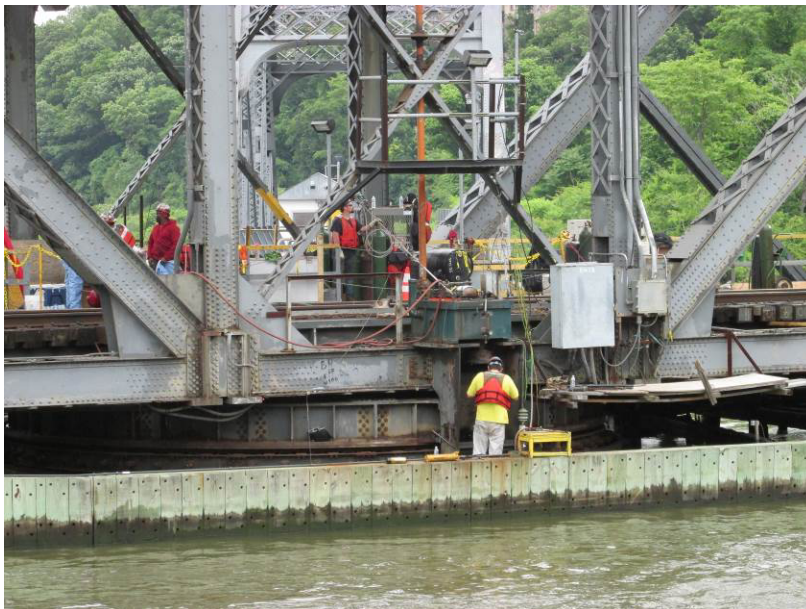
CAPTION: Spuyten Duyvil with old drum girder in place blocking access to pivot pier.

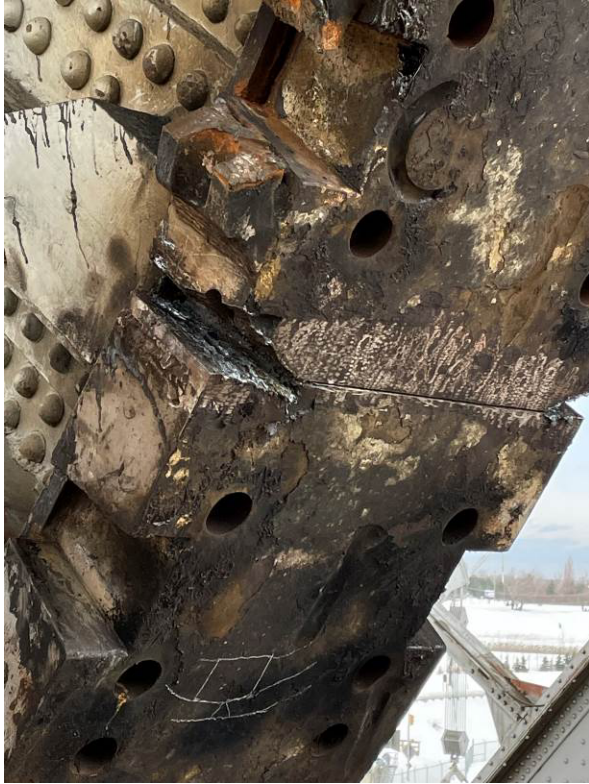
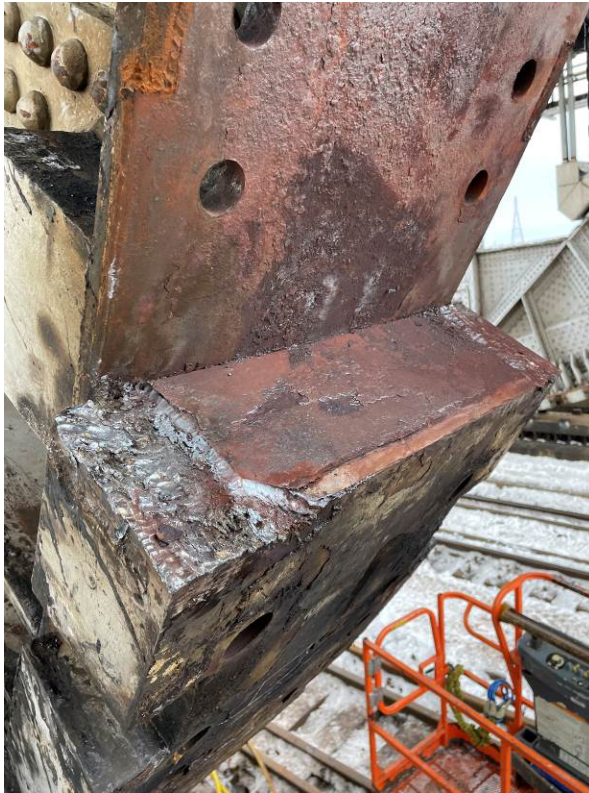
CAPTION: Top photo show excavation of the added weld at the tread joints. Second photo shows joint after one tread section is removed, showing the depth of the added weld.

- *Tread and track had been welded to the girder flanges and required removal*
- *Tread to tread butt joint had been welded (no nondestructive and positive method to confirm depth accurately. Ultrasonic Testing results varied, so the team opted to grind the intersection for visual confirmation.*

1. Identify the depth of weld repairs at the butt joint locations, and extent using mandatory exploration grinding, and confirm this splice joint with the length of the newly fabricated forgings.

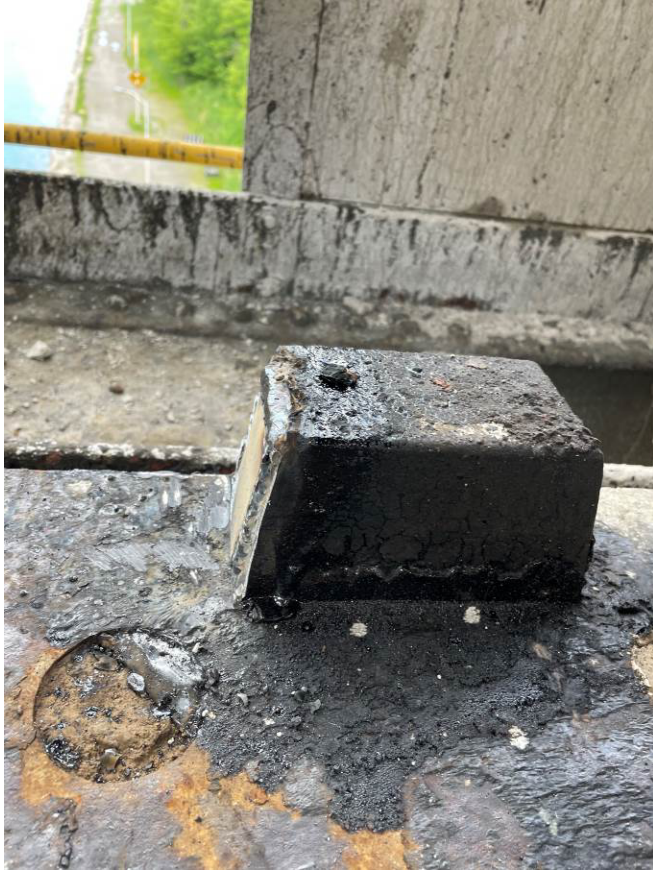
CAPTION: Temporary alignment fix included the addition of ¼ inch plate welded to the old lug to properly align the span at the toe end.

Upon the first test seating of the East leaf, it had shifted to the North at the toe end alignment. After some discussion, it was determined that the South side (old tread and track) were too sloppy and allowed for the bridge to be slightly steered by the North tread and track “first lug and pocket”. This was temporarily corrected by welding ¼ thick plate at the North lug to push the leaf straight to the rest pier. This was within the limits of thermal expansion extremes for the 100 ft leaf.

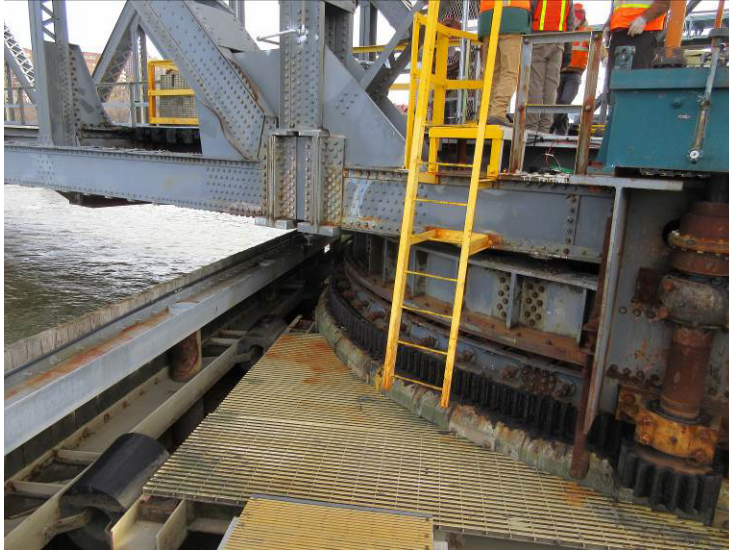
CAPTION: Original drum girder in position blocking off all access to the center pivot pier for routine maintenance.

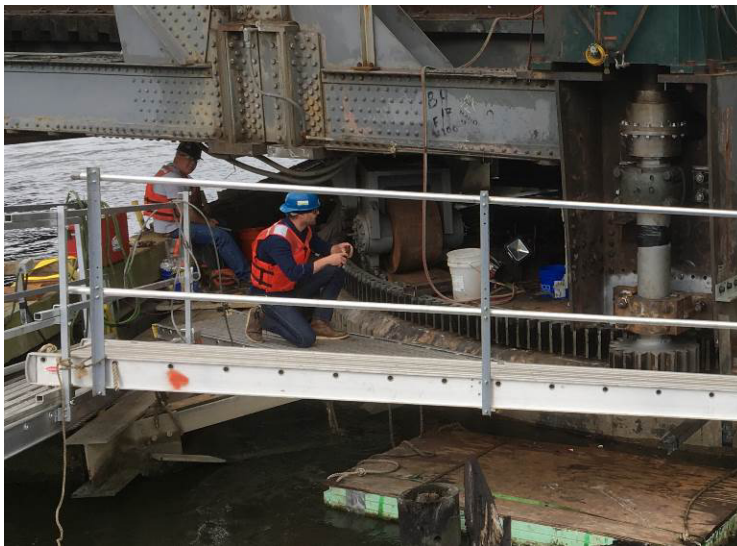
CAPTION: Bogie design allows for access between the four bogies by eliminating the continuous drum girder.

Design Configuration: Since we wanted to avoid replacing in kind with the tapered rollers, the concept developed included detailing 4 railroad carriage systems that would take approximately 80% of the dead load from the swing span, but also able to transfer the LL traffic to the rail, instead of having a LL passive balance wheel system. Alignment during construction would be simplified to align 4 bogies rather than 64 rollers. The bogies would be located at the distribution girder, so would be an improvement from the old system, where we see the rollers do not take the LL evenly and will wear flat spots over time.
