**HEAVY MOVABLE STRUCTURES, INC.
NINETEENTH BIENNIAL SYMPOSIUM**

**Temporary Hydraulic Operating System:
Installation Challenges and
Construction Usage**

Robert J. Tosolt, P.E.
Wiss, Janney, Elstner Associates, Inc.

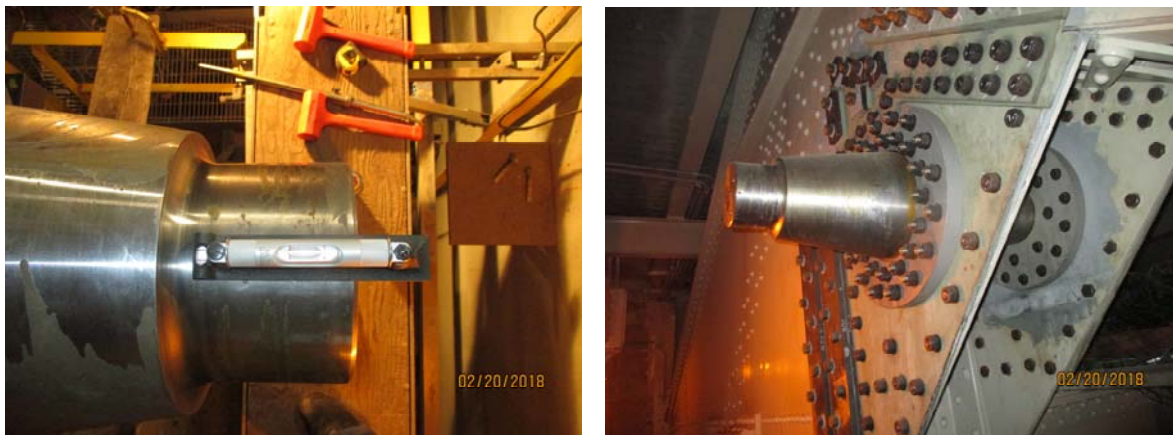
Figure 8 – Alignment Verification and Final Bolting of TOS assembly.

Position and alignment were verified prior to installing the turned bolts to lock the hubs in position.

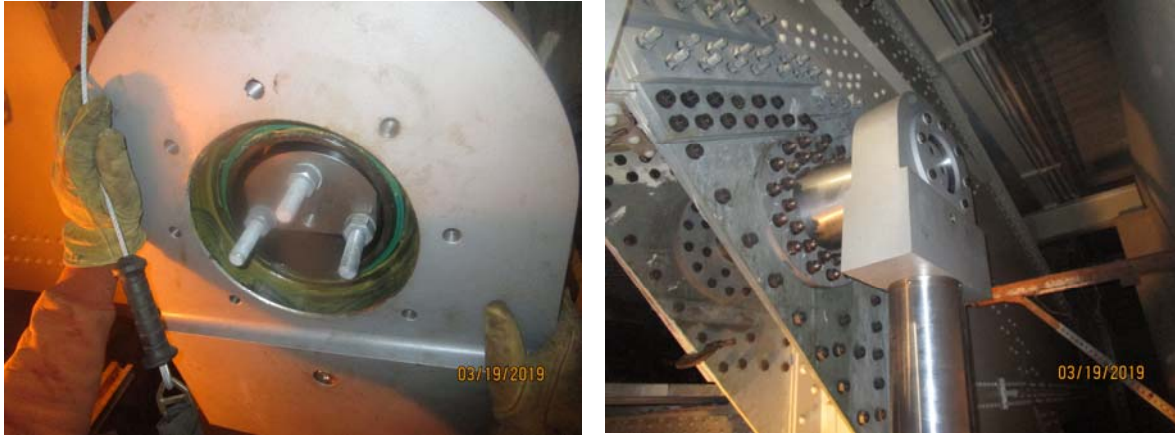
Figure 10 – Fit-up Rod End on TOS Cylinder using Alignment Plug and Final Connection.

To address the above concerns, a custom alignment plug was designed and incorporated into the installation procedure. The alignment plug was developed in conjunction with the shop drawings so that the necessary details could be reflected on the trunnion fabrication drawings. The top of the alignment plug was manufactured to the same radius and tolerance as the end of the trunnion, and was mounted to the end face of the trunnion with fitted bolts to ensure alignment of the top of the plug with the top of the trunnion. During installation, the plug was mounted to the end face of the trunnion and provided an initial contact point for the spherical bearing in the rod end that could be achieved independent of the radial fit, as the plug was only a segment and not a full diameter. Once the rod end rested on the alignment plug effectively establishing the proper elevation, the rod end was able to be axially shifted across the alignment plug onto the trunnion to complete the assembly. During this work, the alignment plug supported the weight of the piston rod and mitigated the side loading concern.

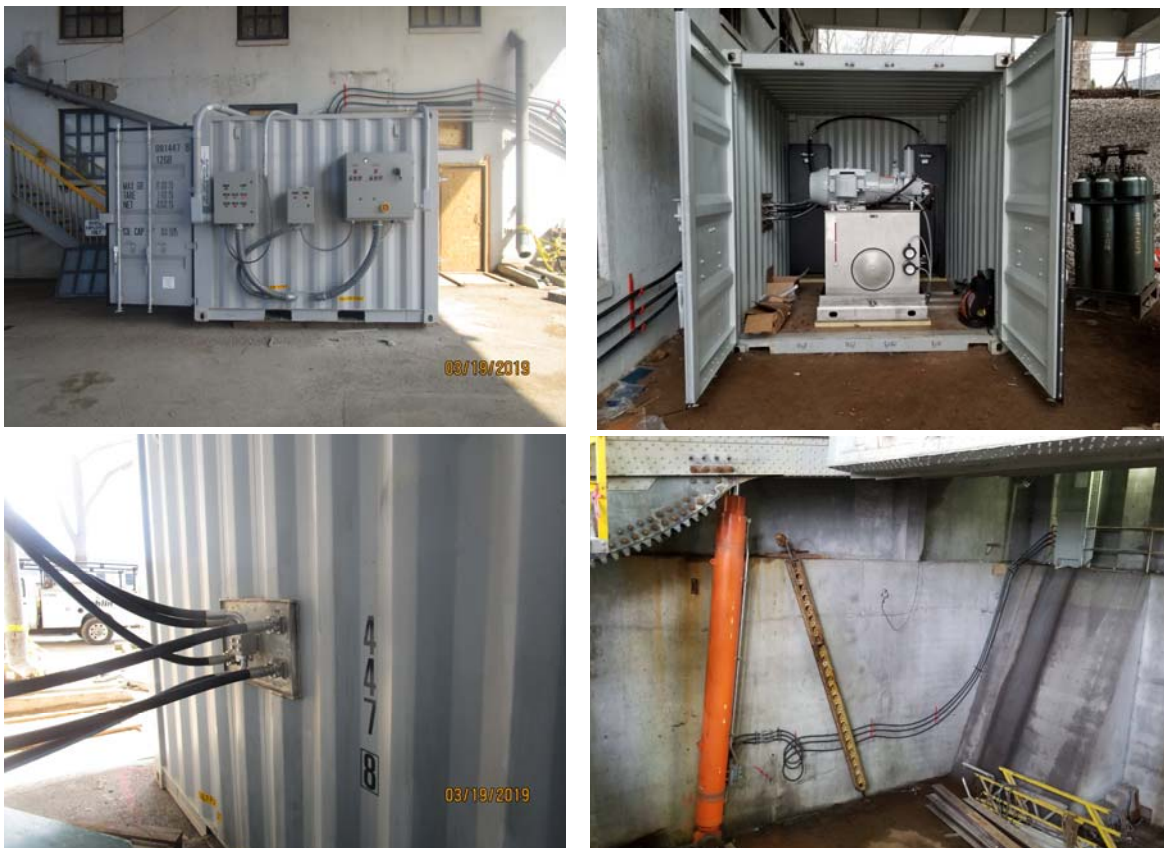
Figure 11 – TOS Hydraulic Power Unit Arrangement and Routing to Cylinders.

Once the cylinder connection was made, the existing main drive machinery needed to be disconnected and the TOS operating system brought on-line so that the cylinders were not back driven. In conjunction with the installation of the mechanical components of the TOS system, the control system modifications were performed to accommodate the TOS system and the HPU was fabricated and installed at site to be prepared for cylinder connection. Due to the temporary nature of the installation and the need for timely installation and hook-up, the HPU for the TOS on each leaf was built into a shipping crate to provide for ease of handling and enable it to be located and/or re-located at site as necessary to suit construction needs. The TOS HPU was located at the approach side of the bascule pit and hydraulic lines were routed through the wall of the pit enclosure and along the sides of the pit wall to the manifolds at the cylinders.

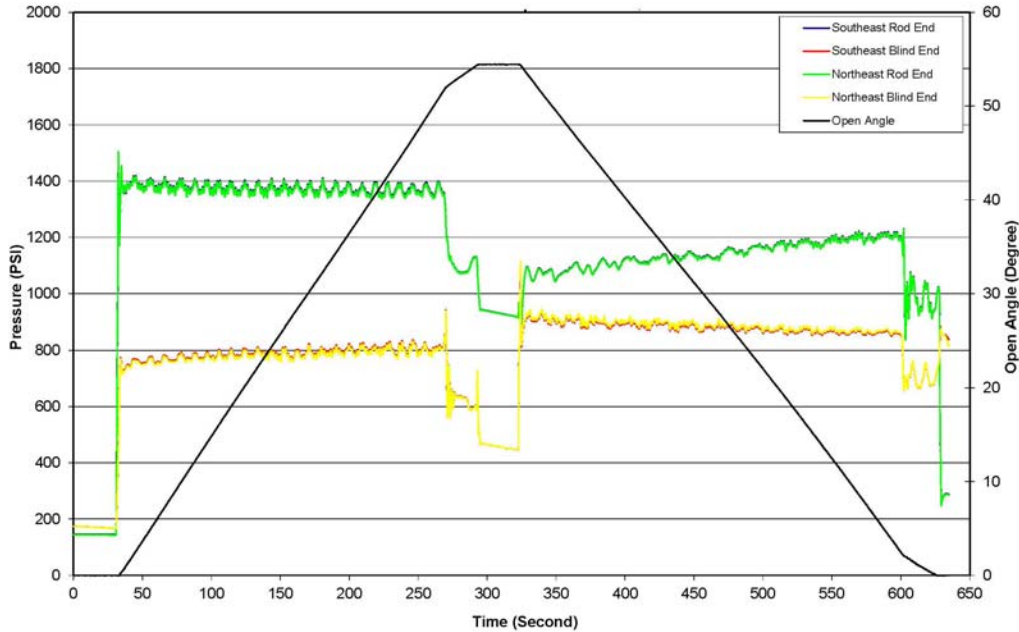
Figure 12 –Hydraulic Operating Loads, Blind End and Rod End Pressures

Following installation and connection of the TOS, the mechanical drive machinery was disengaged by de-coupling the cross shafts from the central machinery. Operating loads were recorded as part of the TOS start-up to verify the proper operation of the hydraulic controls as well as to document operational loading and balance. Test ports provided on the cylinder manifolds facilitated monitoring and recording of the blind end and rod end pressures via pressure transducers. From a review of the recorded pressures in Figure 12, it is clear that all operating pressures were well controlled throughout operation and remained well within the modified design pressures of 1700 psi at the rod end port and 1300 psi at the blind end port.

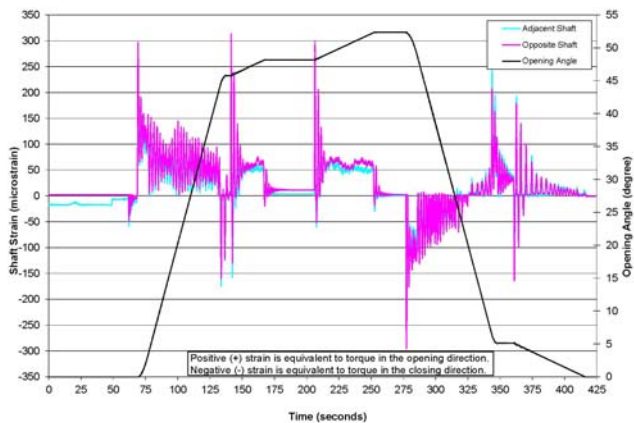
Figure 13a –Operating Loads via Existing Machinery

The total operating load under the TOS was also compared to the operating loads on the existing machinery determined via strain age testing of the existing machinery. From a review of Figures 13a and 13 b, it is clear that the TOS system produced far better and smoother control of the

leaves than the existing open gear driven machinery which exhibit numerous load fluctuations and spikes that are not apparent under the hydraulic system.
