**HEAVY MOVABLE STRUCTURES, INC.
NINETEENTH BIENNIAL SYMPOSIUM**

**Union Pacific Railroad West Colton Yard
Transfer Table Replacement**

Reid C. Hoffman & Kyle M. Gable

Modjeski and Masters, Inc.

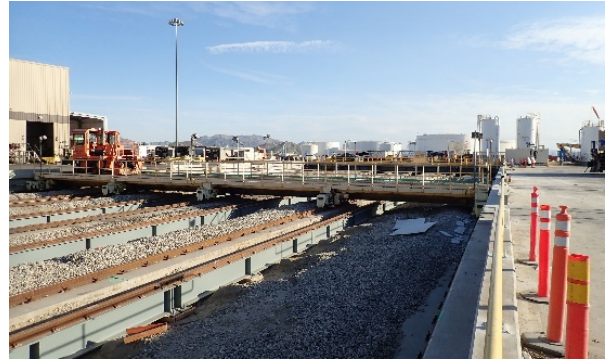
Photograph 1– General view of the West Colton Yard Transfer Table

Union Pacific Railroad (UPRR) owns and operates a rail yard in Colton, CA, which includes a locomotive repair facility. Part of the facility is a transfer table that connects six tracks on the west side to eight tracks on the east side (see Photograph 1). Locomotives come from the rail yard on the west side, are loaded onto the transfer table, the table then moves to the corresponding track on the east side, and the locomotives travel to their designated bay in the diesel shop for repair, maintenance, painting, etc.

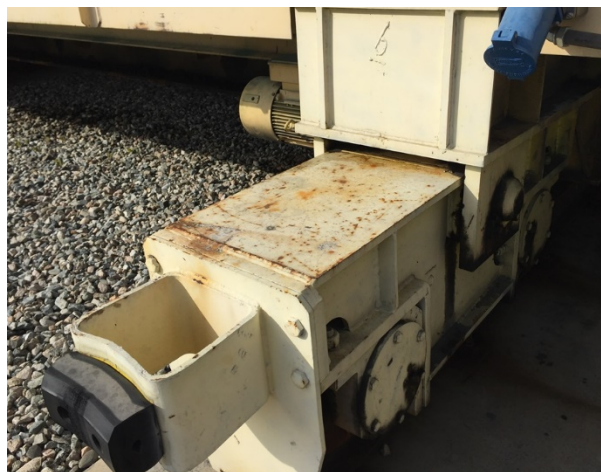
Photograph 4 – Original transfer table drive truck

Creaking and popping noises were noted at two of the drive trucks. These noises were caused by misalignment of the drive trucks, and therefore the wheels, to the foundation rails. Excess noise was not the only symptom associated with this misalignment issue. The wheel flanges would ride hard on the rail head leading to accelerated component wear. In addition, it contributed to the constant headache of the transfer table wanting to travel at an angle to the rails rather than parallel to the rails (skewing) within the pit. Other problems that added to the skew issue were loss of traction at certain drive trucks due to poor load distribution, small variations in motor

Maintenance personnel reported that at times the transfer table would skew up to 1' from end to end and the table would get “jammed” in the pit (see Photograph 3). The accepted method for correcting skew was to run the table at full speed into the wall at the end of the pit to “swing” the table around until all five bumpers contact the wall. Over time, these high-impact stresses deformed the bumpers (see Photograph 4) and intensified the mechanical and structural issues.

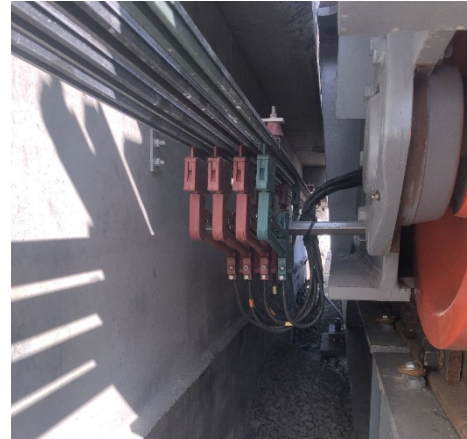
Photograph 5 – New conductor bar system

The existing transfer table pit was equipped with a conductor bar system routed along the East wall to provide the main power connection to the existing transfer table. To maintain serviceability of the existing transfer table during commissioning of the new transfer table, the design included a new conductor bar system routed along the West wall of the pit (see Photograph 5). The main service line to the pit was

tapped with a feeder to the new conductor bar system. This setup allowed for both transfer tables to be used interchangeably throughout the on-site testing periods of construction. Following the testing and closeout of construction, the original conductor bar system was removed along with the existing transfer table. The new conductor bar system, consisting of a rail and collector for each of the three phases and ground, remained to provide the main power connection to the new transfer table. A disconnect switch is also included in the rail yard to safely disconnect power to the conductor bar system while personnel are working within the pit.

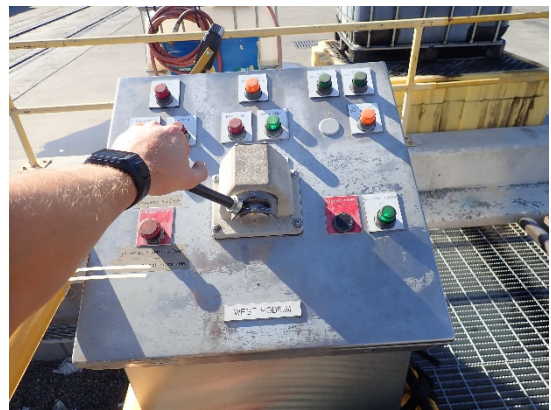
Photograph 6 – Operator Podium

To operate the transfer table, an operator podium is located on each end of the transfer table (see Photograph 6). A joystick is provided to run the table in either direction. The joystick control is set up so the operator can control the speed of the table based on how far they move the joystick away from its center position. Depending on the position of the joystick, the table will run at zero speed, creep speed, half speed, or full speed. Each operator podium is also equipped with indicator lights for skew warning, skew fault, brakes set, brakes released, near track aligned, near end of travel, and end of travel. Aligning the desired tracks is strictly dependent on the operator, so there is no need for a track aligned indicator light. The control power ON pushbuttons at each operator podium are interlocked to allow operation from only one podium. There are other safety features incorporated into the control system such as initiating creep speed when the table reaches end of travel at either end of the pit.

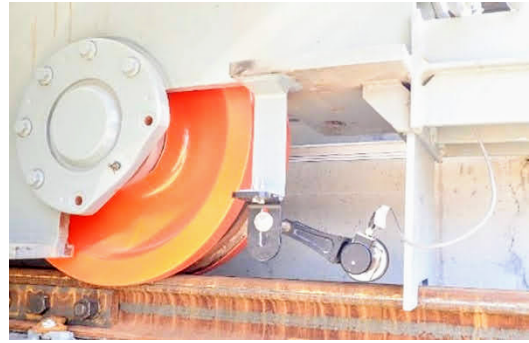
Photograph 7 – Position encoder

A skew control system was implemented into the design to continuously correct skew of the transfer table. The skew control system works much like that of a tower drive vertical lift bridge. A position encoder is mounted at each end truck wheel assembly (see Photograph 7) to provide absolute position feedback from each end of the table as it moves along the foundation rail. The position encoders are spring loaded to hold their wheel on the foundation rail. Each end truck with an encoder also has a barrier in front of the encoder to prevent debris from damaging the encoder. The PLC control system utilizes the feedback from each encoder to calculate the difference in position from one end of the transfer table to the

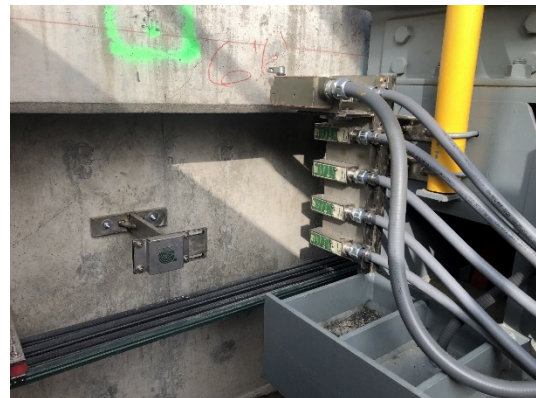
Photograph 8 – Limit switches

Maximum skew lever arm type limit switches were located at each end of the table. In a skew event, these limit switches were designed for the lever arm to contact the pit wall and trip prior to the table skewing enough to become jammed against the pit wall. Multiple proximity type limit switches were located at each end of the transfer table with target magnets strategically placed at various locations along the pit wall to indicate significant positions of the transfer table (see Photograph 8).

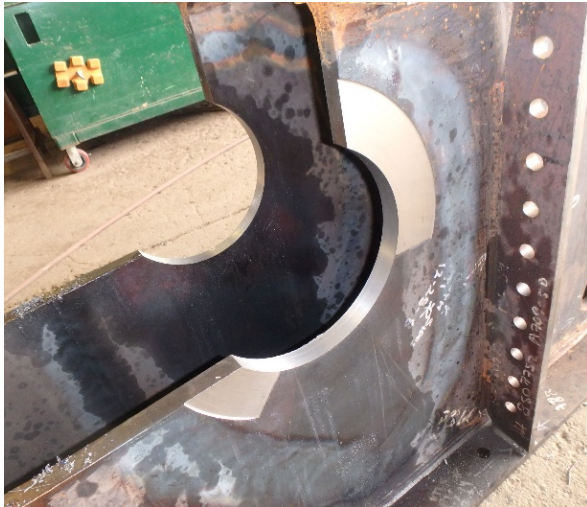
Photograph 9 – Machining warped truck web for wheel block installation

Construction of the West Colton Yard transfer table began in 2018 at a shop in El Centro, CA, about three hours south of the rail yard. One of the first hurdles to overcome during construction was machining the trucks to mate with the wheel block assemblies. The truck weldments have a top and bottom flange as well as two web plates. After welding, the web plates had warped and were no longer parallel to one another. As the spot facing and boring operations were performed on the truck webs this issue became increasingly more obvious. In the most severe cases, the web spotface did not clean up the entire wheel hub mating interface on the truck web (see Photograph 9). Another issue with the spot facing and boring procedure was that these operations were initially performed on individual trucks in different machine setups for each side of the truck with no reference from one side to the other. Even if this method could have produced individual trucks with proper wheel bores, all six trucks would then need to be precision assembled in order to meet the wheel alignment tolerances. In the end, a three-part solution was developed. First, the transfer table was fully assembled at the shop and then the trucks were precision machined for the wheel block assemblies. A FARO laser tracker was used to generate a 3D point cloud of

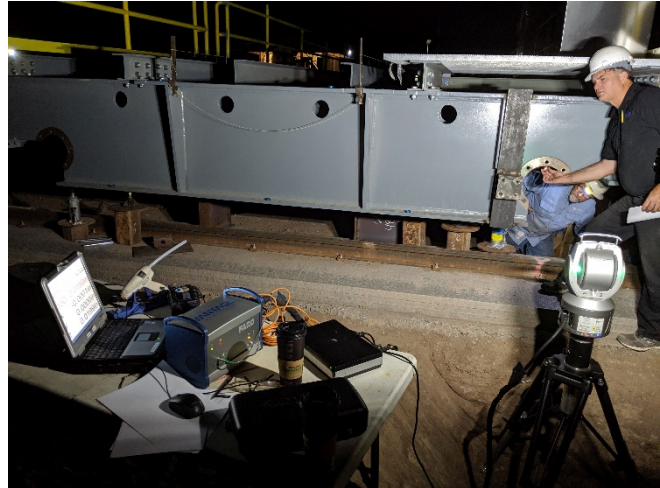
Photograph 10 – FARO laser tracker was used to map wheel block bores

all 12 wheel block bores in the six fully assembled truck beams (see Photograph 10). The point cloud data were analyzed, and the ideal bore locations were calculated to give the wheels the best possible alignment. Each truck bore was re-linebored, and spot faced if necessary, by offsetting the line bore equipment from the existing bore according to the calculated value from the laser tracker data (see Photograph 11). Second, the truck web spot facing was permitted to remove slightly more material than what is recommended by the wheel block manufacturer, but calculations confirmed this was an acceptable deviation. Third, some of the truck bores did not have enough material remaining to locate the new bore in an ideal location. These bores were machined to an oversized diameter, and the wheel block hubs were fitted with custom eccentric collars (perfectly matching the oversized diameter), which brought the wheel hub back to the ideal location (see Photograph 12). With these methods the wheels were installed to meet the tight parallel and angular alignment tolerances, which helped prevent loss of traction and skew.

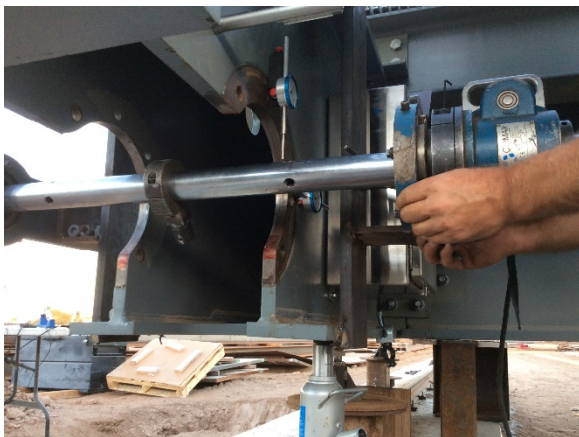
Photograph 11 – Lineboring trucks on fully assembled table for wheel block hubs

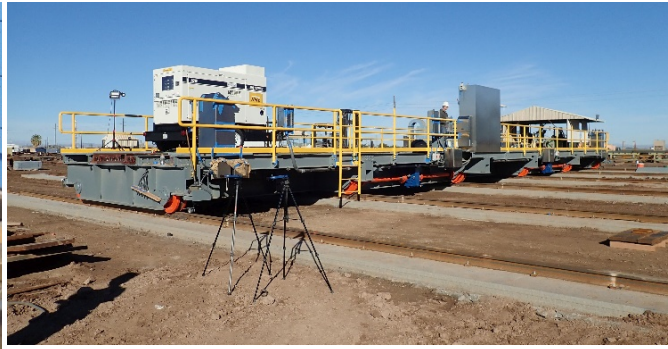
Photograph 13 – Fully assembled transfer table on temporary crane rail track at the shop in El Centro

Once the transfer table was fully assembly at the shop, and the machinery and electrical control equipment were installed, the table was test operated. The pit at the West Colton Yard was simulated at the shop by pouring temporary foundations and laying six 100' tracks of crane rail (see Photograph 13). Before operating the table, a machinery spin test was performed. The transfer table was jacked to raise the drive wheels off the tracks, and the machinery was run for 30 minutes in forward and reverse. Once the spin test was completed successfully, the transfer table was lowered back onto the tracks and test operations were performed. The transfer table was run more than a dozen times up and down the tracks at full speed. The table operated smoothly, and no significant defects were noted.

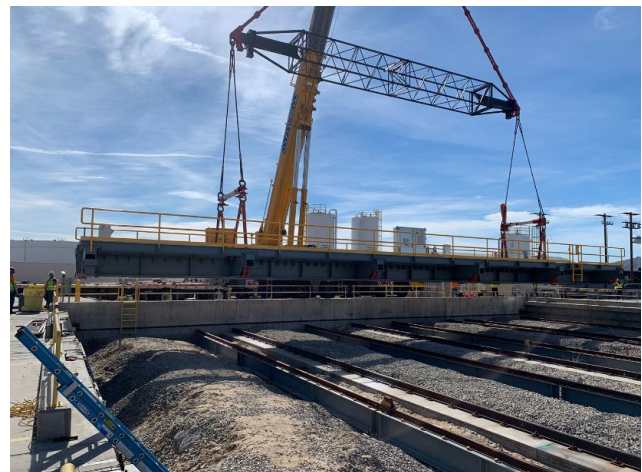
Photograph 14 – Fully assembled transfer table being set into position in the pit at West Colton

Once the shop testing was complete, the transfer table needed to be transported from El Centro, CA three hours north to Colton, CA. The original plan was to move the 99 foot long, 17.5 foot wide, 8.5 foot tall, 225,000-pound table in two pieces. However, the Contractor developed a procedure, and secured permitting, to move the table in a single piece without disassembly. The endeavor required specialized lifting equipment and independently operated trailers with remote steering, but the time and effort saved in the pit at West Colton was well worth it (see Photograph 14).

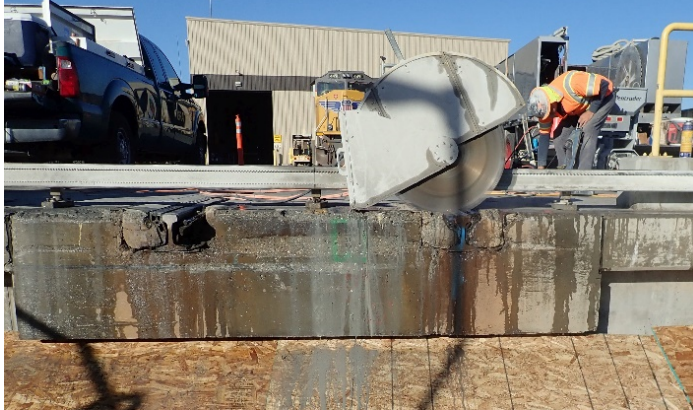
Photograph 15 – A small amount of the west pit wall is being trimmed off

With the transfer table at its destination in the pit at West Colton, all of the final testing and tweaks still needed to be performed while keeping the original table fully operational. When the new transfer table was tested in the pit, it rubbed hard on the sides of the pit walls. The table could not be fully tested or commissioned without some adjustments. As a result, the approaches were cut back a small amount to match the original design drawings and to make room for the new table (see Photograph 15).
