**HEAVY MOVABLE STRUCTURES, INC.
TWENTIETH BIENNIAL SYMPOSIUM**

**Navigating Mechanical Challenges
During the Construction of the
North Hero Movable Bridge**

Joshua Kuehn, PE, MBA
WSP

Introduction to the North Hero Movable Bridge Project

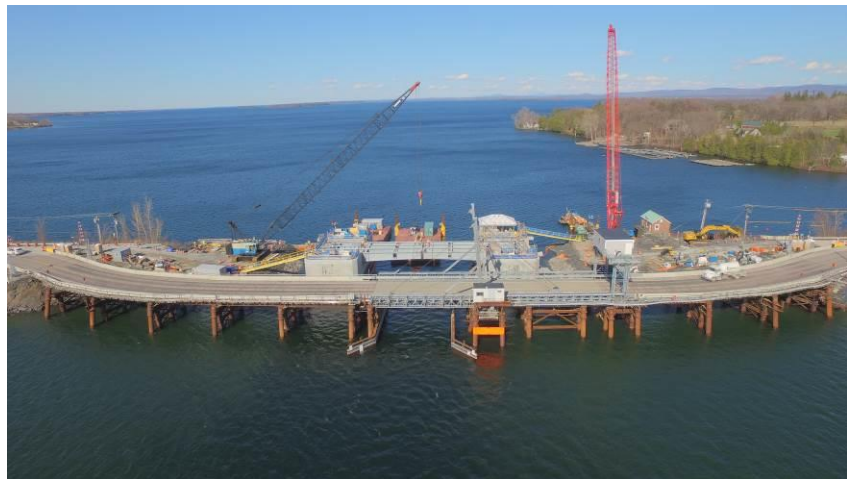
Photo No. 2: The North Hero Movable Bridge Construction site with the temporary bridge adjacent to the new hydraulic bascule bridge.

However, due to the significant outage and impact on the local community, a temporary bridge was erected adjacent to the construction site. This bridge was installed before the demolition of the existing bascule bridge, constructed in 1953. The contractor maintained the temporary bridge, ensuring it met all the opening requirements established by the United States Coast Guard (USCG). These requirements posed a challenging decision to work through the winter.

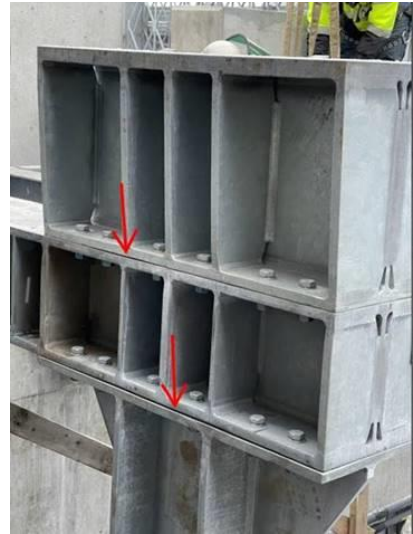
Photo No. 4: Steel gaps in the trunnion support are shown.

The North Hero movable bridge experienced slow progress due to issues with the trunnions' steel support beams. The connections were not in full contact across the mating surfaces. This full contact is essential for properly bearing the load of the bascule bridge's weight through the trunnions. To address this, the mating steel was measured, and custom tapered shims were manufactured to fill the gaps between the trunnions' vertical steel support beams and the horizontal supporting steel beams. Additionally, shims were added between the trunnion weldments mounted on top of the horizontal support beam.

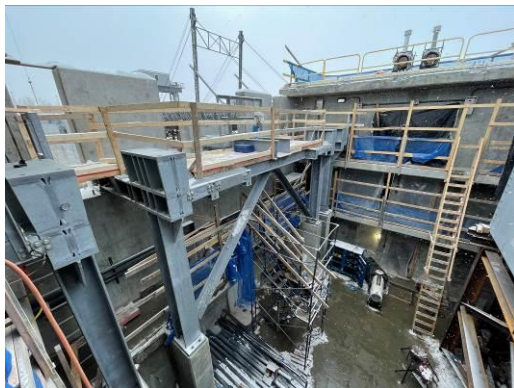
Photo No. 5: North Pier before the erection of the bascule span.

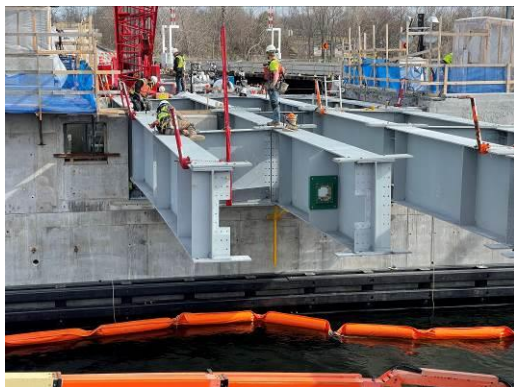
Photo No 6: Erection of the South Bascule steel.

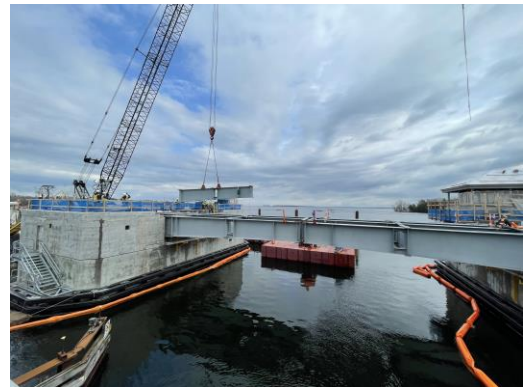
Photo No 7: Erection of the North Bascule steel.

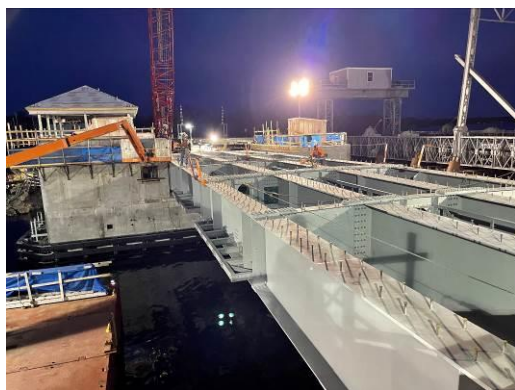
Photo No. 8: North and South Piers bolts being snug tighten during a night shift.

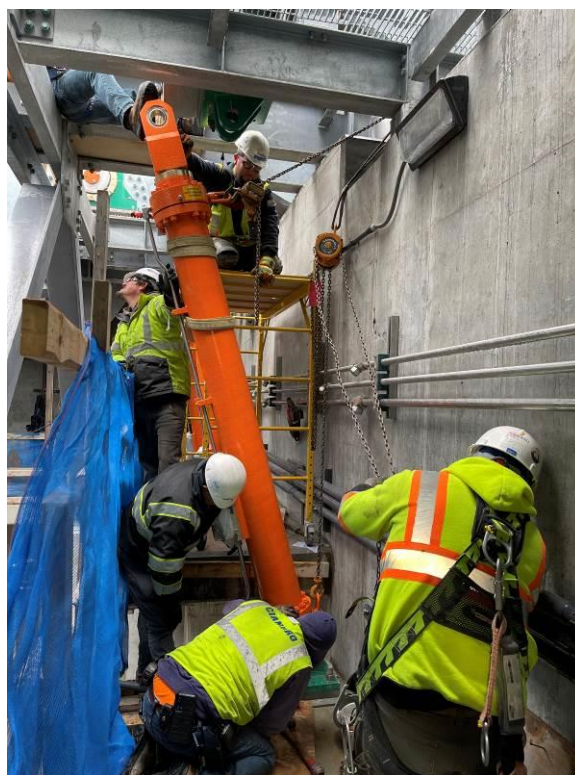
Photo No. 9: Installation of hydraulic cylinders installed on the North Pier.

Simultaneously, the preassembled hydraulic power unit was installed in the machinery room adjacent to the pit in the pier. Three hydraulic lines ran from the power unit along the inside of the pier wall and connecting to four hydraulic cylinders that were lowered through the erected steel of webs and stringers. Each hydraulic cylinder was connected to a girder, with two center support girders connected to the counterweight each having their own hydraulic cylinder. This setup created a rigid bridge deck and distributed the load to the four hydraulic cylinders. Live load shoes were positioned beneath each of the four girders, and the four span locks were installed with two actuators per leaf. The guides and lock bars were positioned on the leaf accordingly, and the receivers for the opposite leaf's span locks were also installed. The resulting leaf was constructed completely without a bridge deck, with all the machinery installed.

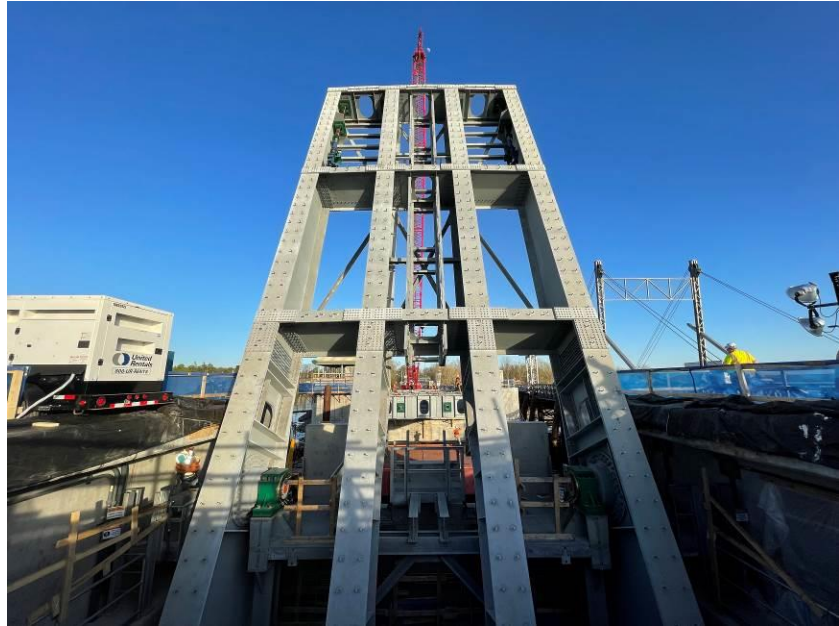
Photo No. 10: North Pier partially assembled in the open position.

Once the completed span had all the bolts in place and snug tight, and all the machinery was installed, the contractor placed a generator capable on top of the pier towers. The generator would power the hydraulic power units by connected it to the electrical mains at the PLCs. The span's balance was confirmed using pressure sensors at all supporters. These sensors were at all supporting points forward of the trunnions and the counterweight support steel aft of the trunnions. After final checks, the counterweight support steel was removed and the power turned on. This caused the bascule span to raise into the upright position without incident. Once fully raised, steel beams were used to secure the counterweight in the upright position. The beams held the top of the counterweight pinned against the back of the pier pit wall preventing unwanted movement.

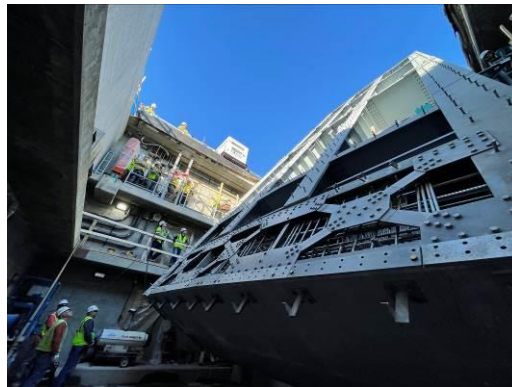
Photo No. 11: North Pier partial assembled view from pit.

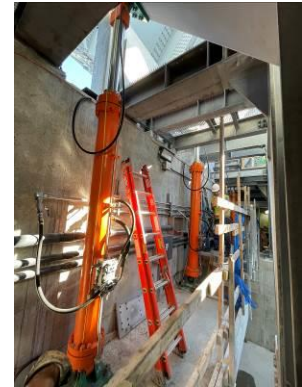
Photo No. 12: North Pier hydraulic cylinders fully extended.

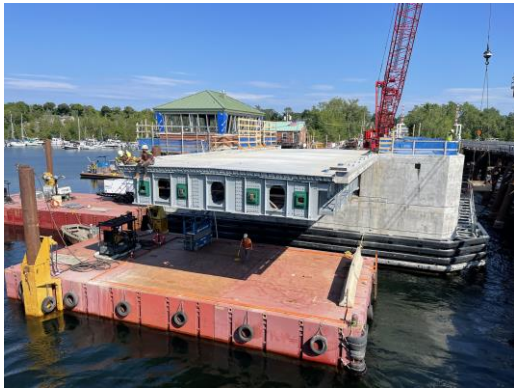
Photo No. 13: Completed steel and deck on the South Bascule Span with leaf in the lowered position.

With one leaf pinned in the open position, the contractor was able to shift focus to the other leaf and replicate much of the work already completed. The primary distinction in this phase was that the snug tight bolts for the steel structure would be fully torqued down. Which would ensure a secure and stable assembly. Additionally, the bridge deck was set to be completed and poured, a crucial step that included filling the counterweight with concrete. This meticulous process ensured that both leaves of the bridge were structurally sound and ready for the final stages of construction.

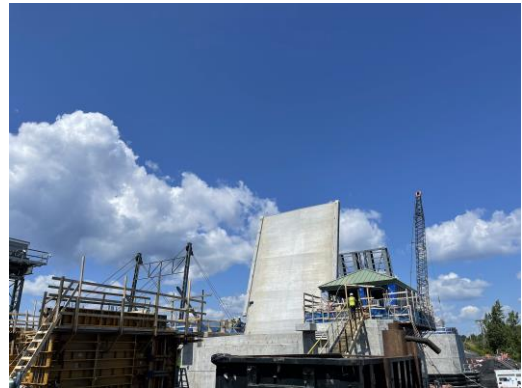
Photo No. 14: Completed South Bascule Span in the upright position with the incomplete North Bascule Span open in the background.

After the second span installation was complete, it was raised into the upright position and securely locked in place. Which mirrored the process used for the first span. Steel beams were used to pin the counterweight in the fully open position against the back pier pit wall, ensuring stability. Subsequently, span one was lowered using generator power, which allowed the iron crews to tighten all the bolts and pour the grid deck. Once the work on span one was fully completed, both spans were raised into the upright position. This enabled the channel to be fully open and operational. This process ensured the structural integrity and functionality of the spans, facilitating smooth and efficient operation.

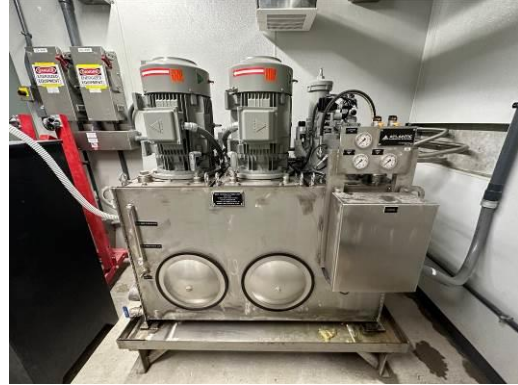
Photo No. 16: North Hydraulic power unit in the pier's machinery room.

During the testing phase of the second span, an issue was discovered with the lowering cycle. While the span could be raised and stopped successfully, it could not stop during the lowering cycle. Instead, it would drift slowly and uncontrollably into the fully seated position. This problem was traced back to the third hydraulic tank line, which was designed to hold pressure during operation. However, this pressure kept the local check valves at the cylinder open during the lowering cycle due to the pressure on the rod side of the cylinder. Consequently, hydraulic fluid from the rod side would travel to the cylinder side through the orifice in the local cylinder manifolds, causing the span to drift into the lowered position.

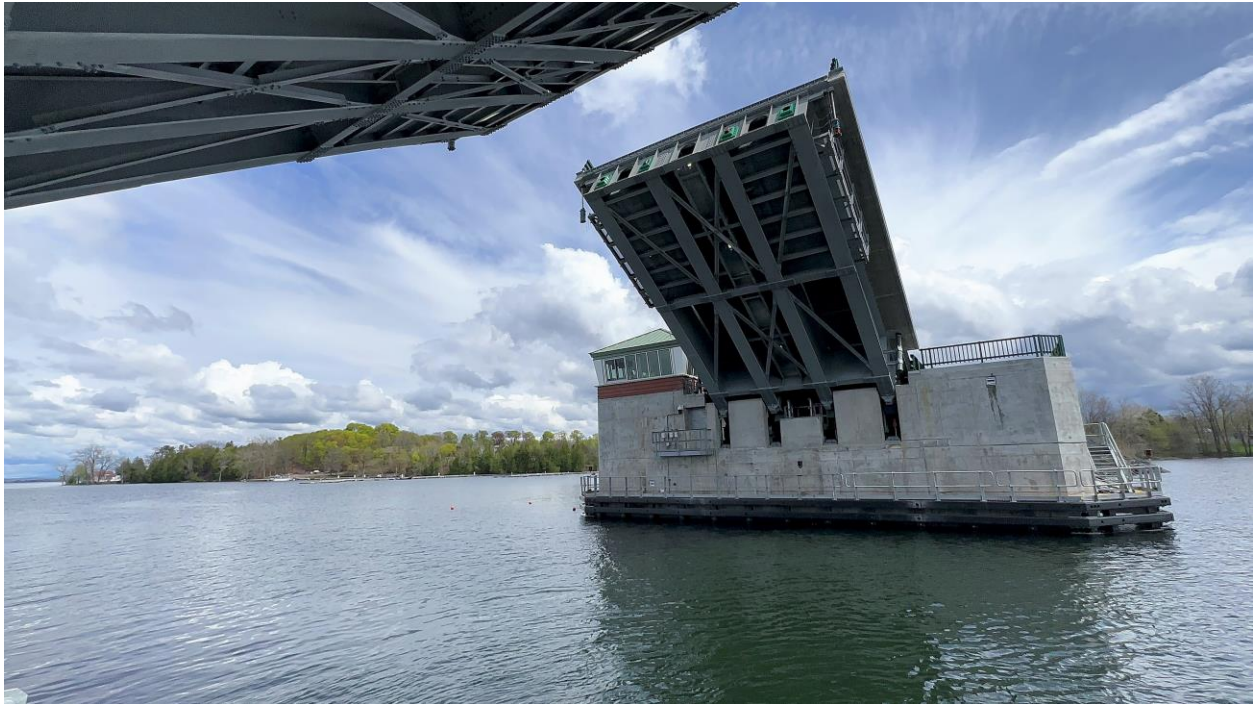
Photo No. 18: Completed North Hero Movable Bascule Bridge.

Upon its completion in the second quarter of 2023, the North Hero Movable Bascule Bridge became fully operational and functioned seamlessly. The bridge tenders found the operations straightforward and user-friendly, while the machinery components were designed for ease of maintenance and longevity. The project culminated in a highly satisfactory outcome, with the client expressing their approval of the bridge's performance and reliability. Consequently, VTrans assumed ownership of the bridge, ensuring its continued operation and upkeep.
