**HEAVY MOVABLE STRUCTURES, INC.
TWENTIETH BIENNIAL SYMPOSIUM**

The Rehabilitation of the Rio Vista Bridge

Jorell Gonzales, PE
Caltrans

Raymond Lopez, PE
H&H

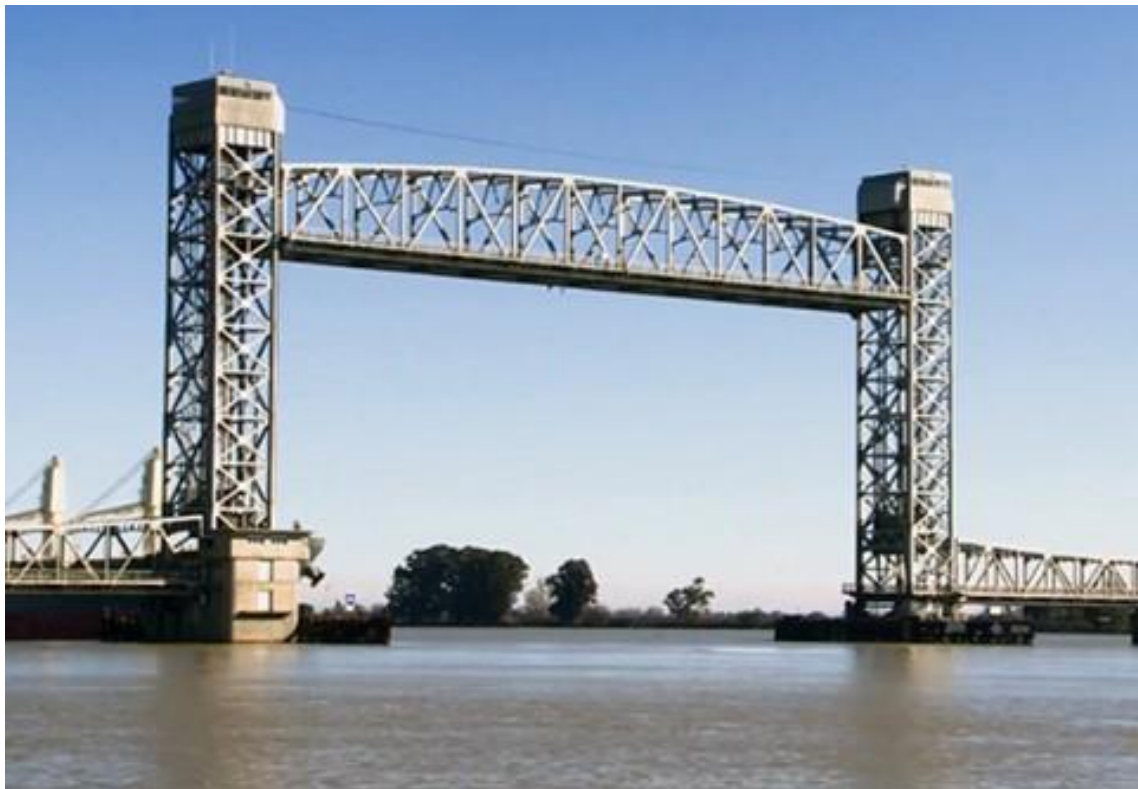
Figure 1: Rio Vista Bridge

The Rio Vista Bridge officially the Helen Madere Memorial Bridge named after Helen Madere, was originally a bascule bridge first built in 1918 and opened in January 1919. This bridge was reconstructed, becoming a tower bridge on 1943-1944 and first opened April 1, 1960. Providing a two-lane roadway and two sidewalks, the bridge stretches a total length of 2890 feet and 30.5 feet wide. The 1,550,000 pound movable span itself is 306 feet. Rio Vista is one of several movable bridges in the Sacramento-San Joaquin River that serves as a route for vessel traffic to the Port of West Sacramento and Yolo county.

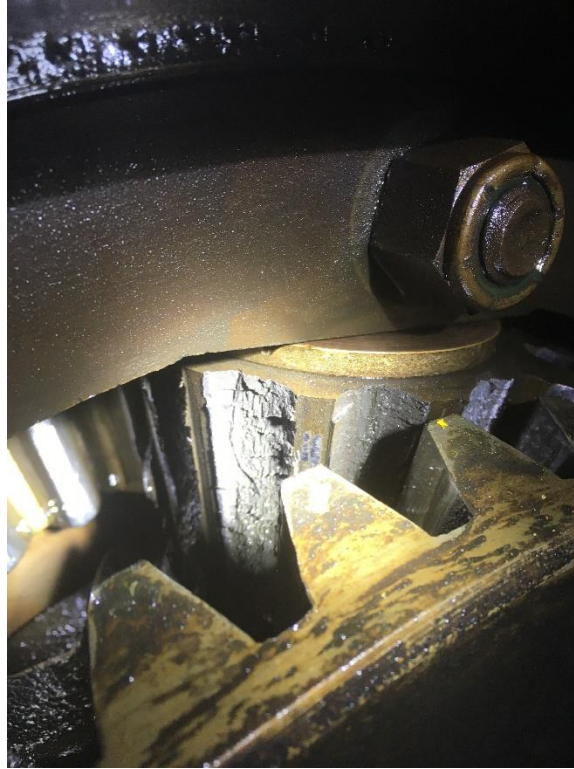
With the East gearbox declared as critical failure, an emergency directors order was initiated that led to hiring Golden State Bridge, GSB, to remove both gear boxes. The gear boxes were sent to Steward Machine, to be inspected and repaired. The East gear box had broken teeth on several gears, and the West gear box teeth had stress fractures discovered through NDT techniques. The manufacturer began to repair the gear boxes and replace the broken components.

Figure 2: East Gear Reducer, Broken Gear

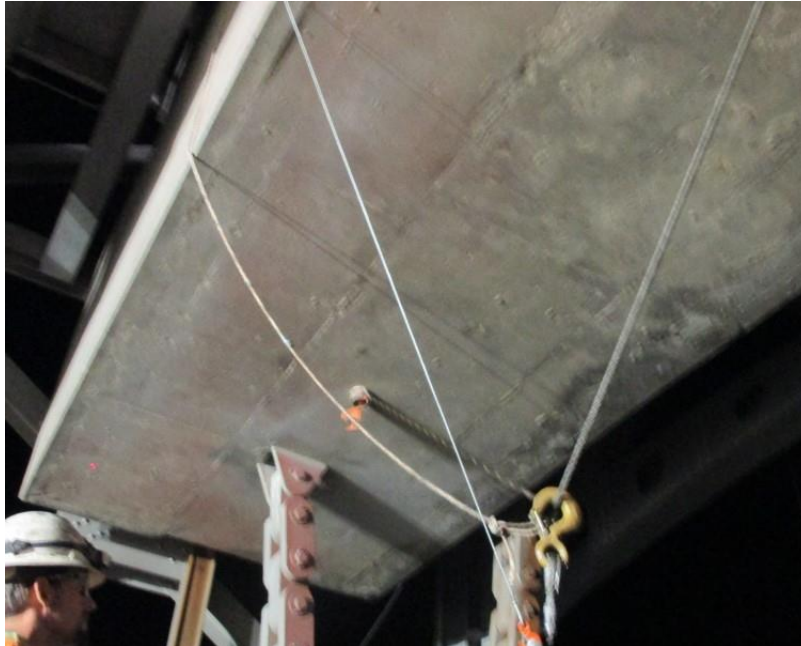
The plan involved pulling each of the two counterweights down. Two $\frac{3}{4}$ -inch wire ropes were tied around each counterweight that fed into a winch on the roadway level. Bridge elevation change was monitored with tape measures attached to the movable span and digital range finders targeting the counterweight. During lifting procedures, each winch would pull down the counterweight in 5 foot increments. Elevation changes were compared between span ends on each interval to prevent skew. Several teams were distributed throughout the span to ensure no issues would occur. When the bridge was at the fully raised position, the sheaves were tied to the structure to lock the span in place.

Figure 3: Counterweight pulled down with a winch to raise the movable span.

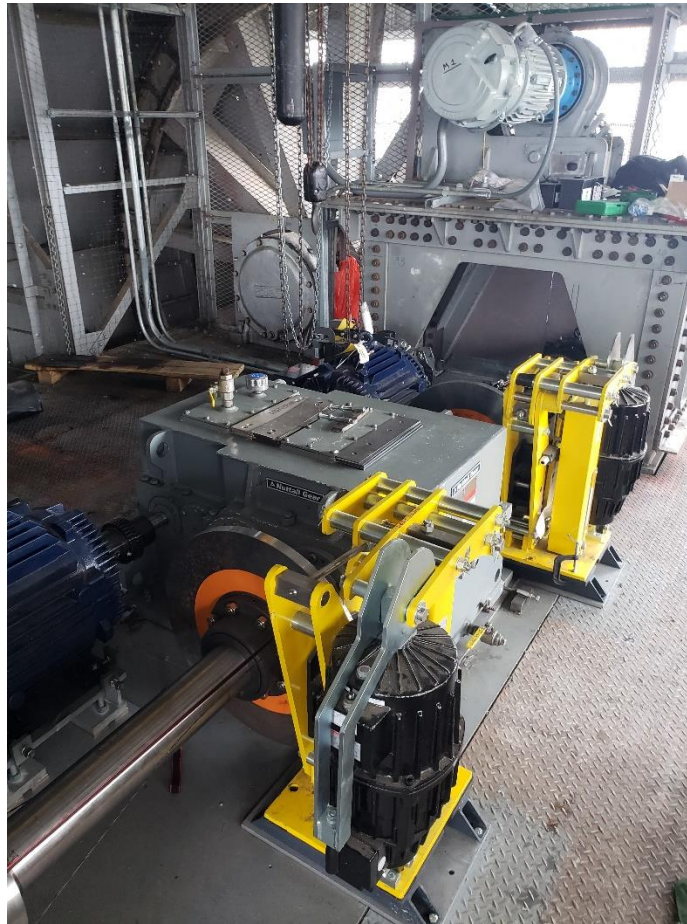
Figure 10: Installed Main Operating Machinery
