**HEAVY MOVABLE STRUCTURES, INC.
TWENTIETH BIENNIAL SYMPOSIUM**

**Rt. 30 over Beach Thorofare -
Rehabilitation of a Historic Complex Single
Leaf Bascule Bridge**

George Zimmer, P.E. (WSP USA)
Melissa Dawson, P.E. (WSP USA)
Brianna Rela (WSP USA)
Milind Kasbekar, P.E. (NJDOT)
Georgio Mavrakis, P.E. (NJDOT)
Muhammad Akhtar, P.E. (NJDOT)
Rama Krishnagiri, P.E.

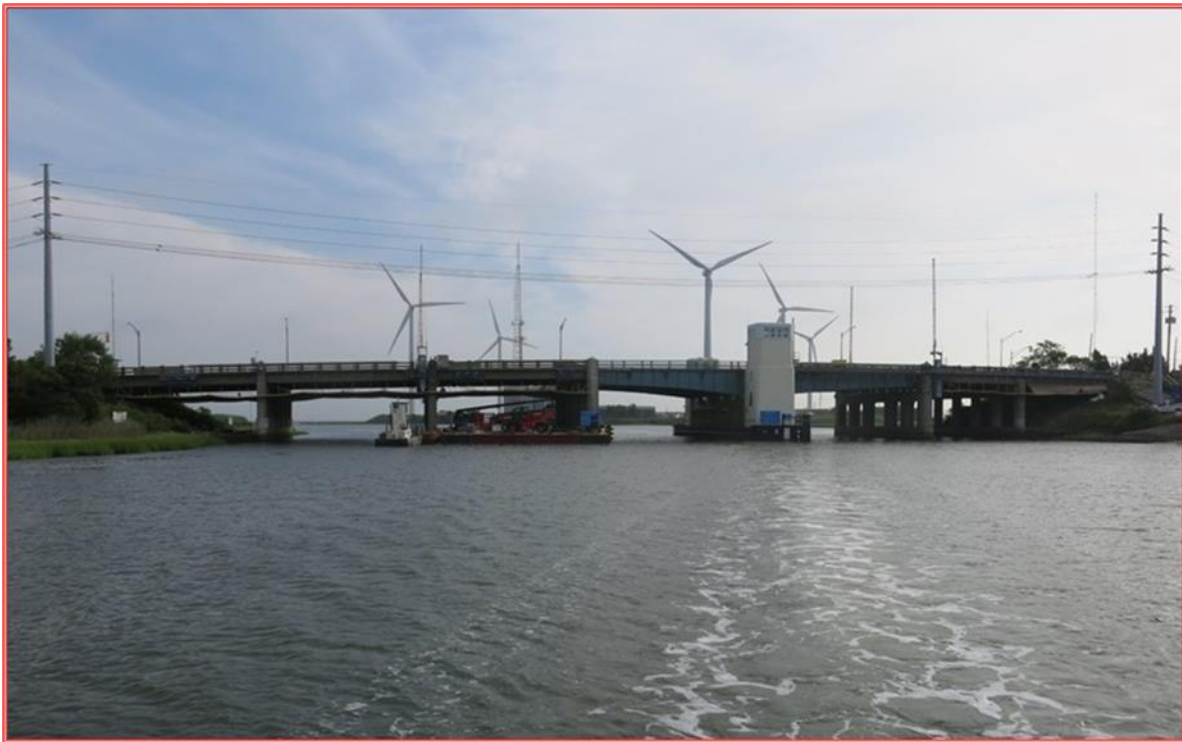
The original structure, built in 1941, is a 7-span, 471-foot-long bridge with 5 approach spans of concrete encased steel stringers, a single leaf, three girder, simple trunnion bascule main span with floorbeams, stringers, and purlins and a girder-floorbeam anchor span. The bascule span deck is an open steel grid deck while all approach spans have a reinforced concrete deck. The bridge carries three lanes of traffic in each direction, (2) 11'-0" lanes and (1) 12'-0" lane, divided by a concrete median barrier in the approach spans and custom aluminum barrier in the bascule span. The bridge also has a sidewalk ranging from 6'-3" to 7'-11" wide along each side. The Route 30 Bridge is a critical toll-free link to Atlantic City and is vital to its economy. Situated very close to the city's commercial corridor, the bridge also provides important access to the Atlantic Ocean for maritime traffic. This structure serves as an emergency evacuation route, and also needs to open for recreational and commercial vessels to access the Intracoastal Waterway.

Figure 1: Rt. 30 over Beach Thorofare Bridge

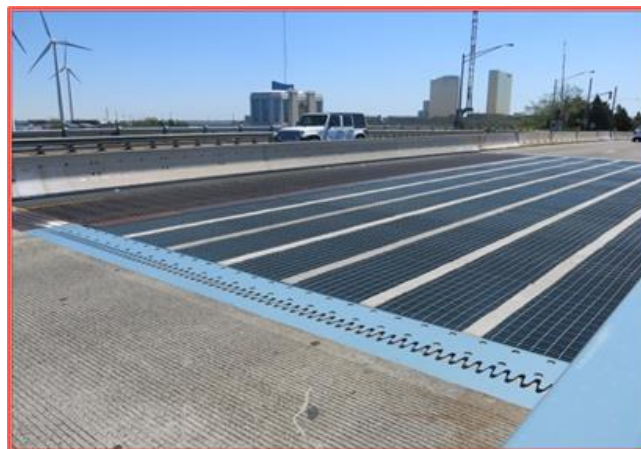
Figure 7: Stage 1 Finished Steel Open Grid Deck

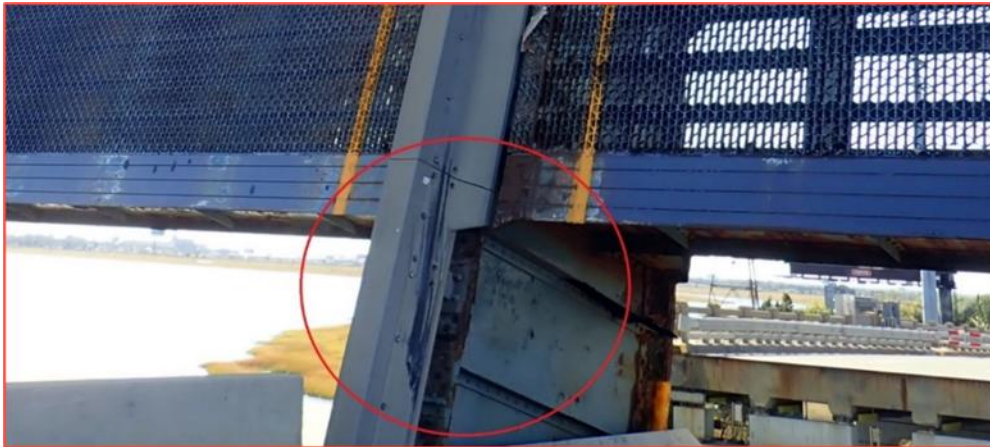
the same capacity as the NJDOT Standard Concrete Median Barrier. Additionally, the median has experienced at least one previous vehicular impact and remained intact, showing its ability to provide resistance, albeit details of the prior collision are not available (Figure 8).

Figure 8: Impacted Aluminum Median Barrier

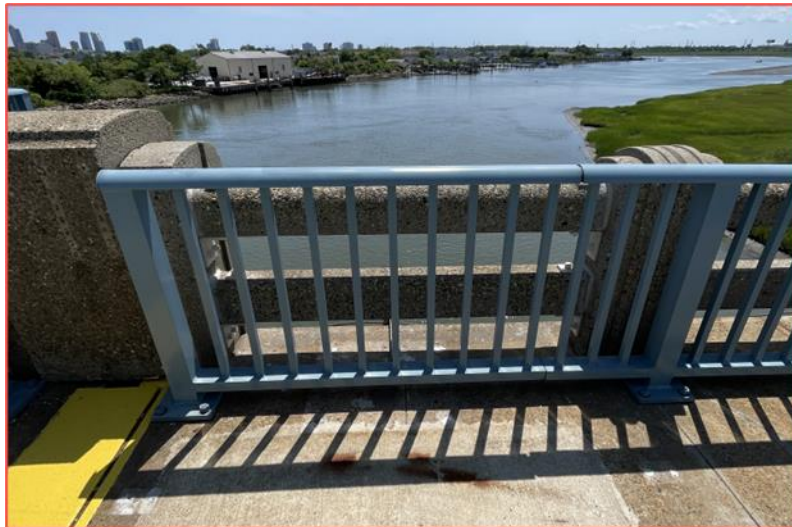
The existing fascia railings were inadequate in height to meet current OSHA code. Options considered to comply with OSHA were to replace the railing in its entirety with a new, taller railing of the same appearance, adding a top rail by drilling and grouting into existing, or to leave the railing as is and provide a new aluminum open railing system in front of it while not obscuring the original rails. Ultimately the third option, shown in Figure 11 was preferred and an aluminum railing with the least impact to views of the existing railing was selected.

Figure 11: New Aluminum Railing in Front of Existing – Note the original concrete railings are visible
