**HEAVY MOVABLE STRUCTURES, INC.  
TWENTIETH BIENNIAL SYMPOSIUM**

**Structural and Mechanical Construction  
Details for Replacement of a  
Bascule Span Superstructure with Minimal  
Impact to Rail & Marine Traffic**

Chuck Davis, PE  
Scott Bridge Company

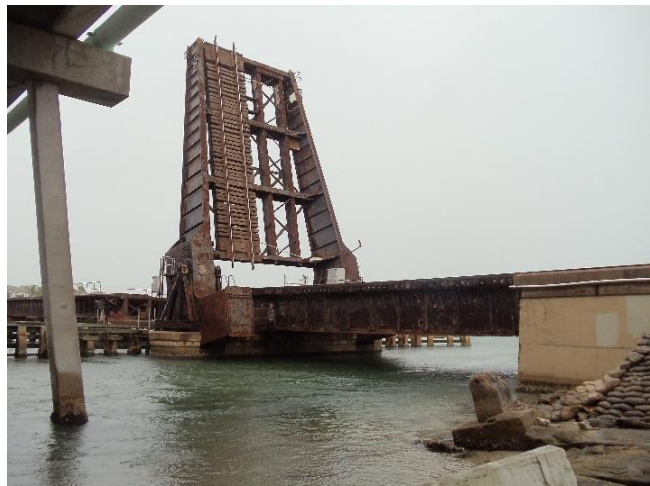
Existing Bascule Span in the Raised Position

The bascule span was replaced in 1935 when the original span was struck by a train. The span was of riveted construction, consisting of four lines of steel stringers and four floorbeams that frame into two main girders of built-up I-shape construction in the forward section and counterweight box heel ends.

The bridge's operating system consisted of a single induction motor connected via a belt drive to multiple stages of open gearing. The two main pinions drove curved racks mounted on the inboard face of each main girder.

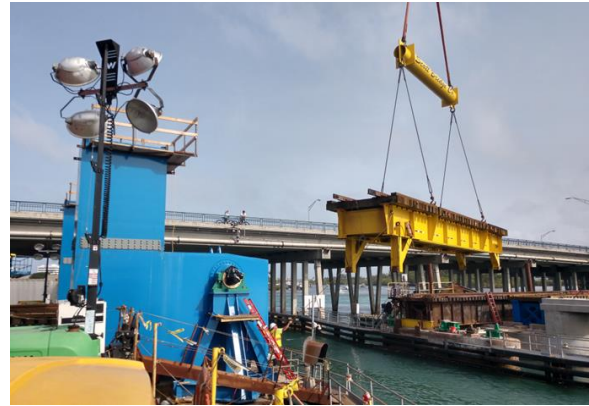
Flying jump span being removed from the channel

The FJS utilized W44 rolled beams with continuous cover plates on the top and bottom flanges needed to increase the strong axis inertia for this deflection-driven design. In addition, special bearings were designed and fabricated to bear on the existing narrow heel pier and toe pier bridge seats. A unique delta frame brace was added below the span at each end to transfer longitudinal train forces to the face of the pier.

New copper naphthenate ties were installed, and hook bolted to the span in preparation for reattaching the existing rail currently in service on the old bascule during the original 24-hour demolition outage. Lifting lugs were incorporated into the exterior web stiffeners of the FJS to facilitate quick connect and disconnect to a Manitowoc 16000 440-ton lift crane. This crane was positioned on the adjacent platform and was used to set the FJS in place and lift it out to pass boats. Spanning 55 feet over the Loxahatchee River the lifted weight of the FSJ was approximately 55 tons. In discussions with the USCG Miami office, it was agreed that the FJS would be lifted out once mid-morning and once late afternoon, 7 days per week, for one hour each during the outage to facilitate boat movements through the bridge. The railroad agreed to reschedule their freight trains to provide a reliable lift-out schedule for boaters to plan their morning and afternoon trips. Guide plates were incorporated into the lower delta frame brace and on each pier to facilitate easy and accurate removal of the span.

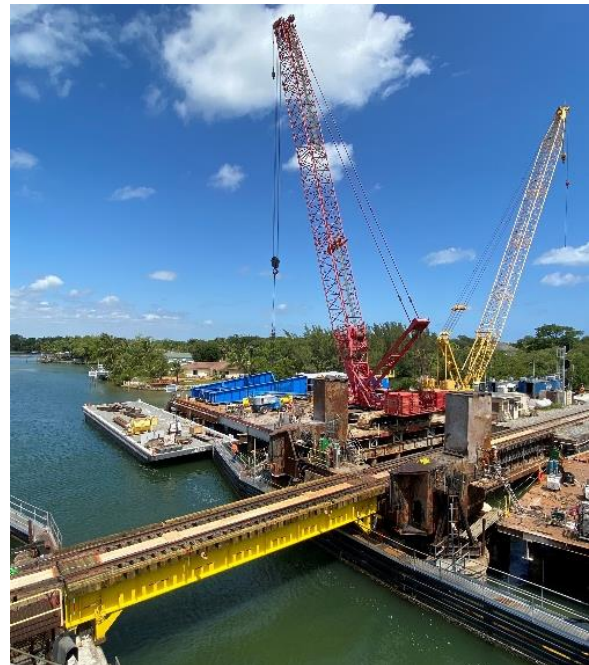
Flying jump span installed and open for train traffic

To facilitate the process of the upcoming bascule span changeout, a method was needed to accommodate the passage of both trains and boats for the 45-day changeout timeframe. After considering other options, the concept of using a removable span on the existing alignment was the most cost-effective and schedule-friendly option. This temporary span would be designed for an E80 loading with full impact and high longitudinal traction forces required by AREMA Chapter 15. This liftable span was nicknamed the Flying Jump Span (FJS) and was developed and designed in collaboration between the GC engineers and Genesis Structures of Kansas City, Missouri.

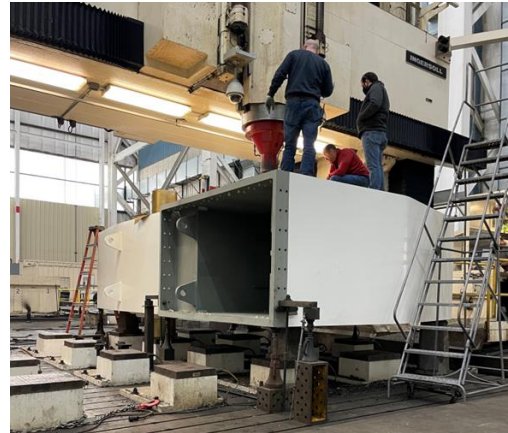
Machining a counterweight girder

The goal for the bascule leaf was to fabricate the bascule leaf accurately enough that the critical alignment of the trunnions in the girders would not be disturbed when the splice was made. G&G led the process of proposing fabrication details to achieve this goal. They changed the splice between the counterweight girders and the bascule girders from a structural connection to a machinery connection with the faying surfaces machined and tight tolerance bolts for alignment. After the main box section was fabricated, the trunnion hub bores, the rack mounting surface and bolt holes and the toe splice surface and bolt holes were all machined in one setup on their 10m gantry mill in Cordova, AL.

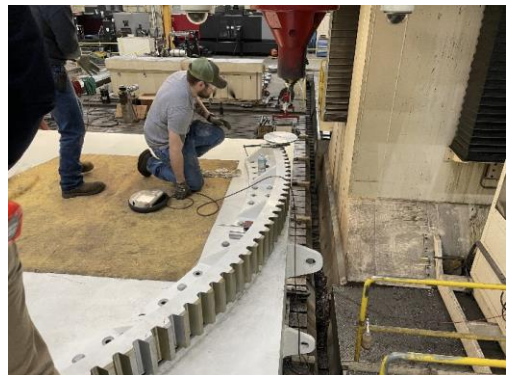
Checking rack alignment on the mill

The design drawings called for installation of the racks on the counterweight girders with undersize bolts to allow for field adjustment after the alignment was verified under full dead load. This incremental approach to mounting the racks did not align with the contractor-proposed outage durations and installation plan. G&G was confident that they could fabricate the counterweight girders to a level of precision that would not require field adjustment of the racks. They proposed to perform very detailed alignment checks of the

racks relative to the trunnions after assembly of the components with the counterweight girders using two independent means: Laser tracker measurements performed by IPM and measurements performed by G&G using their gantry mill as a coordinate measuring machine. TranSystems mechanical engineers accepted this approach. The shop checks were so critical to the project that both the GC and the MBPC attended the checks to verify what measurements were taken before approving installation of the final turned bolts in the shop.

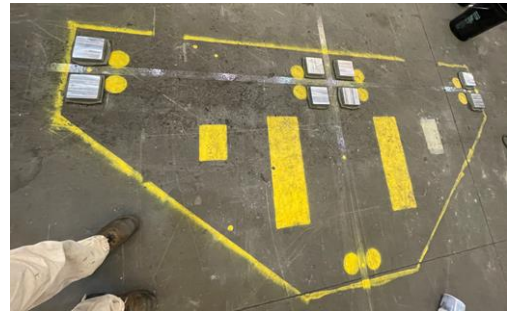
Layout of sole plates to support towers at shop assembly

- Sole plates that would support the towers were laid out and grouted in place.
- The sole plate elevations were surveyed with a laser tracker, and then shim packs were made up so that the top of the shim pack was at a precise elevation, ready to accept the towers and open gear frames.

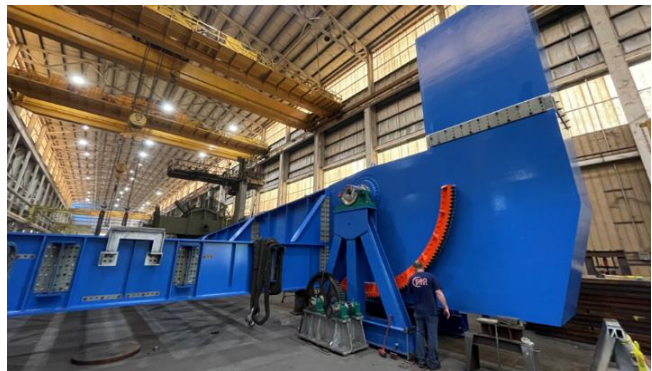
Completed shop assembly of leaf supported on towers

- The counterweight girders were set in the bearings and supported so that the toe splice was vertical.
- The trunnion alignment between the two counterweight girders was verified via laser tracker and piano wire to ensure that the sole plate support scheme was adequate.

- The toe section was assembled, lifted with a crane, and spliced to the counterweight girders.
- The crane was released and the trunnion-to-trunnion alignment was rechecked via piano wire to confirm that it was not disturbed. The trunnion-to-bearing alignment was checked as well. The backlash and alignment were checked at the rack and main pinion. The backlash was adjusted so that there was more backlash vs. the final criteria to account for the dead load deflection of the towers once fully loaded with the counterweight boxes full.

The shop assembly was witnessed by the GC and the MBPC, and independent verification of critical alignments was done via laser tracker measurements performed by IPM. The shop assembly was successful, and no major changes were made to the plan for field assembly.

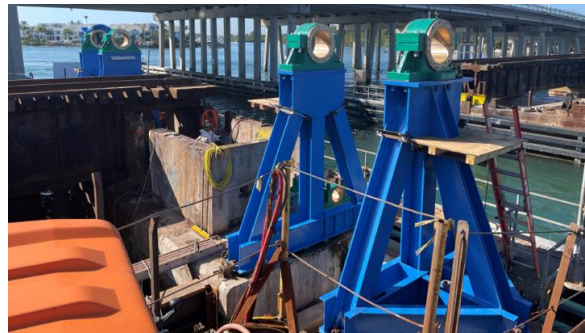
Towers installed and aligned on pier

After removal of the templates, the sole plate elevations were surveyed with a laser tracker and then shim packs were made up. The towers were then installed on the sole plates and shim packs. All four towers were set in a similar manner. Elevations were verified with a laser tracker and minimal adjustments were needed. The laser tracker was then used to adjust the four bearings into precise alignment.

Installation of the open gear frames followed a similar process as that used for the towers. In addition to the laser tracker, a bore telescope was used to verify the coaxial alignment of both pairs of bearings that support the main pinion shaft on each side of the bridge. Once all four towers and both open gear frames were installed, the anchors were installed and tightened and the main pinion shaft was installed, followed by installation of the counterweight boxes. The trunnion alignment was verified with a bore alignment telescope as an independent check of the laser tracker alignment checks.

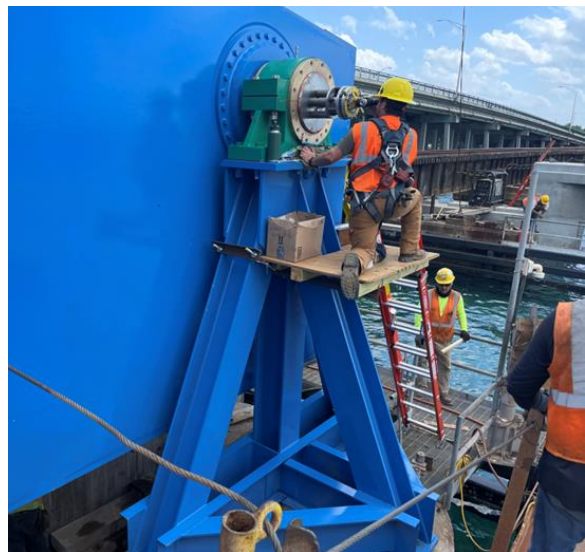
Checking trunnion alignment after setting counterweight girders on towers

The trunnions were aligned to within .010-in., half of the specified tolerance. The towers were grouted at this stage and the anchors tightened. In preparation for the second rail outage, the counterweight boxes were filled. As this loaded the towers, the trunnion alignment was monitored. The increased load also caused the girder to rotate as the support deflected. Prior to the outage, the girder was adjusted so that the splice was vertical to a high level of precision.

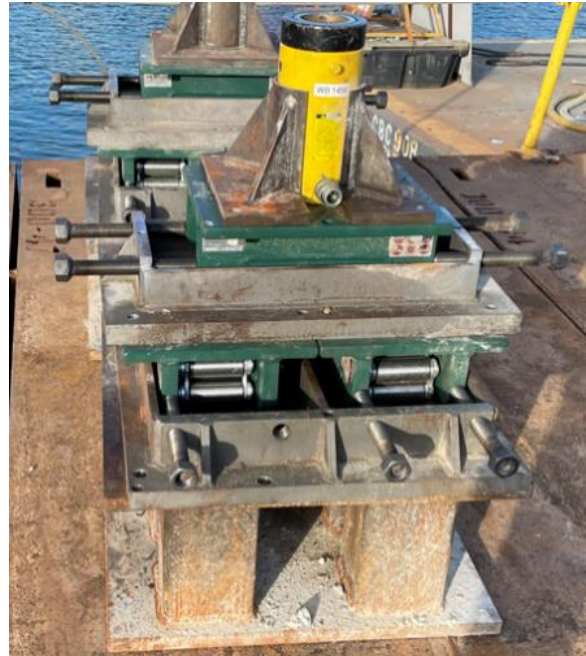
Manipulator to aid alignment of toe section

After the painstaking effort to achieve trunnion alignment, a major risk was that a counterweight box would get bumped by the toe section, and the alignment of the trunnions would be lost. The toe section was lifted into place using two cranes, one of which was barge-mounted and would be subject to movement due to wave action in addition to wind loading of the large structure. To mitigate the risk of a collision, a plan was devised to land the structure on four manipulators to stabilize it. The cranes would still support a portion of the load to make adjustment straightforward and precise.

The manipulators were comprised of a double stack of Hillman rollers with a jack on top for vertical adjustment to permit very precise 3-dimensional adjustments of the leaf position.

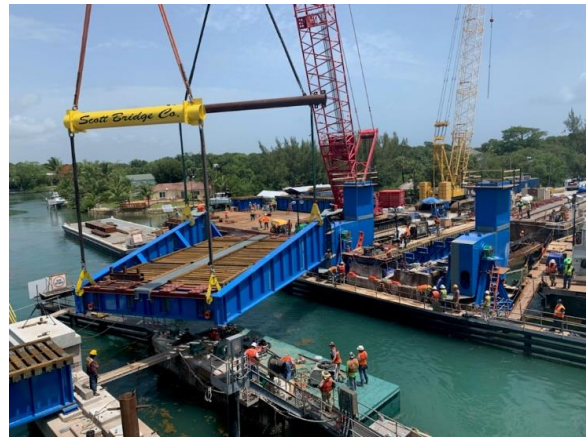
Lifting toe section into place

The toe section had been pre-assembled on the adjacent work platform and was lifted and swung into the channel, landing on the manipulators within inches of final position. The position of the toe section was adjusted with the manipulators relative to the counterweight girders until both gaps closed and all splice bolts could be installed by hand.
