Failure Analysis
of
High Strength Bolt's
Loss of Tension
on
Two Movable Bridges

William J. Doherty, P.E.
Florida Department of Transportation
Bureau of Structures Design

2nd BIENNIAL MOVABLE BRIDGE SYMPOSIUM

Based on
Report of May 15, 1987
Abridged: October 1, 1987

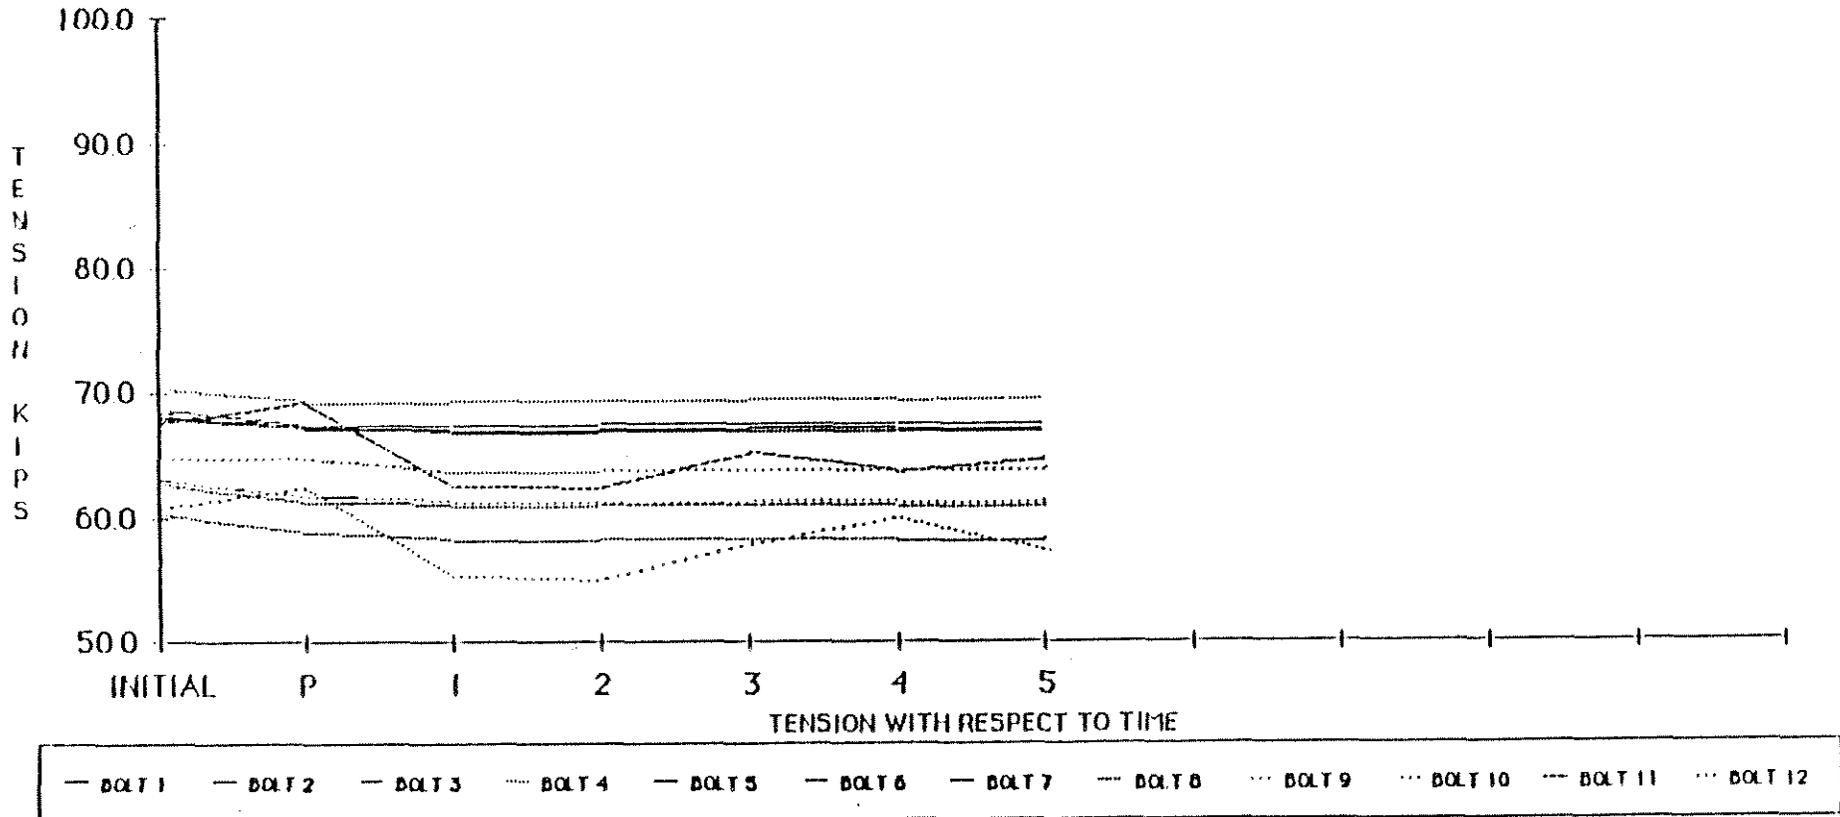
TEST NUMBER SIX

CONFIGURATION: 7/8" A325 Bolt, hardened washer under nut

TIGHTENING SEQUENCE: 12,11,8,7,4,3,1,2,5,6,9,10

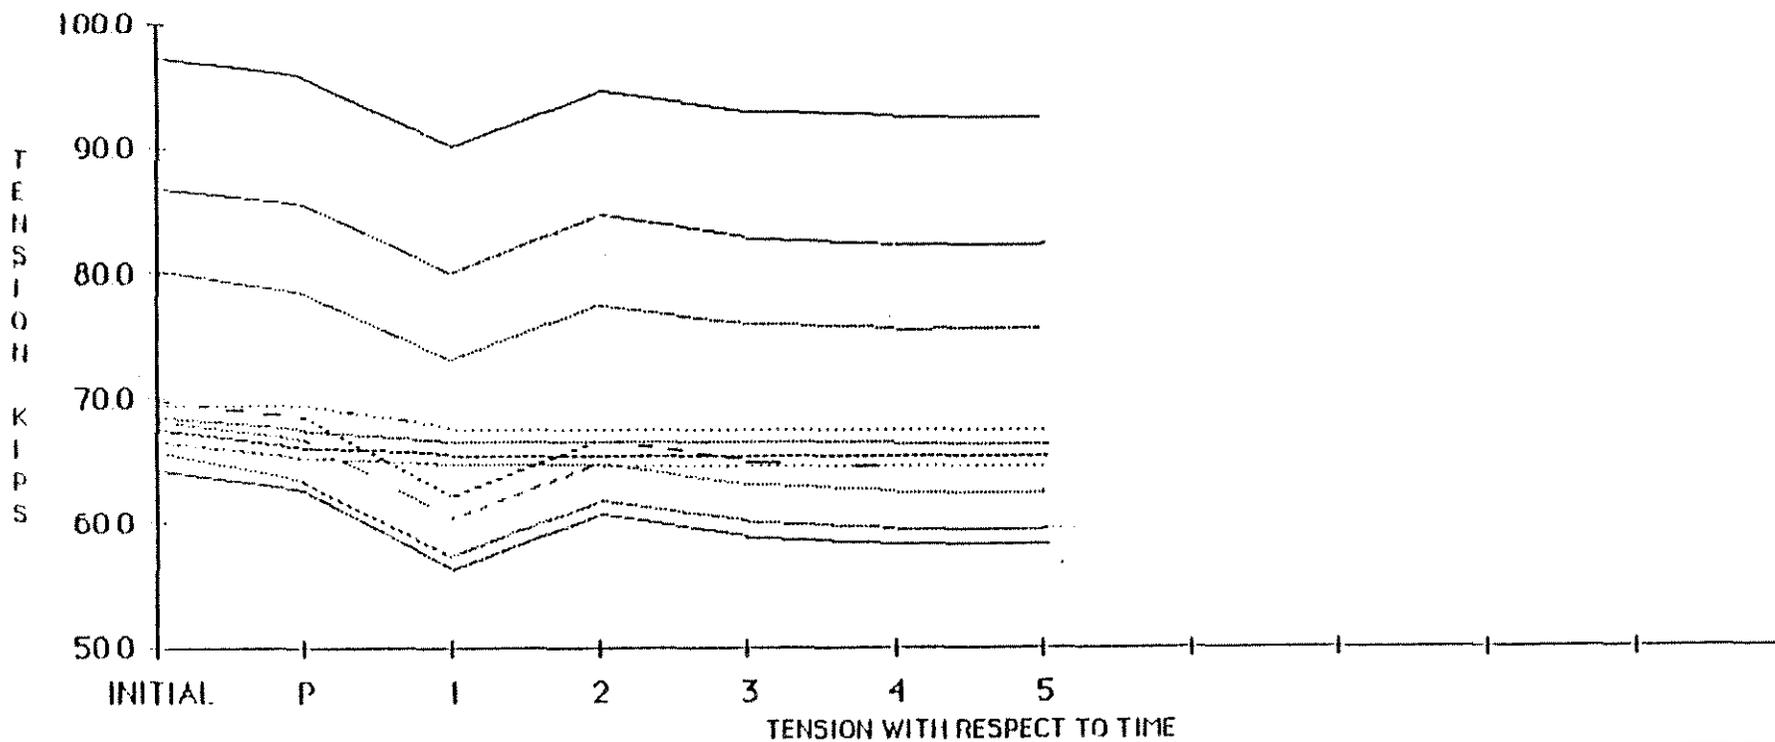
Figure 7

TEST NUMBER SEVEN

CONFIGURATION: 7/8" A325 Bolt, hardened washer under nut
(Reuse of Test No.3 Bolts)

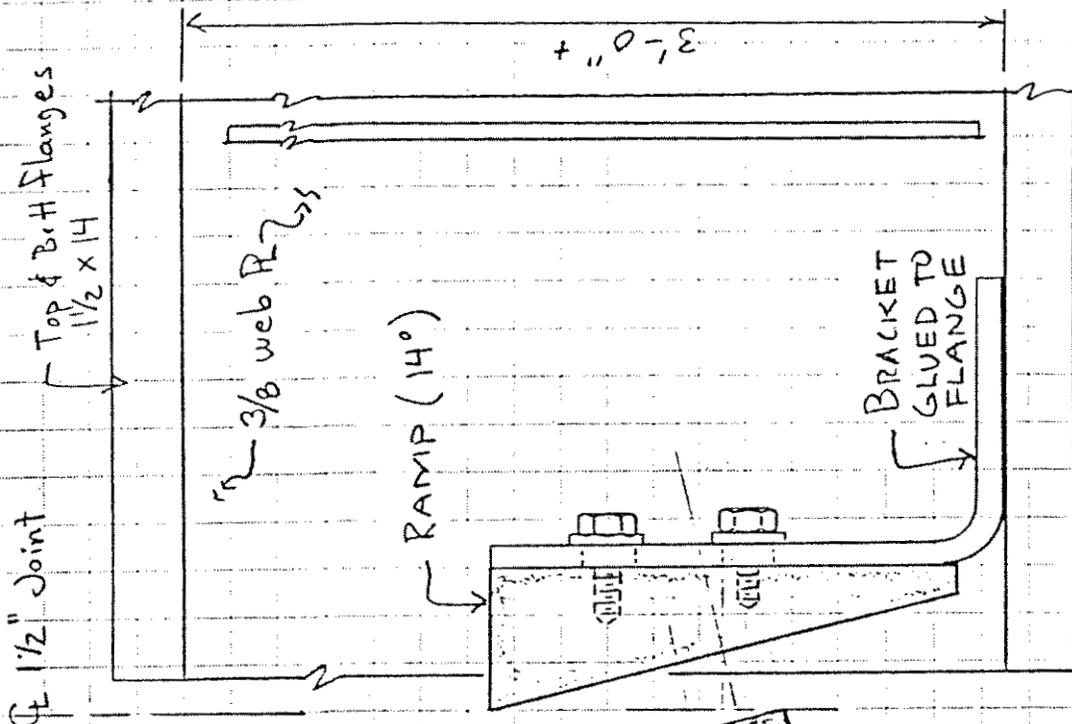
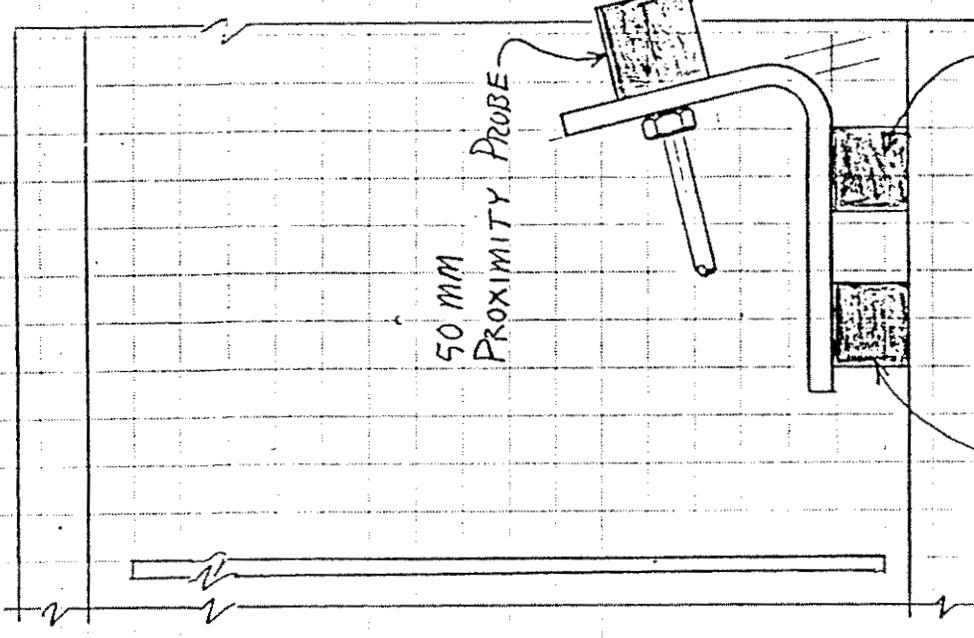
Figure 9

In summary, based upon all the test data presently available from both bridges, the opening and closing operating sequence generates a wrenching action on the structural connection NOT considered in the original design. Design assumes perfect alignment of the main girders during construction. The live load shoes are shimmed to align and maintain main girder contact. If these conditions are met, the shimming will still NOT take care of the rack/pinion teeth synchronization between the main girder racks. This will always result in some torsional, wrenching or prying action in the cantilevered structural connections (e.g., between main girder and front floor beam). The live load dynamics and an apparent amplification via total wrap-up (figure 9) are the type of unexplained loads imparted to these connections.

Bascule Bridge Operational Sequence Adjustment - In the closing cycle of the each span, the drive motor(s) torque should be removed prior to, or at the point of main girder contact with the live load shoes. If the structure has air buffer cylinders, the span should be allowed to seat itself due to the weight of the span. After a reasonable time delay, the span locks may be driven. Once these are seated, then set the brakes. This removes all torsional wind-up or wrap-up in the gearing system which causes an amplification of the live load on the structure (ref.3). This will also remove considerable vibration from the structure which contributes to joint slip and fatigue (Ref. 2, pgs.288 & 313).
