Session (3-1)
"Major Rehab. of Jefferson and Jackson
Street Movable Bridges",
I. J. Dvorak, Teng & Assoc. Inc., Ill.

MAJOR REHABILITATION OF JEFFERSON AND JACKSON STREET MOVABLE BRIDGES

Ivan J. Dvorak, P.E., Senior Vice President
Teng & Associates, Inc., Chicago

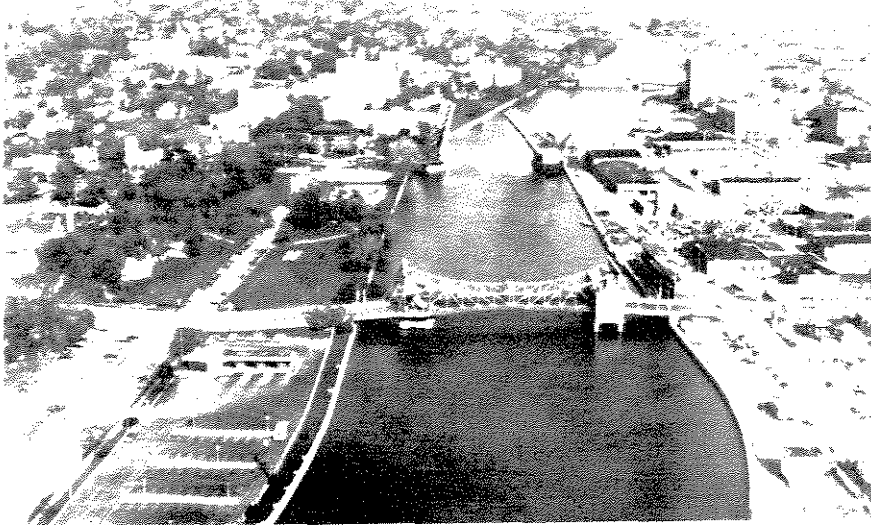
Figure 1 – Jefferson and Jackson Street Bridges

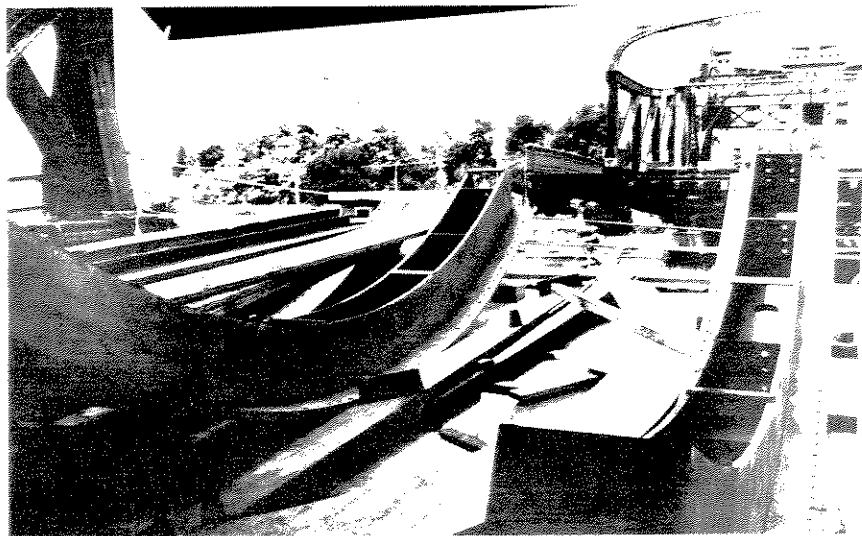
Figure 8 – Continuous Curved Segmental Girder Weldment Prior to Installation

It was important that the new design will keep local stresses of top flange within allowables. This was achieved in conjunction with the redesign of track and segmental plates. The new geometry facilitates a more direct transfer of the rolling concentrated load to the track box girders webs. (See Figure 7 for new detail.) By using A588 steel, the length of line bearing required was minimized. The existing top flange plates, angles and stiffener to flange connections were removed. The new flange plates were sized to keep the local tension bending stresses below the AASHTO allowable. The existing webs and side plates were cut in the field to accommodate the height of new flange and track plate. In order to attach the new top flange to the existing webs of track or segmental box girders, a weldment of a flange and two web plates was designed. (See Figure 8). This weldment was then connected by high strength bolts to the webs of existing track or segmental girder. (See Figure 9 and 10).
