HEAVY MOVABLE STRUCTURES
MOVABLE BRIDGES AFFILIATE
3RD BIENNIAL SYMPOSIUM

Session (3-11)
"Using Air Bags to Reposition A
Rolling Lift", Fred Parkinson,
Parsons Brinckerhoff Michigan Inc., Il.

USING AIRBAGS TO REPOSITION A DAMAGED ROLLING LIFT BASCULE

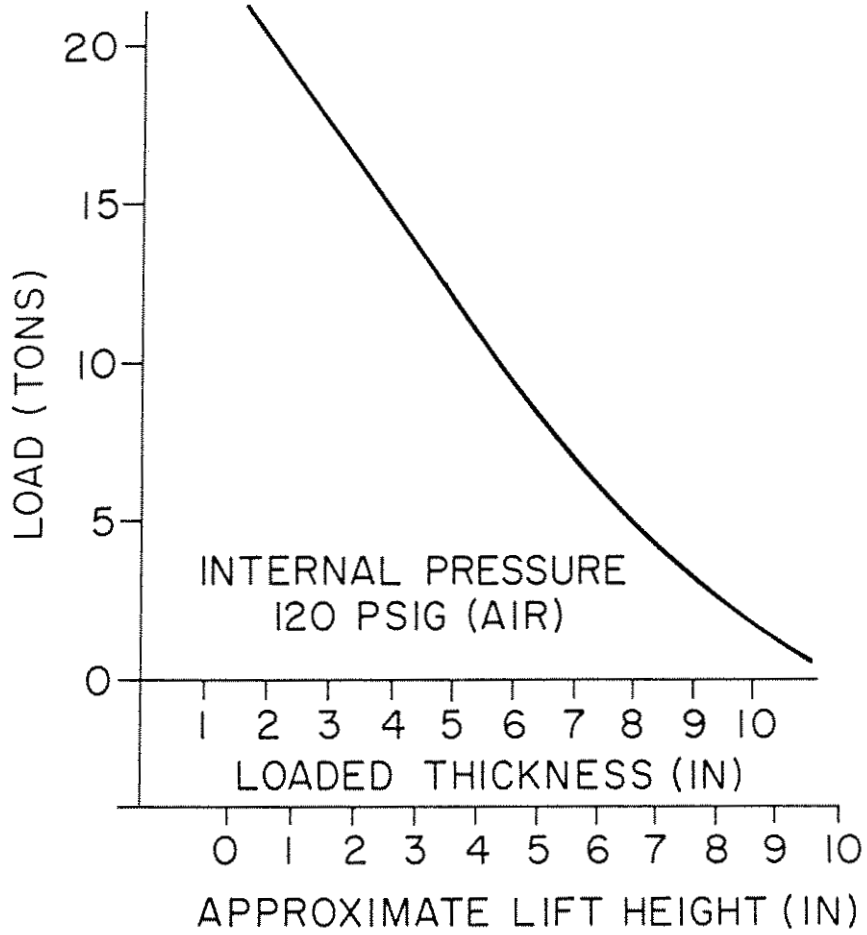
FIGURE 2

calibration curves that enabled the contractor to estimate the maximum load lifted for a given stroke, a sample of which is shown in Figure 2.
