HEAVY MOVABLE STRUCTURES
MOVABLE BRIDGES AFFILIATE
3RD BIENNIAL SYMPOSIUM

Session (5-1)
"Self Destruction of a Strauss Bascule
Bridge", John A. Schultz, Jr.,
Hazelet & Erdal, Chicago, IL.

SELF-DESTRUCTION OF A STRAUSS BASCULE BRIDGE

By John A. Schultz, Jr.
Associate
Hazelet + Erdal, Inc.

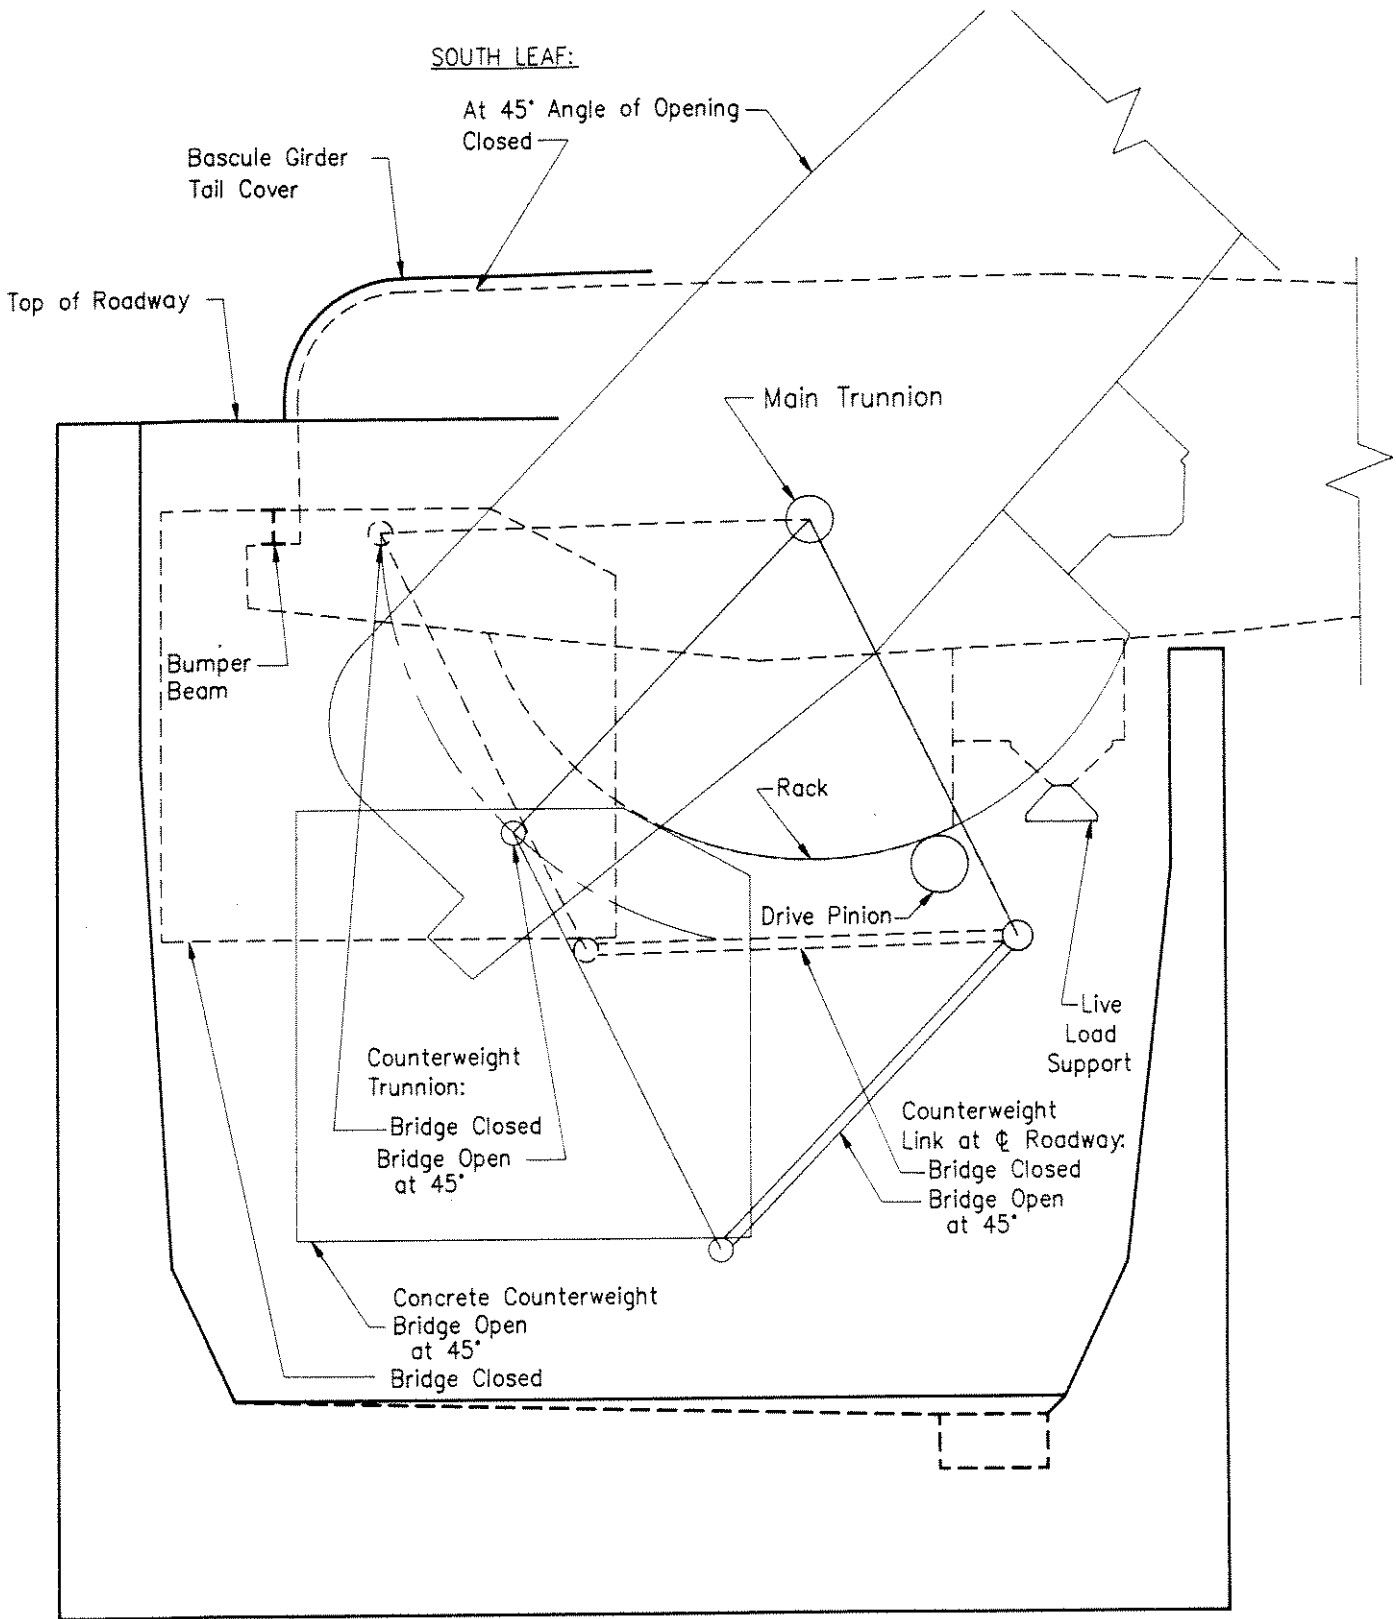
TAYCO STREET BASCULE BRIDGE
 OVER
 U.S. CANAL
 MENASHA, WISCONSIN
FIGURE 1

in place of cast iron counterweight, which cost = 15 to 20 % of cast iron, pound for pound, at that time. This innovation, used on his first bridge built for the W&LE Railroad in 1904, was adapted for use by nearly all designers for new bridges by 1906. He also developed and utilized a suspended (pivoting) counterweight in all his bascule bridges which, when the counterweight was located below the roadway, kept the counterweight arm as long as possible while limiting pit depth. (See Figure 1.) This was the case at Tayco Street.

SECTION THROUGH COUNTERWEIGHT PIT
 SHOWING BASCULE LEAF AT 45° ANGLE OF OPENING
