HEAVY MOVABLE STRUCTURES  
MOVABLE BRIDGES AFFILIATE  
3RD BIENNIAL SYMPOSIUM

Session (5-10)  
"Bolted Connections For Machinery;  
A Case Study", R. Mayeaux,  
Mayeaux Engr'g, Inc. Baton Rouge, La.

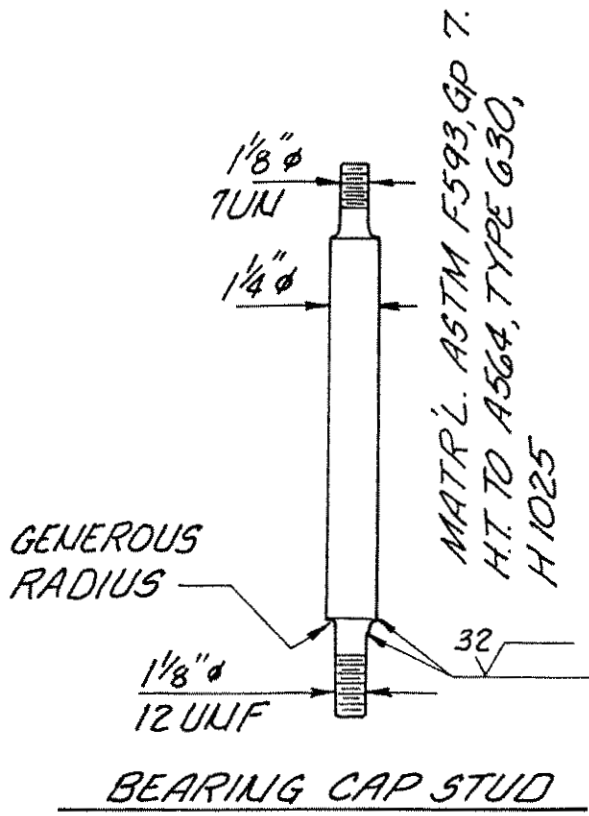
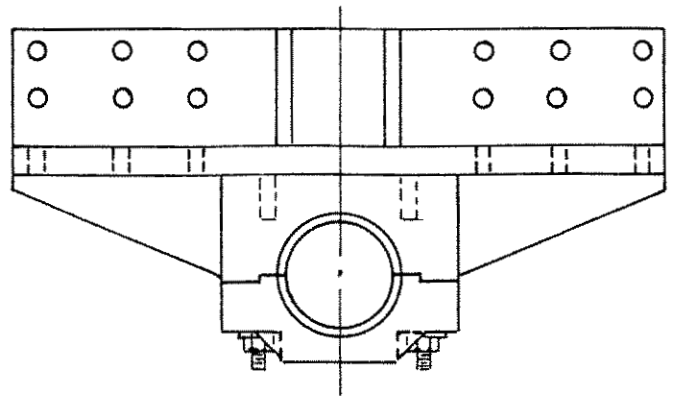
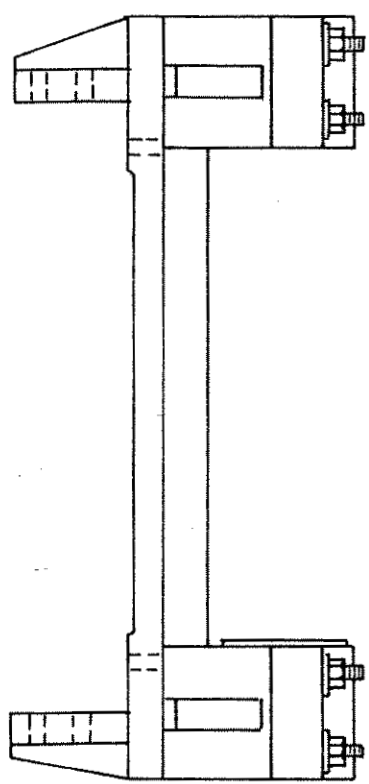
PLATE: 4A

The pinion is the last open gear reduction set of the bridge span drive. One of the vertical gear sets consist of a bull gear on top driving a 6 inch diameter forged steel shaft to the rack pinion on the bottom. Supported by bronze bushings, this shaft assembly turns in a cast iron bearing assembly. The bearing assembly consists of the housing, bronze bushings and bearing caps. See Plate 4A. This gearset-bearing assembly was shimmed and bolted to a built up machinery beam to transfer the rotating forces into the movable span thus, moving the bridge. Problems in this pinion drive assembly had been developing in the form of broken bearing cap studs and loose structural bolts connecting the bearing assembly to the bridge structure. Noticeable movement between the bearing assembly and machinery beam brought these problems to the attention of maintenance personnel.

Indications from this fracture are that three characteristics of the stud can be changed to prevent failure. They are material, geometry and finish. See Plate 4B. The material selected was ASTM F 593, Group 7 heat treated in accordance to ASTM A 564, Type 630, in the H1025 heat treated condition. Otherwise known as 17-4PH stainless steel, this alloy is readily available, equivalent in cost as ASTM A 193, Grade B7, exhibits slightly better impact and machining properties, superior strength and longitudinal toughness and has corrosion properties similar to austenitic, type 18-8, stainless steel. The second change was to use generous fillets at any section changes thus, reducing the stress concentration factor and stress gradient. Low stress concentration was assured by a 32 finish on the stressed areas on the stud by the prevention of tool marks of significant size.
