IMPORTANCE OF LUBRICATING/FLUSHING . . . BASCULE TRUNNIONS

NEW YORK CITY DEPARTMENT OF TRANSPORTATION

BUREAU OF BRIDGES

NICOLAE DINI, P.E.
E.I.C. MECHANICAL SECTION
MAINTENANCE

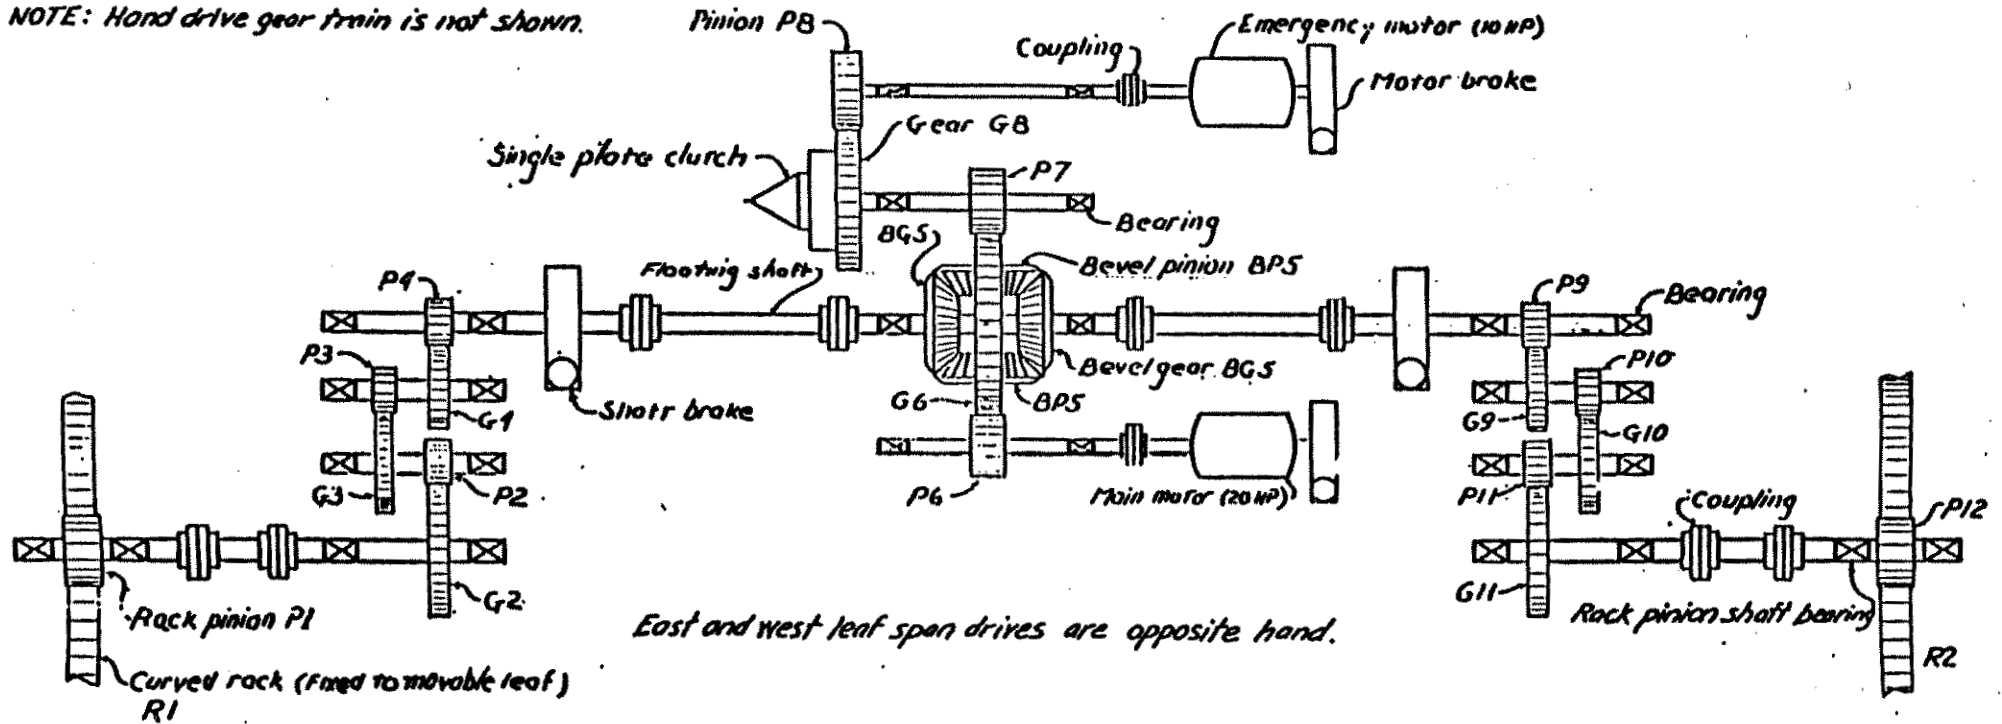
Fig 1

The two movable leaves of the bridge are each driven by virtually identical, but opposite hand, span drives, (See figure 1). Most drive components are located in a box girder which is part of a fixed trunnion shaft about which the bascule rotates.

Rotation of the rack pinions mounted within the box girder of the trunnion shaft cause the racks, fixed to the bascule girders, to rotate. In this manner, the leaves are raised and lowered by electric motors.

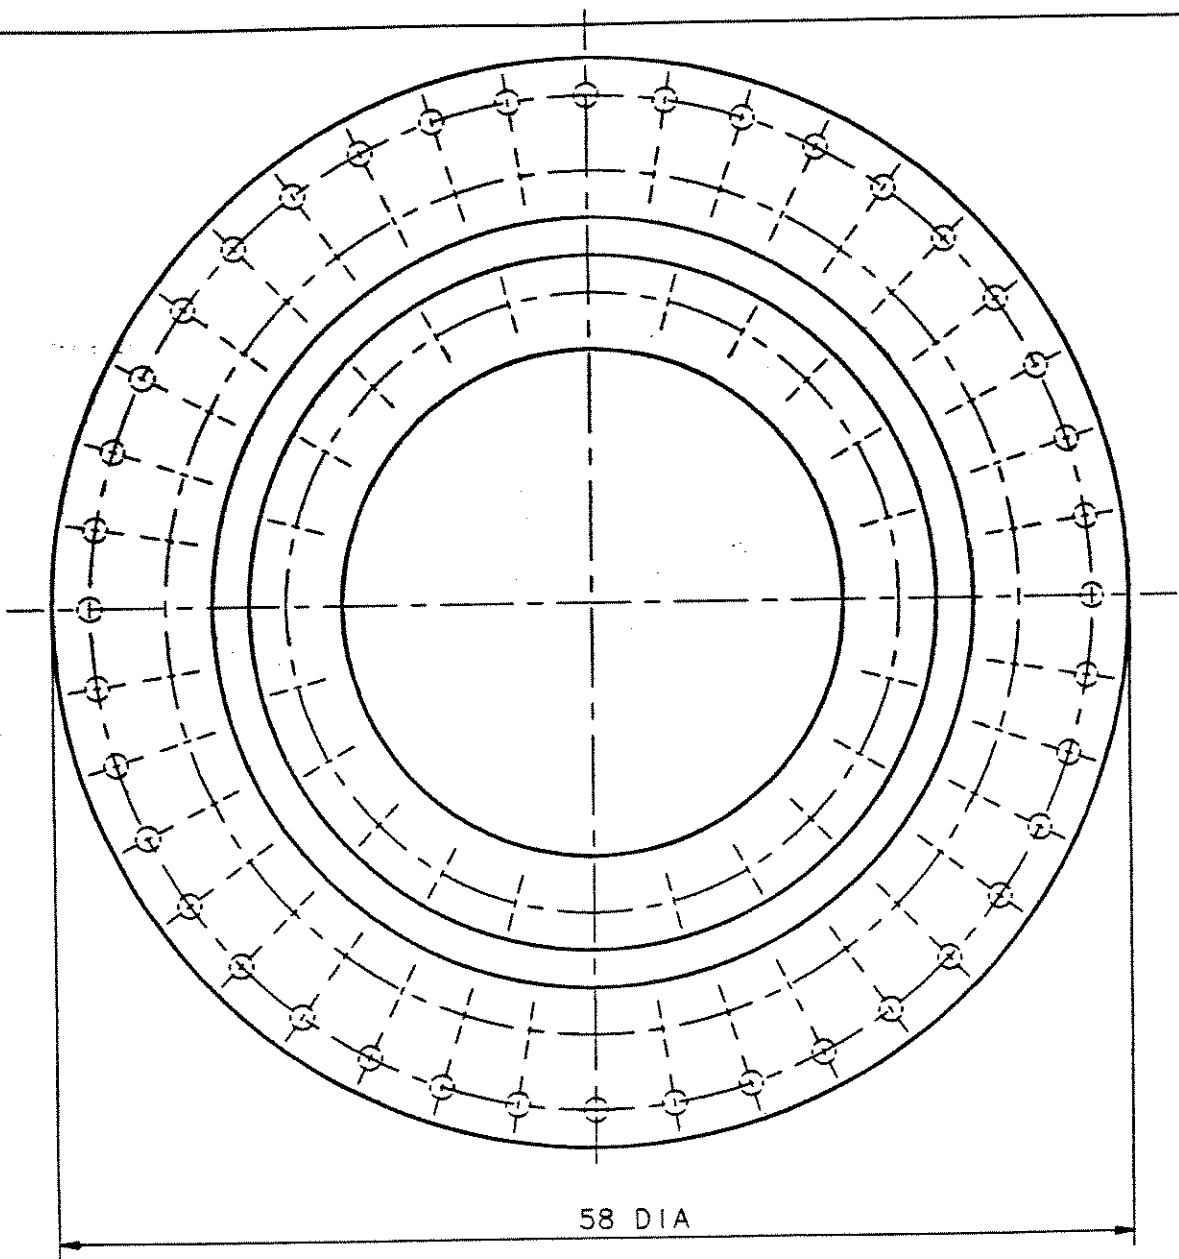
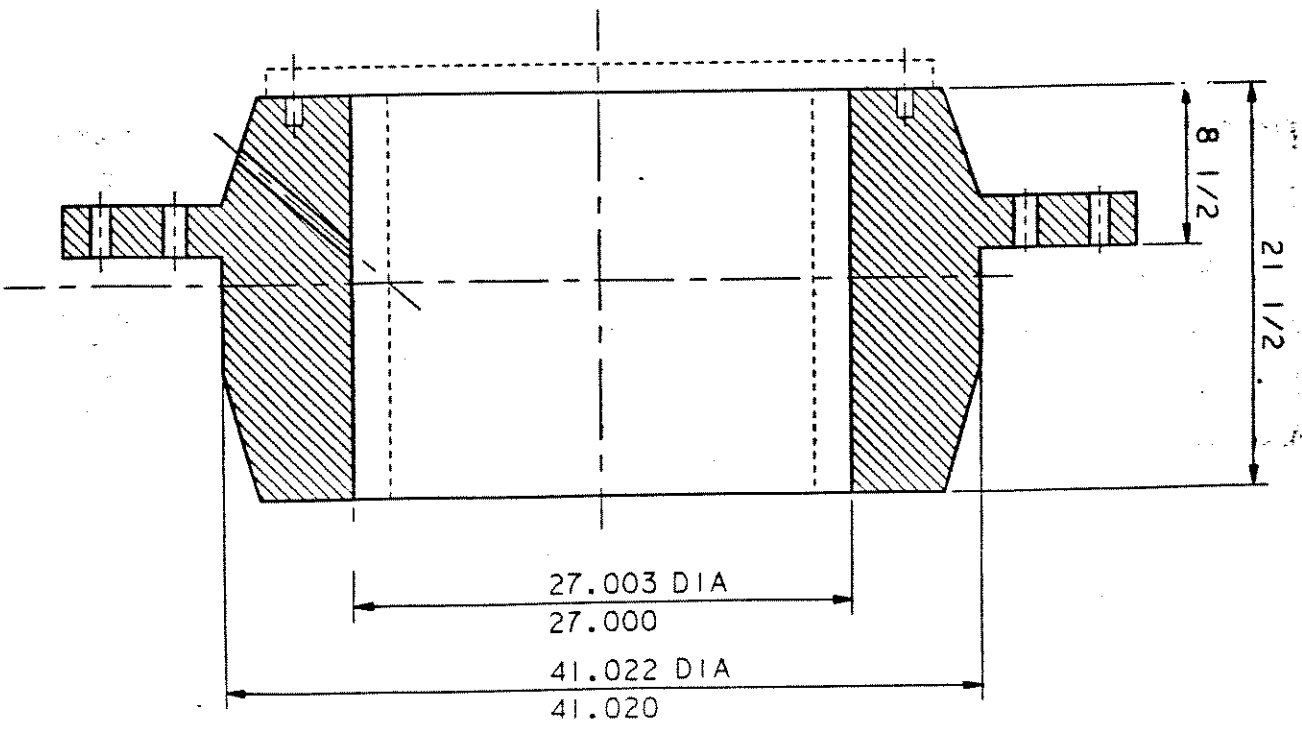
HUB
FIG 5

- a. "the trunnion" (forged steel-nickel alloy), figure 3,
- b. "the bushing" (Phos. Bronze), figure 4,
- c. "the hub" (cast steel), figure 5,
- d. "the collar" (steel, plate),
- e. hardware.
