#24 Author: Paul Bandlow
Stafford Bandlow Engr'g., Inc.
*"Repair of Counterweight
Trunnion Bearing"*

THAMES RIVER BRIDGE
COUNTERWEIGHT TRUNNION REPAIR

Paul M. Bandlow, P.E.

Stafford Bandlow Engineering, Incorporated

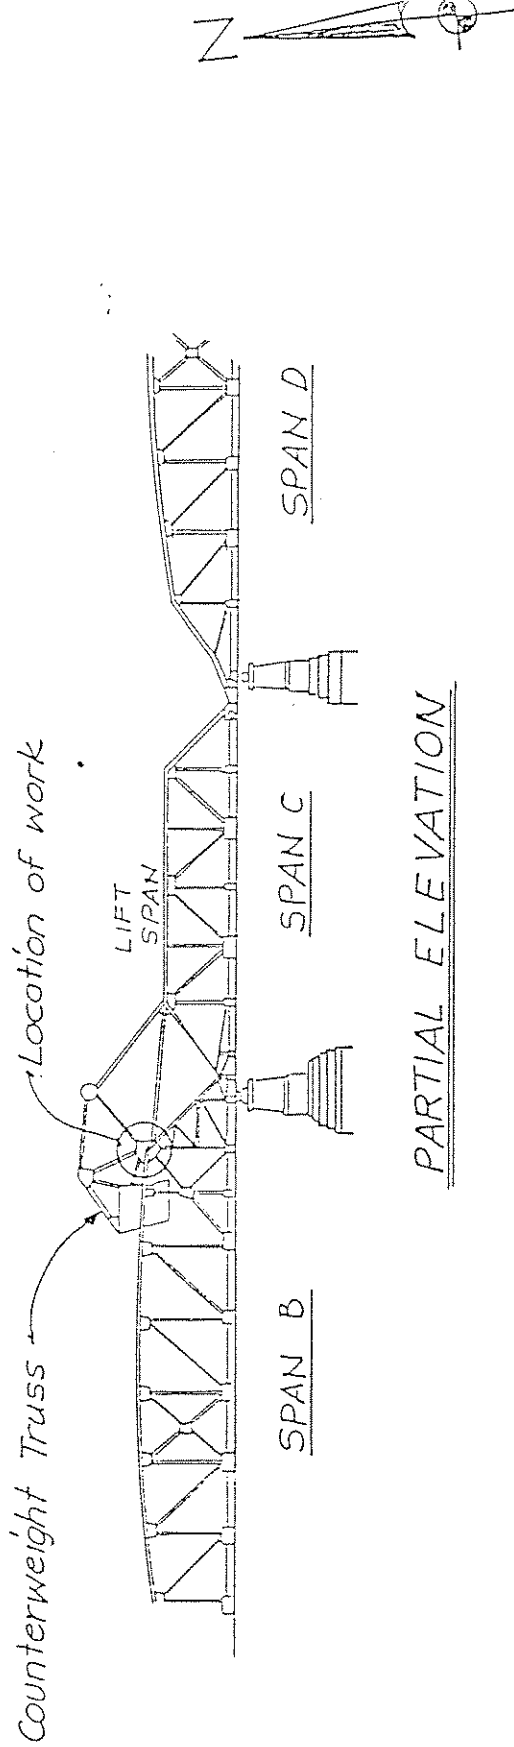
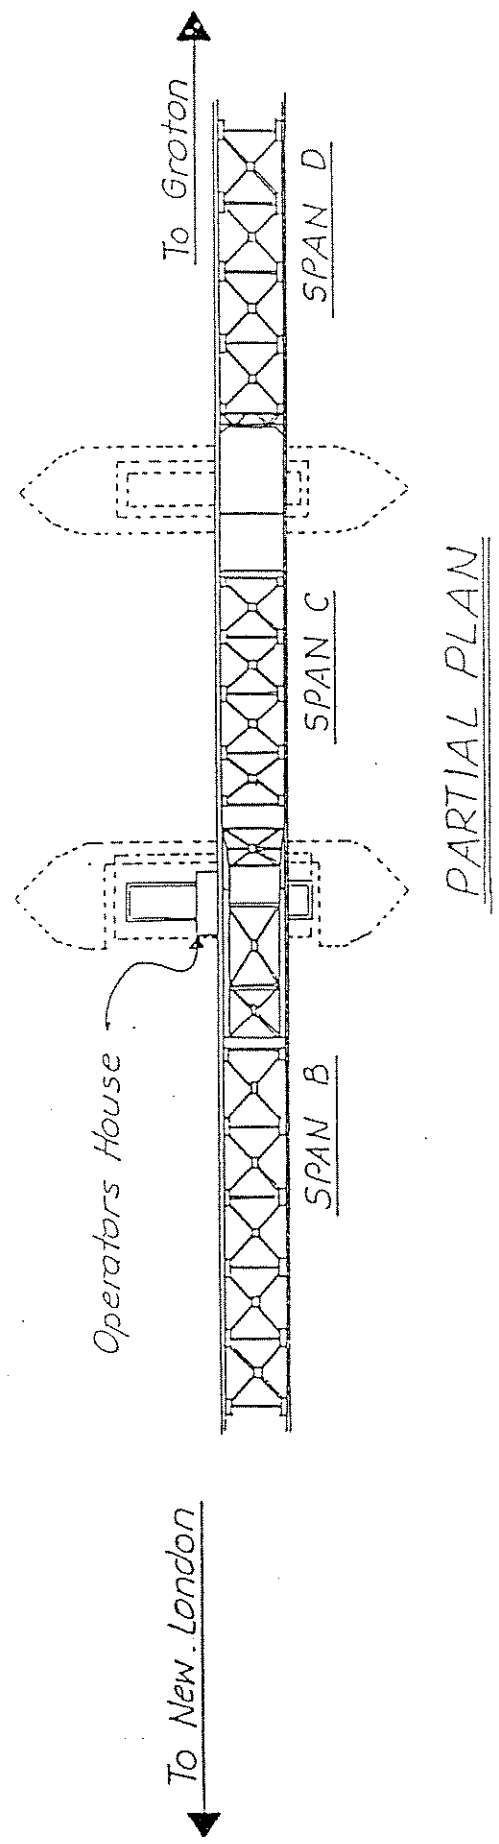
FIGURE 1

In June of 1990 shortly after starting work for Amtrak I was asked to travel to Amtrak's Thames River bridge to investigate loud noises which were apparently emanating from the counterweight trunnion bearing on the south side of the movable span. A partial elevation and partial plan view of the bridge can be seen in Figure 1 at the end of the text. The machinery which powers the movable span is located above the railroad between and just below the two counterweight trunnion bearings. The operating struts are pin connected at the lower counterweight link pin and are pulled back towards the west approach span by the rack pinions; one on each side of the operating machinery. This causes the lift span to rotate about the main trunnion as the counterweight rotates about the counterweight trunnion and the interior angles in the parallelogram change.

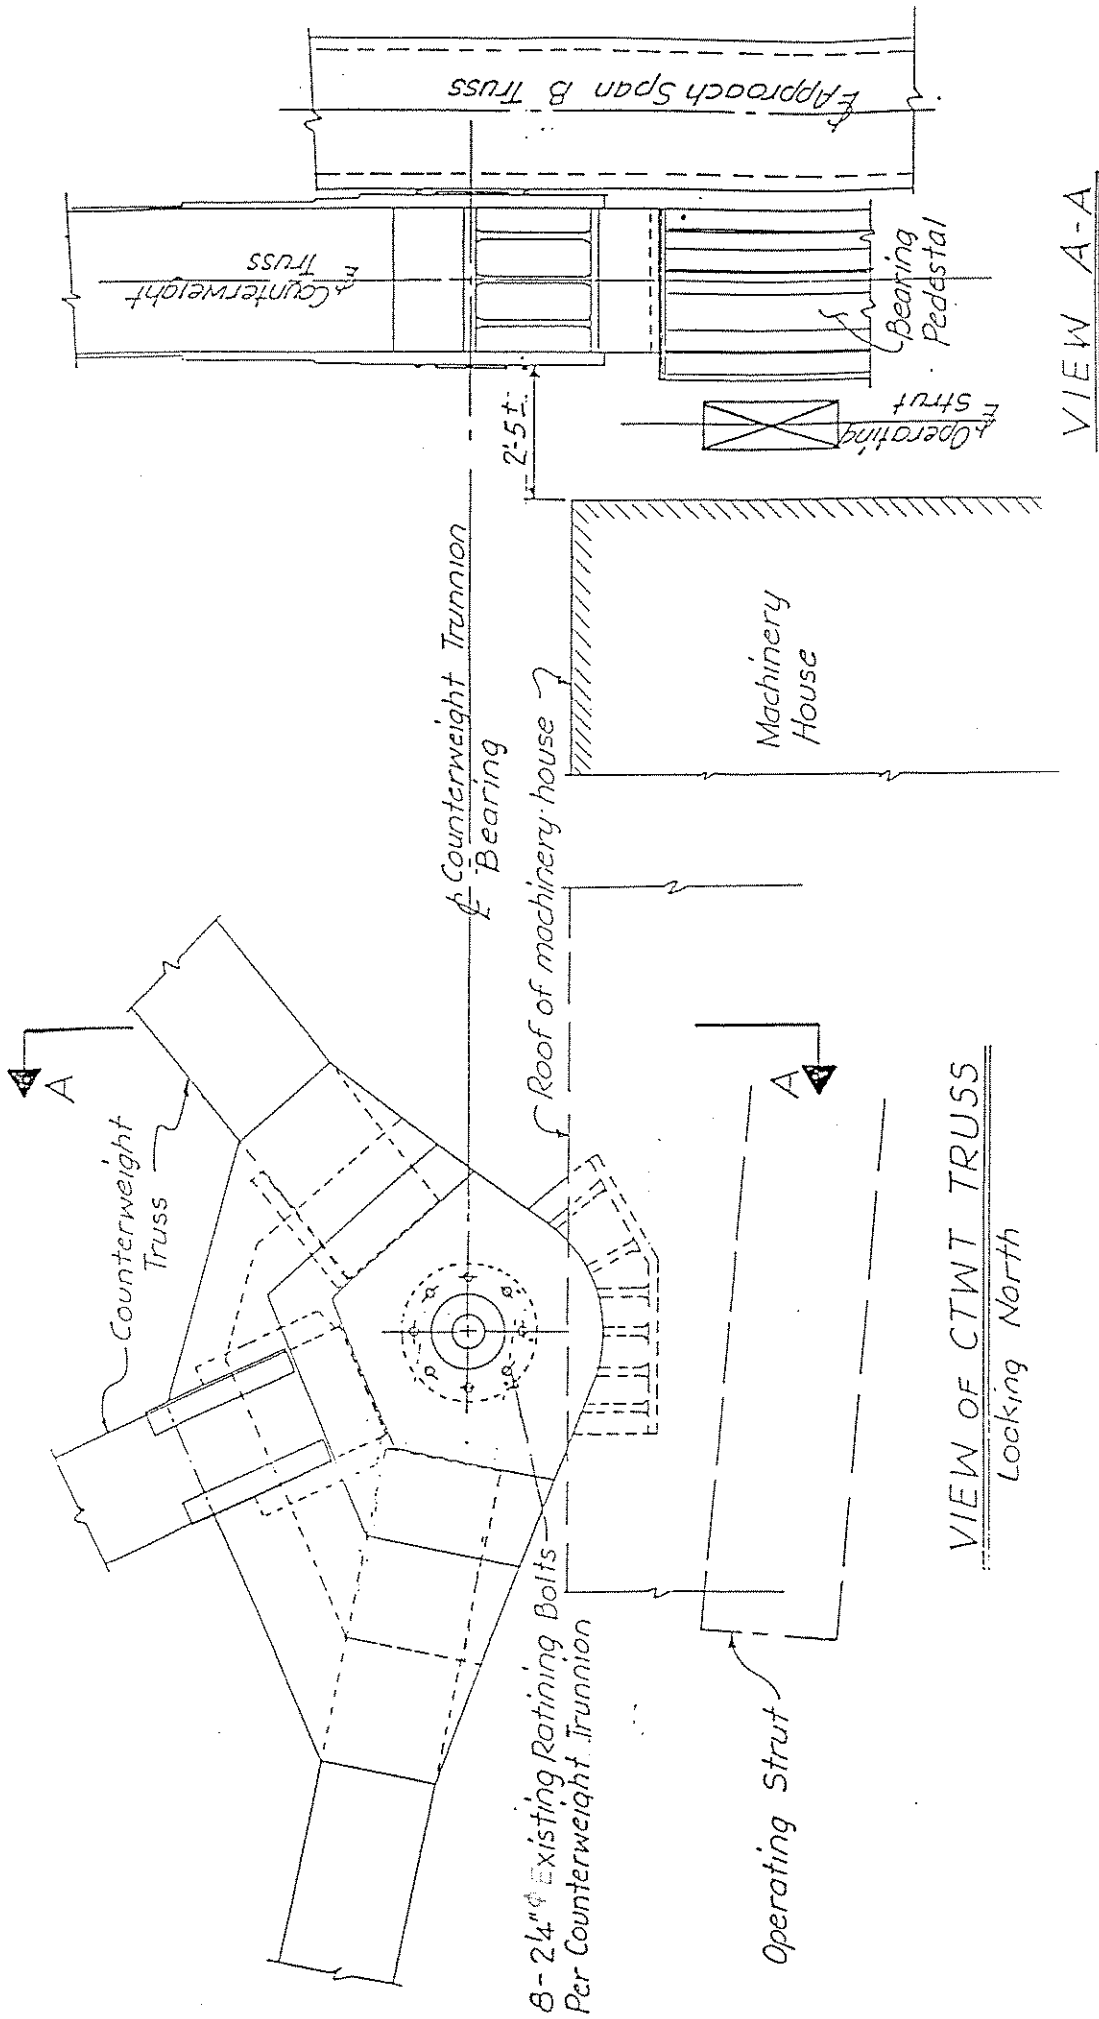
FIGURE 2

A partial view of the counterweight truss can be seen in Figure 2 at the end of the text. The relative location of the machinery house and the operating strut can be seen in this figure. The counterweight trunnion bearings are 35-1/2" in diameter and approximately 38" long. The journals are effectively a 35-1/2"
