***Emergency Repair of a 7 Million
Pound Swing Span (I-Street Bridge
Center Bearing Repairs)***

Jeffrey S. Mancuso, P.E., Southern Pacific Lines

Jeffrey W. Newman, P.E., Modjeski and Masters,
Inc.

LOCATION: I-STREET BRIDGE – SACRAMENTO, CA

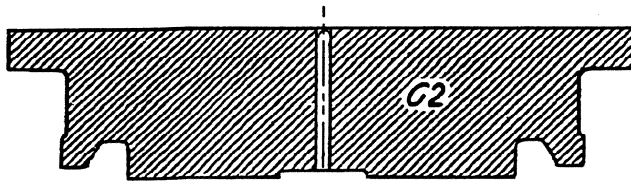
Top pivot casting, C2, surfaces were all in "mint" condition.

The top steel lens, C4, was in generally good condition with no defects to the top, but the convex surface had light galling and the central circular half of the contact surface was dry.

The center bronze lens, C5, had scoring on both surfaces with bronze particles and hardened lubricant in the oil grooves. After cleaning, deep scoring was evident in the center portion and a band of discolored bronze was revealed towards the out half of the wear surface (see Photo 7).

The bottom steel lens, C6, was galled on the top surface with bronze "burn" marks. The bottom was deeply galled to 1/4 inch deep and the centering boss was worn on the edges.

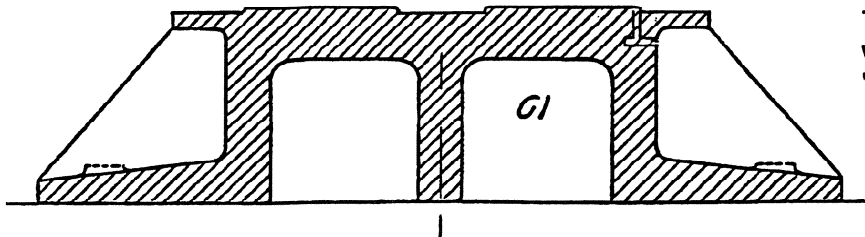
The top surface of the lower pivot casting, C1, was deeply galled and the counterbore or "inkwell" was worn and distorted.

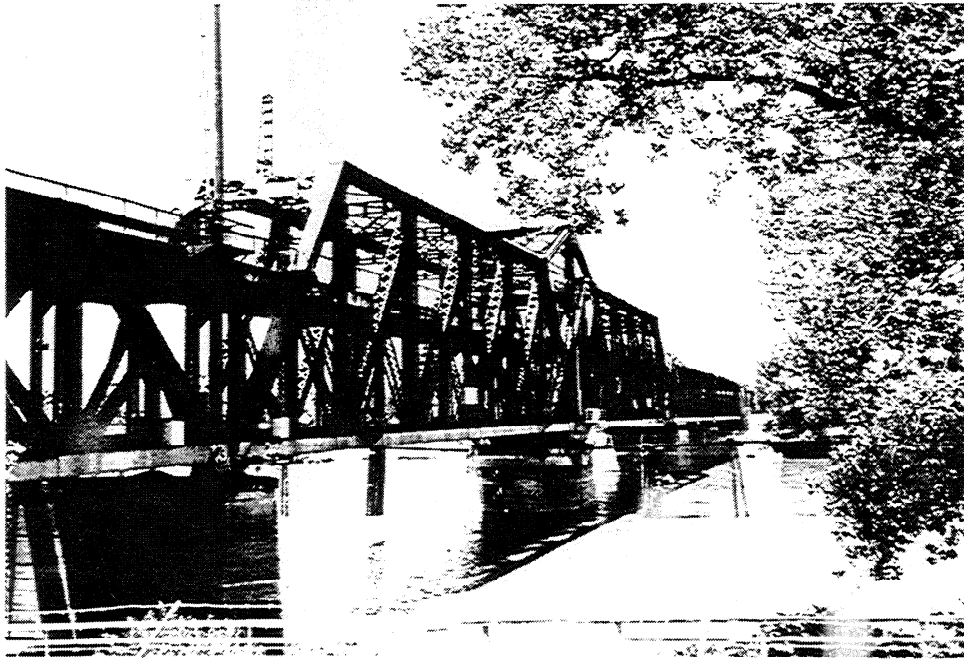
Photo 1 - I-Street Bridge of Sacramento, CA.

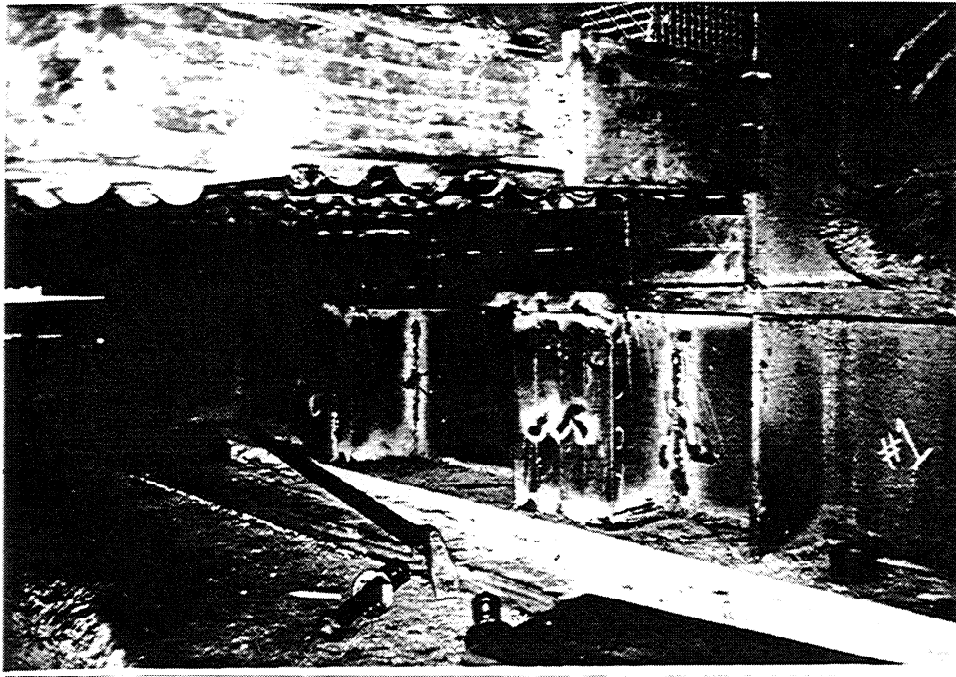
for restraint in longitudinal and transverse directions (see Photo 3). Rotational guides were installed at each end of the swing span (see Photo 4).

Photo 3 - Temporary longitudinal and transverse restraints at center pier to stabilize and support swing span during jacking operation.

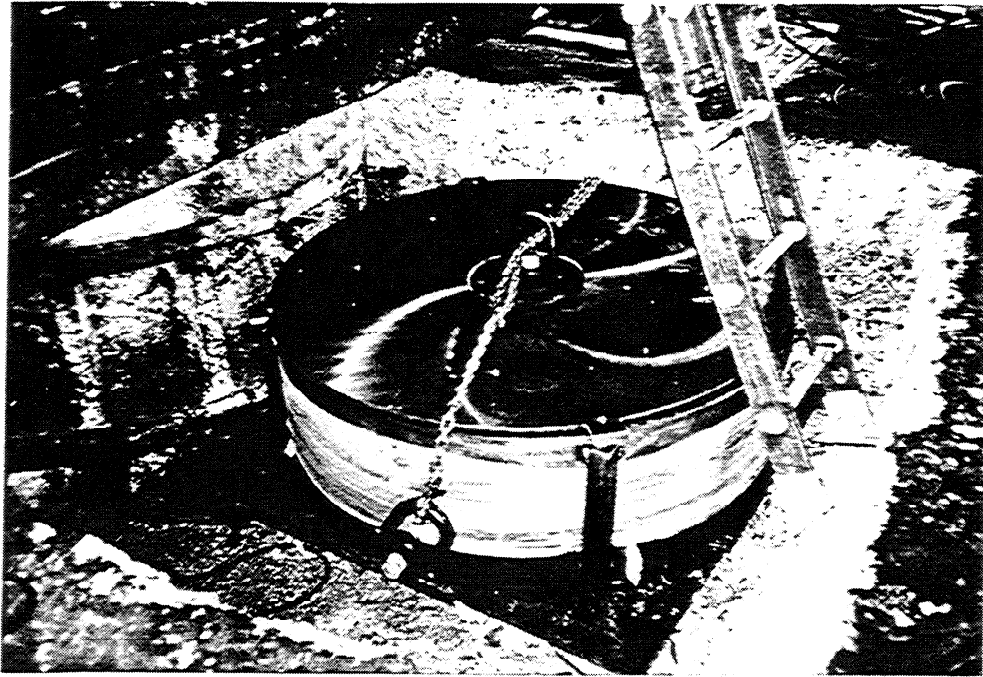
Photo 9 - Three-piece lens assembly is shrink-wrapped and has angle tabs tack welded at four locations on the circumference. The new shim plate rests on top.

Drill bits, reamers, dowels and special low clearance mag drills were obtained and prepared by Stewart Tool Co., Inc. for field drilling, reaming and installation of the dowels into the lower pivot casting. The three lenses were solvent cleaned, pre-lubricated, and shrink-wrapped. Four short angle pieces were tack-welded to the circumference of the assembly for transit and installation (see Photo 9).

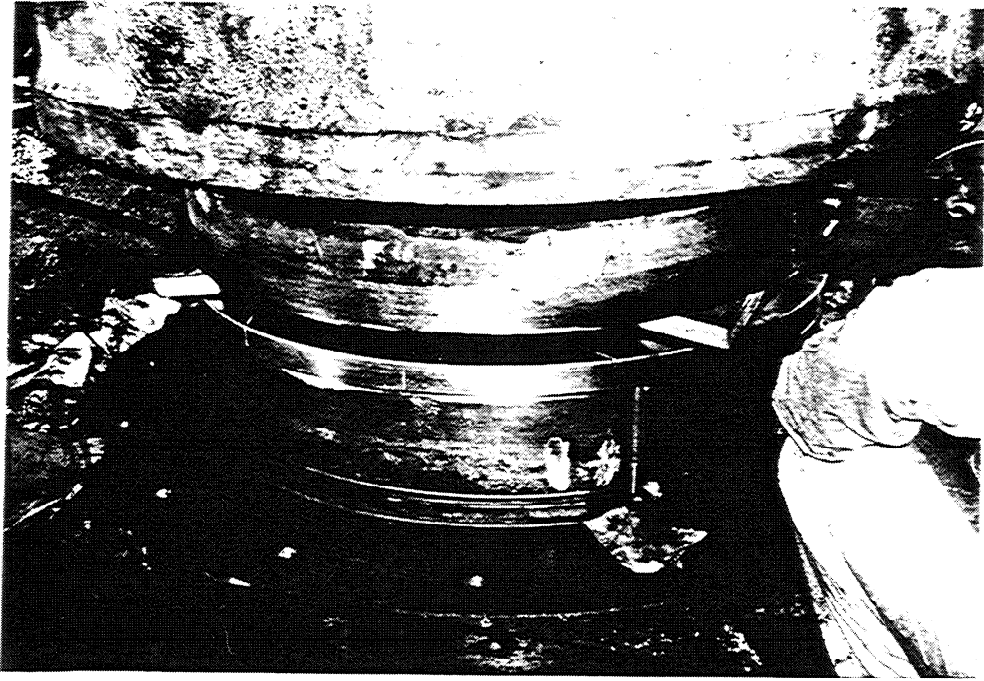
Photo 11 - Top steel lens being seated in the upper pivot casting.

Installation of the three-piece lens assembly (weighing nearly 11,000 pounds) was accomplished using teflon strips to slide on to prevent damaging the machined surfaces. The assembly was then positioned for installation of the edge dowels. The edge dowels were installed and the assembly lowered onto the bottom pivot casting. Strap angles that had been tack welded onto the outside diameters of the steel lenses were ground off and the top steel lens was jacked up to seat in the upper pivot casting (see Photo 11). The area was thoroughly cleaned and gasket sealant was applied to the oil box to prevent oil leakage (see Photo 12). The oil box was filled with fresh oil.
