SEVENTH BIENNIAL SYMPOSIUM November 4 - 6, 1998

"Load Sharing of Vertical Lift Machinery" by

The Use of Load Sharing Devices for Tower Drive Vertical Lift Bridges

Jeffrey W. Newman, P.E. Modjeski and Masters, Inc. Harrisburg, Pennsylvania

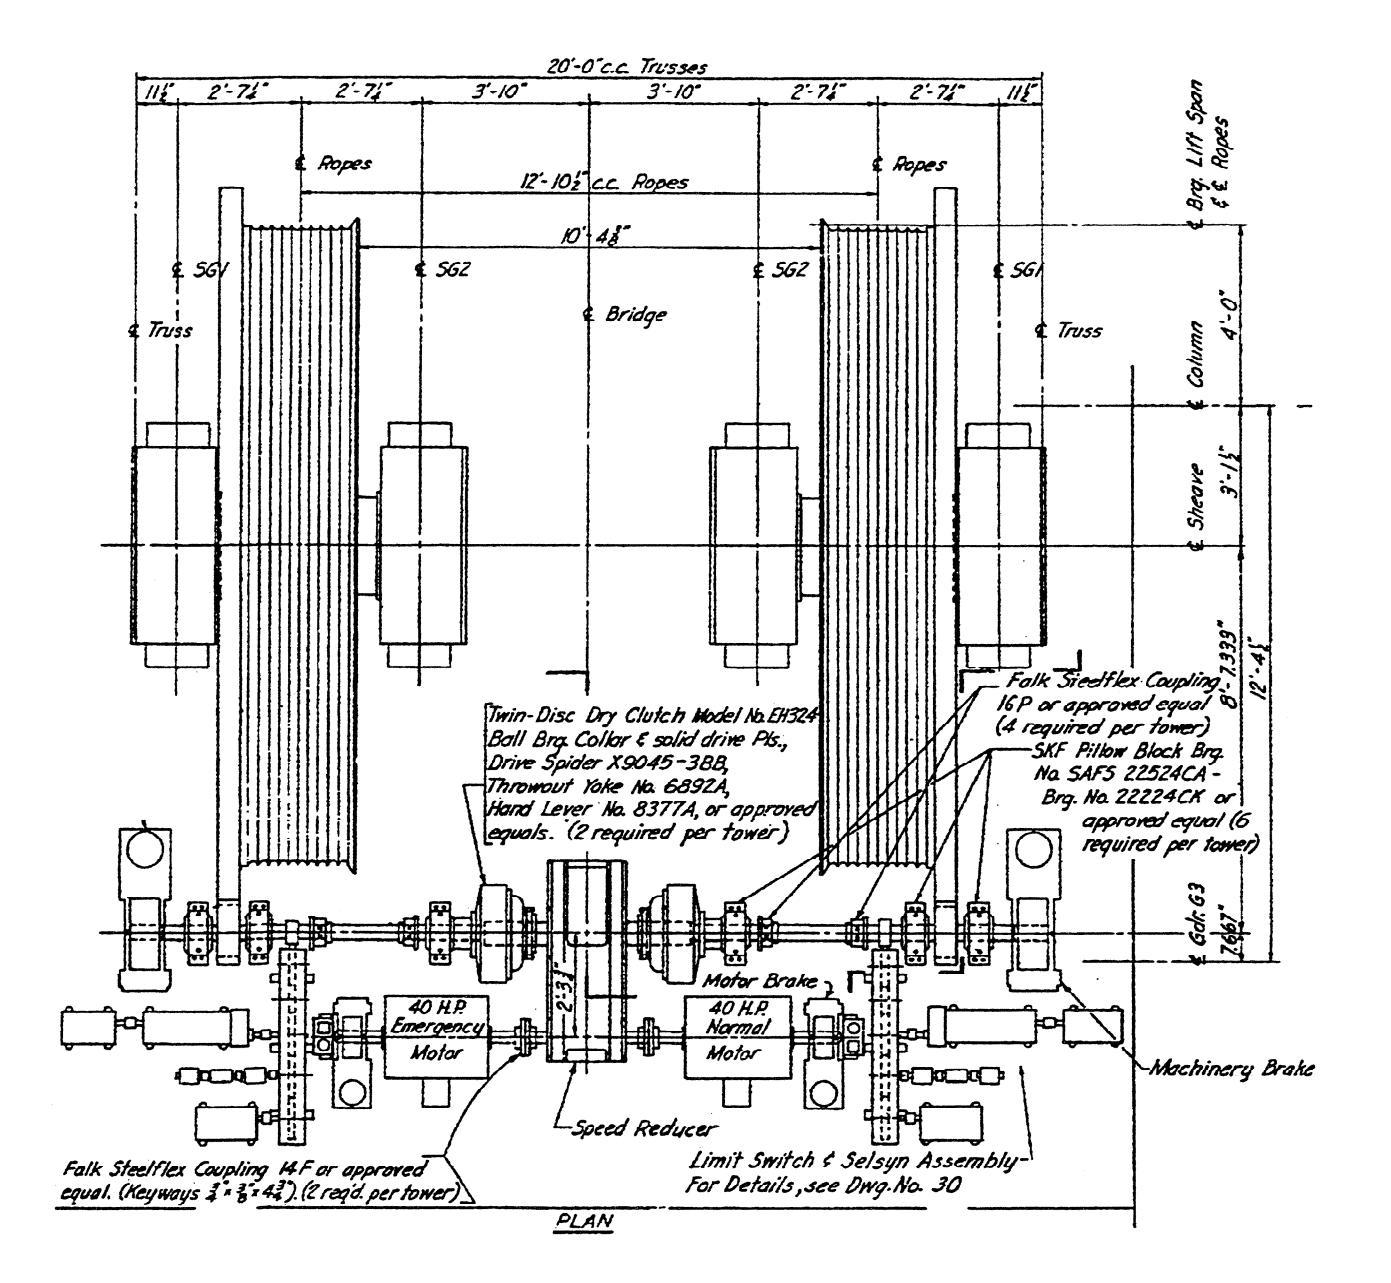
The first case is a tower drive vertical lift that is 366 feet long and 20 feet wide (center-tocenter of trusses). Each tower drive utilizes a 40 HP AC motor that is coupled to a double reduction enclosed gearbox. Each of the low speed shaft extensions drive through a clutch (adjusting device), floating shaft, and finally couple to a drive pinion that engages the sheave ring gear (see Figure 1).

As can be seen, the counterweight ropes are very close transversely $(12'-10 \frac{1}{2}"$ center-to-center) due to the width of the bridge.
