"Stone Harbor Bridge - Emergency Mechanical Repairs"

by David Nyarko, P.E. Parsons Brinckerhoff Quade & Douglas, Inc.

Eighth Biennial Movable Bridge Symposium Heavy Movable Structures Orlando, Florida November, 2000

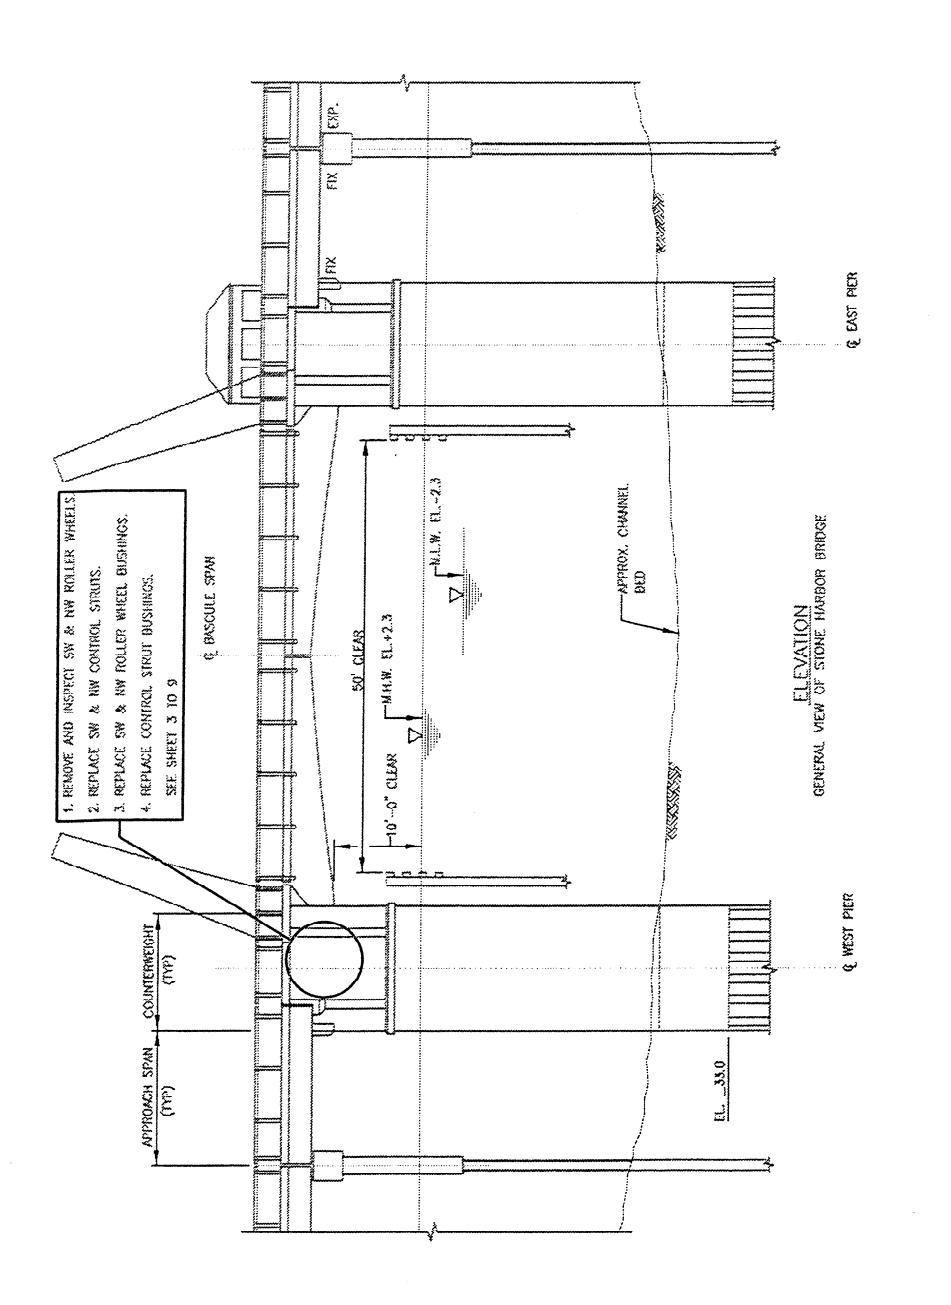
FIGURE 1

The Stone Harbor Bridge, also known as the 96th Street Bridge, carries County Route 657 over the Great Channel (Figure 1). It is located in the Borough of Stone Harbor and the Township of Middle in Cape May County, New Jersey. The bridge has a 19-meter-long (63-foot) Rall-type double-leaf bascule span, linking US 9 and the Garden State Parkway to the beach town of Stone Harbor. The Great Channel is a vital link carrying marine traffic into and out of Stone Harbor—a very busy area for marine and vehicular traffic. In the summer, the bascule span has more than 1,000 openings a month.

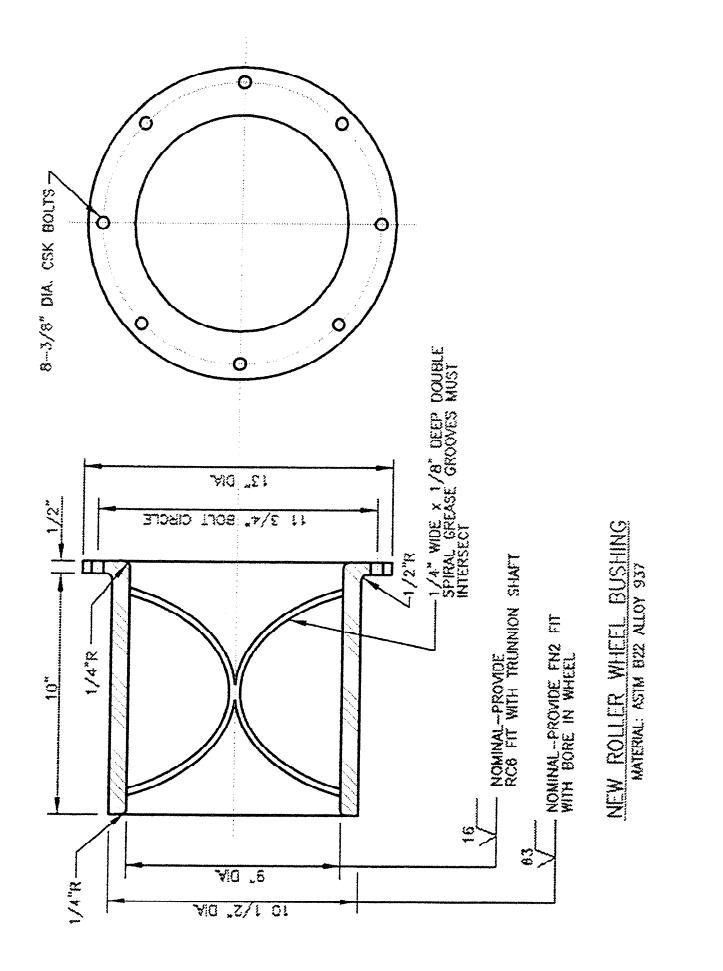
FICHDE O

Although the existing wheel castings exhibited some surface corrosion, they appeared to be in good condition. It was recommended that the wheels be rehabilitated as follows:

- 1. Clean and inspect the wheels for any cracks.
- 2. Re-machine the wheel surfaces.
- 3. Replace the wheel bushings with new flanged type bushings (Figure 8).
