**NINTH BIENNIAL SYMPOSIUM**  
"Preserving Traditional Values with New Technologies"

VERTICAL LIFT BRIDGE REHABILITATION

Kevin R. Eisenbeis, P.E. & Steven M. Warger, P.E.  
Harrington & Cortelyou, Inc.

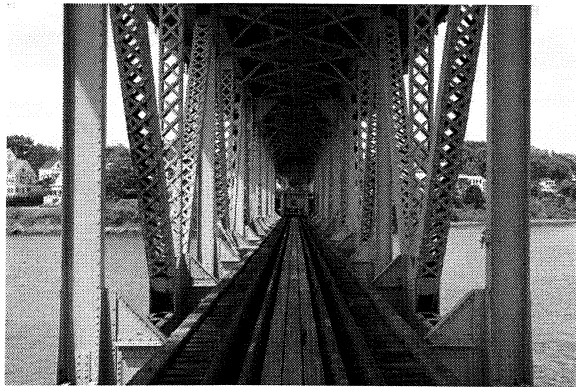
**Figure 7**

### Retractable Railroad Span

One fixed side span of the lower level railroad was converted to a retractable span. Screw jacks were added to raise the lower portion of the span. Railroad wheels, axles and mechanical equipment were added to translate the span along the rail line into the adjacent span. (Figure 7)
