HEAVY MOVABLE STRUCTURES, INC.

STRAIN GAGE MONITORING FOR LOWER CHORD  
REPLACEMENT AT MARINE PARKWAY BRIDGE

Ryan Kanagy  
Stafford Bandlow Engineering

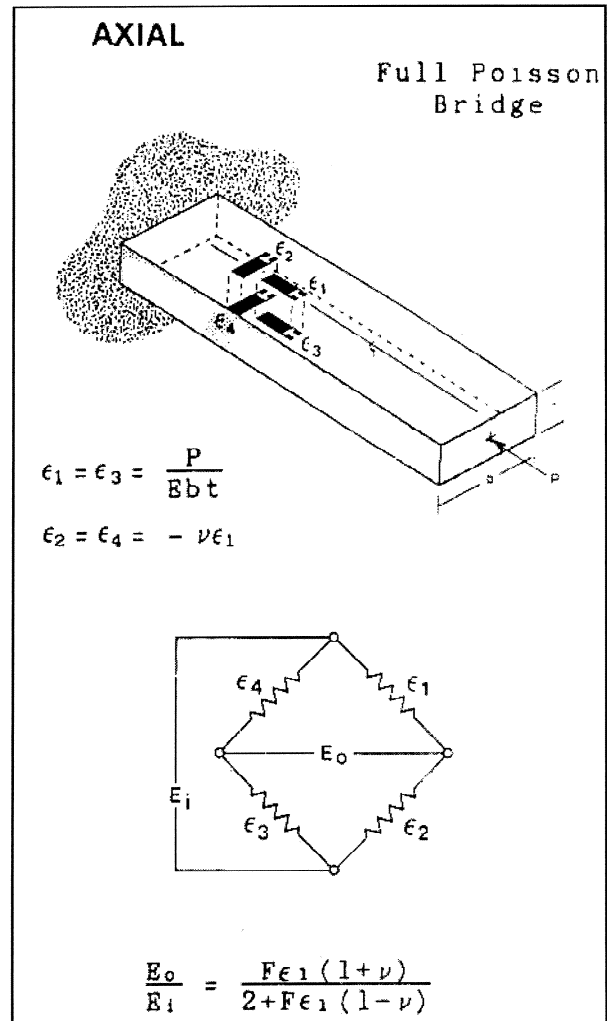
The strain gage installation used to monitor axial loads in the lower chords replacement is known as a “full Poisson bridge” arrangement. This configuration uses a longitudinal gage parallel to the loading and a transverse gage on both the top and bottom surfaces (see Figure 4). This installation differs from the use of a full Poisson bridge arrangement (to measure torque in a shaft) for analyzing the balance condition of a bridge, where both gages are installed at an angle of  $\pm 45^\circ$  from the shaft’s neutral axis.

If desired, a half bridge configuration can be used to measure axial loading. The presence of resistors  $\epsilon_4$  and  $\epsilon_2$ , shown in Figure 4, is what distinguishes the full Poisson bridge from the half bridge configuration, where only the two longitudinal gages are installed. A full bridge arrangement is preferred because it cancels bending strains of equal magnitudes and opposite signs. Therefore, the recorded strain is due to axial force only. Additionally, the full bridge configuration provides better temperature compensation because a gage is present in every leg of the bridge.

Figure 4: Strain Gage Installation Configuration

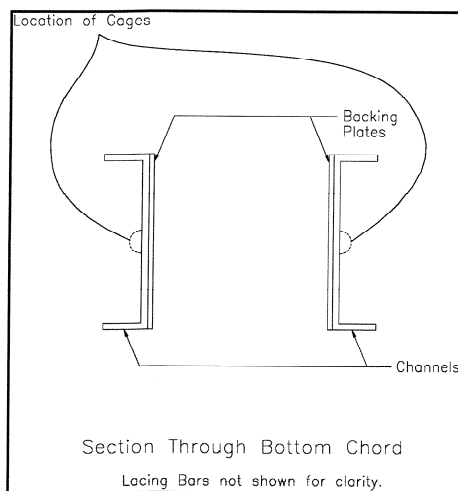
The replacement methodology called for the channels that comprise the existing bottom chords to be unloaded as a pair. Therefore the chord was treated as a unit and gages were installed to the inboard and outboard faces of the channels and connected as a single full bridge. The two sets of rosettes were wired to form the full Poisson bridge described above. This installation results in a reading of the average of the loads in the two channel / backing

plate assemblies that comprised the chord. Figure 5 describes the location for gage installation at the existing chords.

**Figure 5: Strain Gage Installation  
Location at Existing Chords**

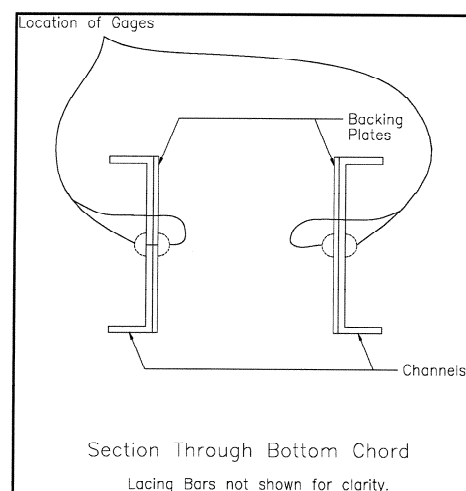
The replacement methodology called for the new bottom chords to be installed one channel at a time. Therefore each channel was treated independently. A pair of rosettes was installed on the inboard and outboard face of each channel / backing plate assembly. The rosettes were then wired together to form a full Poisson bridge. Figure 6 describes the location for gage installation for new chords.

**Figure 6: Strain Gage Installation  
Location at New Chords**
