HEAVY MOVABLE STRUCTURES, INC.

NINTH BIENNIAL SYMPOSIUM
"Preserving Traditional Values with New Technologies"

**MACHINERY REHABILITATION FOR MAIN STREET
BRIDGE, DAYTONA BEACH, FL**

John R. Williams, P.E.
Lichtenstein Consulting Engineers

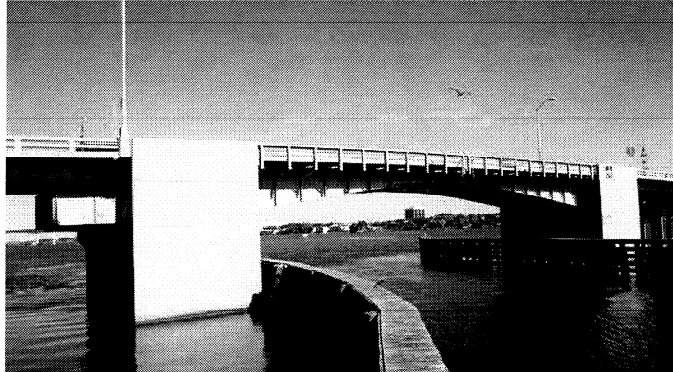
The Main Street Bridge is a double leaf trunnion bascule bridge. The span drive operating machinery for each bascule leaf is identical. Figure 1, page 2 is a schematic of the span drive machinery with component designations. The machinery is located below roadway level on the bascule piers. The machinery rooms are accessed through the operator's house for the West Leaf and through a hatch in the sidewalk at the northeast approach for the East Leaf.

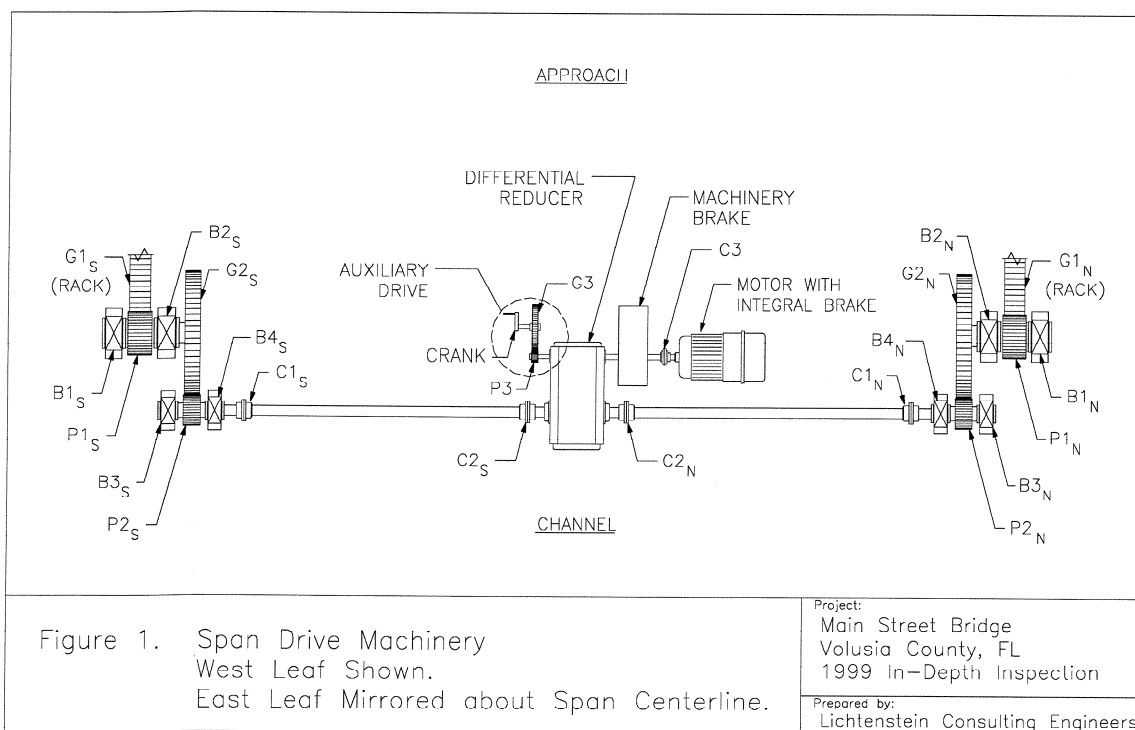
Transverse floating shafts are utilized to transmit power output from the reducer to the first of two open gear sets. The inboard end of each floating shaft is coupled to a reducer output shaft extension. The outboard end of each floating shaft is coupled to a shaft that is simply supported in two bearings. The couplings used are single engagement gear type couplings. These couplings accommodate small amounts of angular and offset misalignment that may exist between the reducer output shaft and the mating shafts. A pinion, being the first gear in the open gear train, is straddle mounted on the mating shaft between the bearings. All open gears with the exception of the rack and rack pinion that comprise the final gearset in the gear train are keyed to their shafts and the shafts are supported in sleeve type split bronze bearings mounted in pillow block housings. The rack pinion is integral with the rack pinion shaft. The rack is mounted to a frame at the underside of the bascule girder and aligned radially about the trunnion.
