MAINTAINABILITY OF A MOVABLE BRIDGE  
by  
Lynn W. Biwer, PE  
Administrator, Mechanical/Electrical Section  
Bureau of Structures  
Florida Department of Transportation

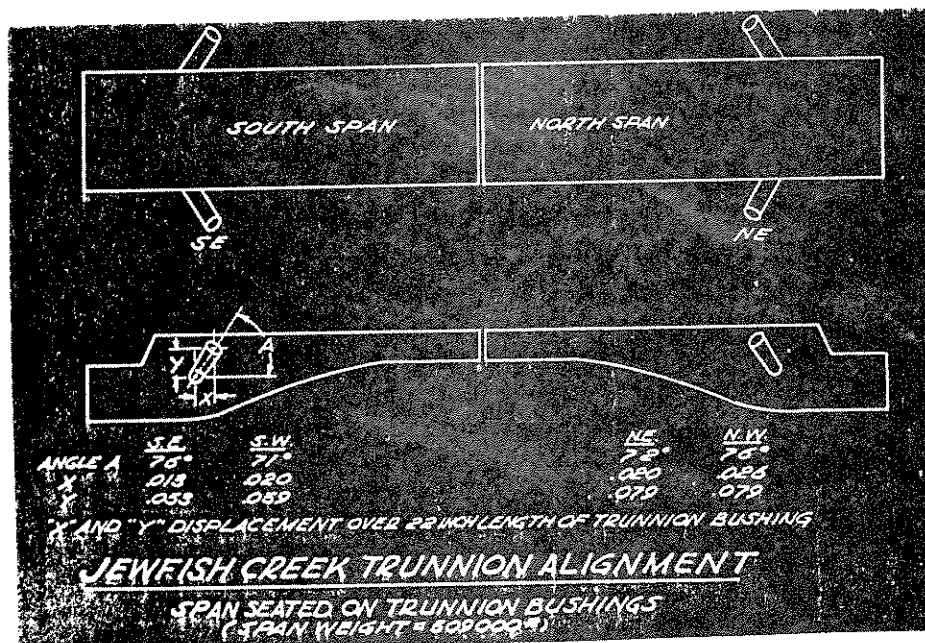
FIGURE 5

During routine inspection of the bridge, fractured bronze trunnion bushings were found; subsequent micrograph studies verified that the failure mechanism was fatigue.

Further inspection showed that the trunnions were considerably misaligned, and inspection records indicated that the realignment had probably existed since the bridge was constructed.

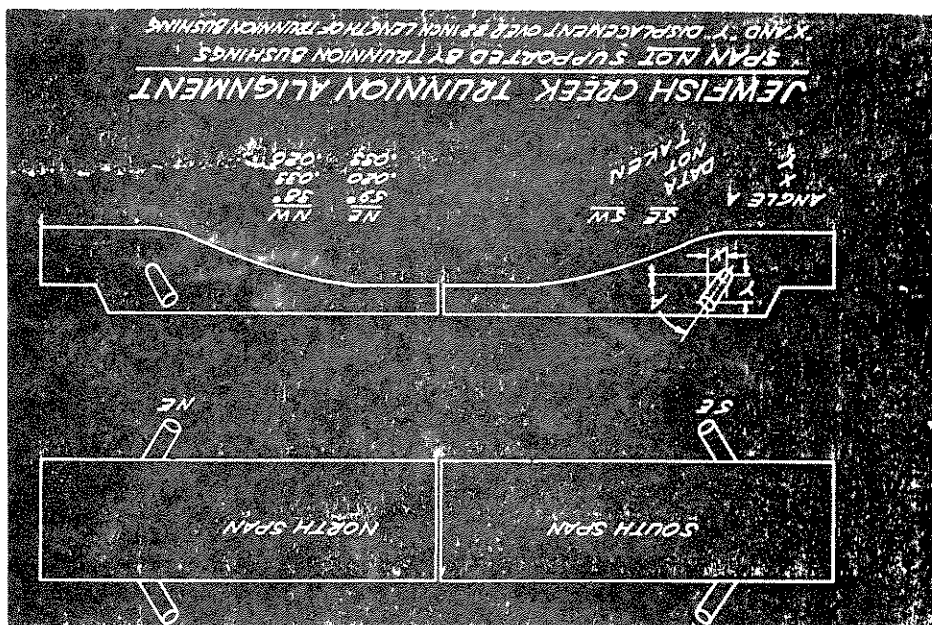
FIGURE 9

The cause of journal corrosion was determined to have resulted from inadequate protection of the trunnion journals from salt water products regularly washing through the upper half to the trunnion bearing, removing whatever lubricant might have protected the surfaces.

A clear determination of the cause of trunnion bearing failure is clouded by two defects, either of which may have caused or jointly contributed to the fatigue failure; (a) trunnion misalignment, and (b) scaling of corrosion products into the load bearing region between trunnion journal and bronze bushing.

Completion of the rehabilitation on this bascule bridge thus involved jacking the span so that trunnion bearings and trunnions could be removed, while still maintaining traffic on the bridge. Significantly, features which would permit jacking a span to repair or replace trunnions or bushings will improve the maintainability of Florida's bascule bridges.
