HEAVY MOVABLE STRUCTURES, INC. FOURTEENTH BIENNIAL SYMPOSIUM

Machinery Rehabilitation at the East 11th Street Bridge over the Hylebos Creek Waterway Tacoma, Washington

Robert J. Tosolt, P.E. Stafford Bandlow Engineering, Inc.

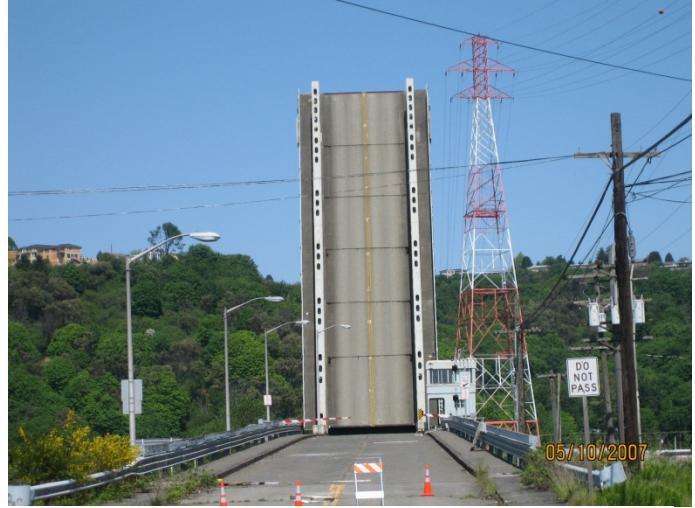
Following shaft failure, the bridge was secured in the open position and the roadway was blocked, limiting access to the East Blair Peninsula.

Figure 2. Hylebos Bridge in 2007. Road closed and leaves secured in open position.

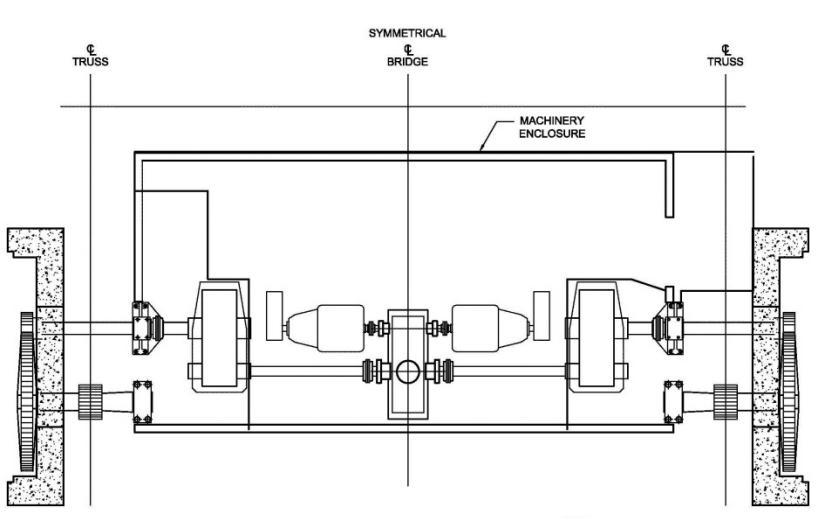
Figure 15. Plan View of Existing Machinery.

The machinery existing utilized conventional mechanical components for the power train with the primary reduction being provided by one primary differential and two secondary enclosed gear reducers. All of the primary components were located in enclosed machinery an whose dimensions room. were constrained by the bascule trusses on either side, the trunnion girder and counterweight fore and aft, respectively, and further by

the fact that the counterweight swings within approximately 6" of the existing enclosure flooring. The final reduction was provided through one open gearset driving the final pinion which mated with the rack secured in each truss. The open gearset was cantilevered outboard of and supported by bearings mounted in the pier wall. The rack pinion which was integral with its

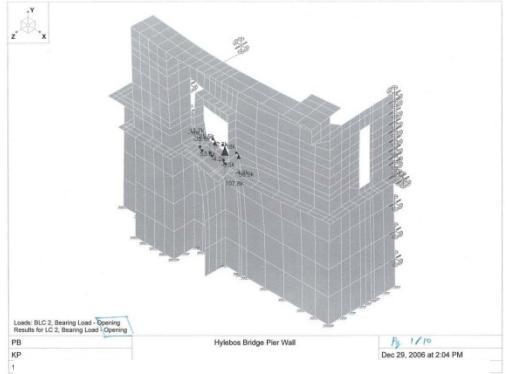
Figure 24. FEA Analysis of Pier Wall and Reducer pedestal.

In order to minimize cost, instead of the machinery room which was originally envisioned to house the reducer, protect it from exposure and provide ample maintenance access, the design focused on a simple pedestal mounted off the existing wall. As environmental concerns prohibited the installation of pilings to provide direct support of the pedestal, the existing pier wall had to be reinforced to support the load. The structural group used FEA to refine the analysis of the reinforced pier wall and ensure that it was adequately sized for the imposed loads.

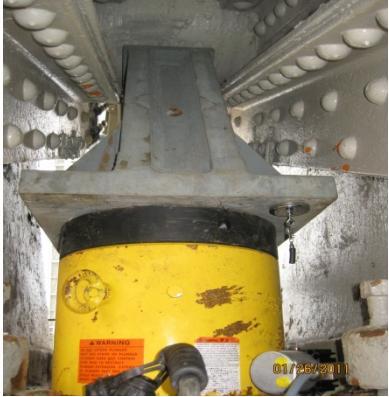
The primary challenge in the replacement of the East Leaf trunnion bearings was arriving at an acceptable removal and replacement scheme. With limited stiffening of the Strauss trunnion girder, it was possible to jack and support each leaf directly beneath each trunnion. The height required to jack the leaf for bearing removal required consideration of the structural framing. The forward support for the approach roadway was mounted between the trunnion bearings. The endmost supports prohibited axial removal of the inboard bearing housing. The leaf would need to be jacked over 9" to allow the bottom of the

Figure 25. Jack and Support below trunnion for leaf jacking.

journal to clear the housing split line and allow the housing to be slid under the journal. This jack height was a concern as the jacking work would be done with the leaf in the raised position where it could be subjected to the maximum wind load.

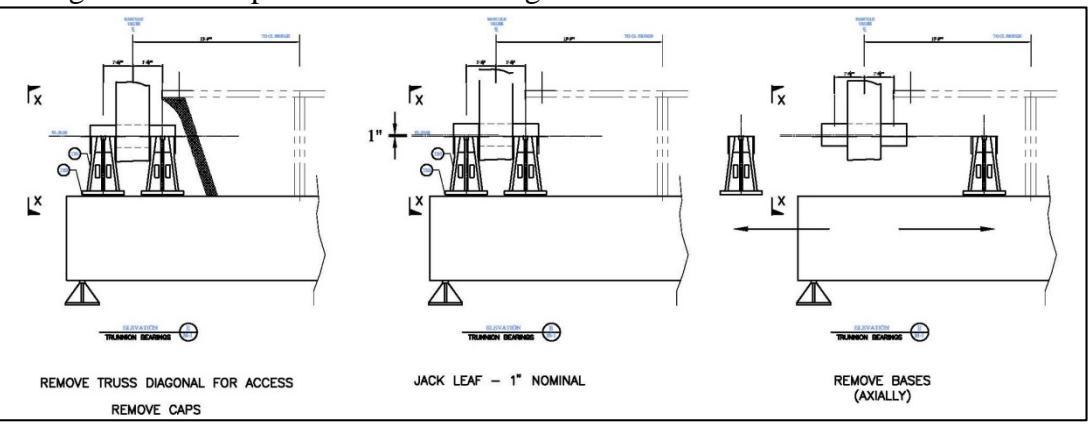
Figure 27. Trunnion Bearing Removal – Option 2

By removing the endmost posts and providing temporary shoring posts, the leaf jacking height could be limited to approximately 1" as the housing would only need to be slid axially away from the trunnion. This latter choice minimized the concern over stabilizing the support against wind loading and was adopted for the final design.

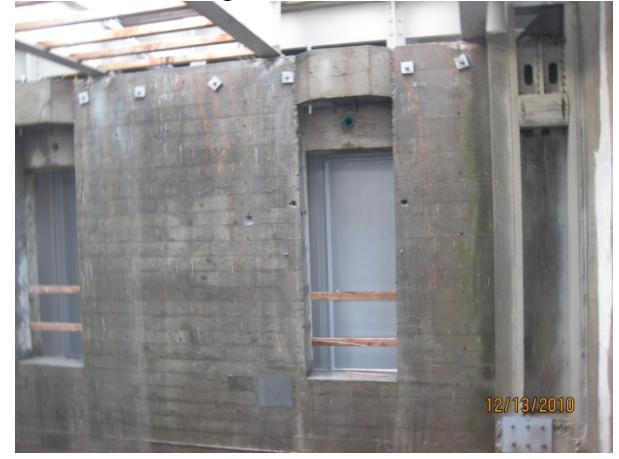
Figure 28. Cutout in Rear Wall for Air Buffers

The primary challenge in the implementation of the air buffers was identifying a location where they could be installed. The preferred location was at the back of the counterweight to optimize the moment arm. However, little space existed between the back of the counterweight and the face of the rear wall. Coordination with the structural group determined that two cutouts could be placed in the rear wall to accommodate the buffers. Several iterations were required to determine the optimal placement for the cutout in the wall taking into consideration structural

concerns over the strength of the mounting surface and mechanical concerns over the buffer stroke and resultant swing radius of the strike plate on the back end of the counterweight. If the buffer was mounted too high, the upper wall did not have sufficient strength. If the cutout was too low, the buffer stroke was too long and the swing radius of the strike plate resulted in interference with the counterweight pit floor. Ultimately, the swing radius of the strike plate was maximized without contacting the pit floor and the upper wall was strengthened for the imposed load. As an electrical room had been added to the

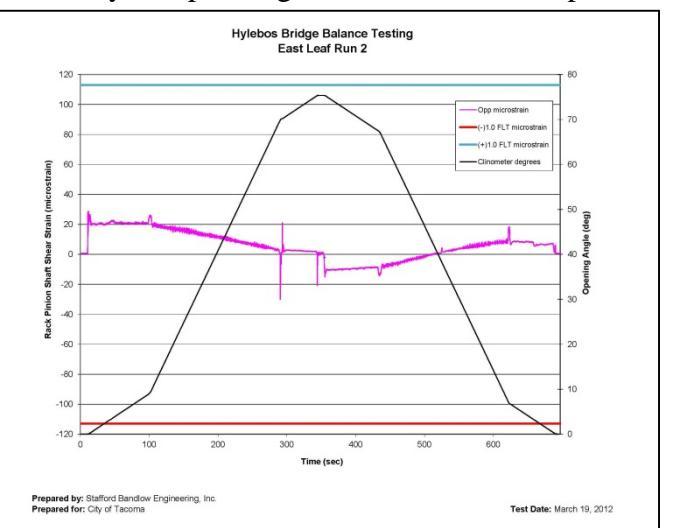
Figure 29. East Leaf Operational Strain Stripchart.

loads during normal operation were approximately 20% of full load motor torque. The measured loads substantiate that the machinery is adequately designed and that the trunnion realignment on the East Leaf has been successful. Further the measured loads are indicative that the machinery has ample reserve capacity to overcome environment loading and future balance changes.
