**HEAVY MOVABLE STRUCTURES, INC.  
FOURTEENTH BIENNIAL SYMPOSIUM**

**Emergency Repair of Counterweight  
Trunnion Pins on the Gloucester Draw  
Bridge**

HDR Engineering Inc.

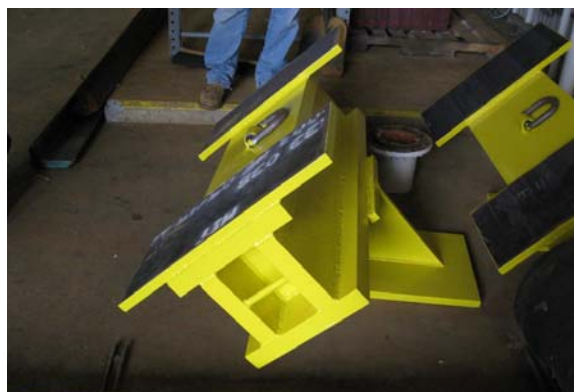
**Figure 6 – Chock beam assembly in the shop**

The first step in jacking the counterweight was to design a system to secure the span in place, at a partially open position, while the repair could be performed. The bascule span was to be relieved of the counterweight load, causing a large imbalance tending to close the span. The concept of inserting steel chocks between the top of the bascule girders and the bottom of the approach girders was developed to keep the span in the partially open position. The chock beams would transfer the load developed from the bascule span closing moment to the approach beams above and resolve the force back to the jacks. There were three wedge shaped chocks constructed of 1" thick 50 ksi steel. The top surface of each chock was a simple horizontal surface, which would mate up with the chock beam. The bottom surface of the chock was angled to 43.8 degrees to compensate for the 2.8 degree incline of the top flange of the bascule girders and the required 41 degree angle of opening of the span. The rectangular chock beam spanned adjacent approach beams with the load applied by the chock at the midpoint between supporting girders. The total length of each chock beam was 4'-1" and was constructed of 2" thick 50 ksi steel.

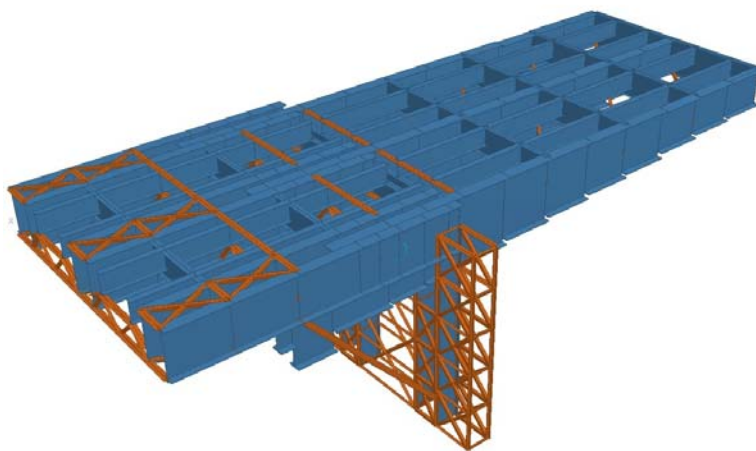
**Figure 7 – Gloucester Draw STAAD model**

HDR performed a Load Rating for the MBTA in 2008, which analyzed all the components of the structure influenced by the live load. The original design live load for the 1910 design utilized an equivalent Cooper E-50 loading with steam locomotive impact effects. The 2008 Load Rating rated the bridge for four loading arrangements, the Cooper E-80 car, MBTA's F40PH (280K) modified car, MBTA's 286K car, and MBTA's 263K car. The analysis of the approach span girders helped determine additional load could be taken, which allowed the design of the jacking system to jack the counterweight from above supported on the approach girders.

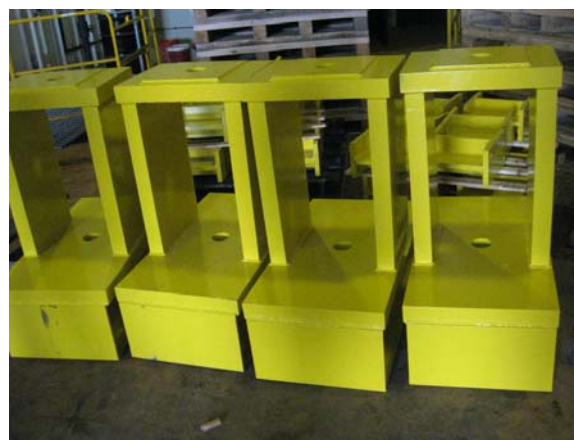
**Figure 8 – Jacking seats in the shop**

Each jacking seat was comprised of two 10x20 channel sections. On top of the two channels were the jack bolsters made up of 2 1/2" 50 ksi steel plate.

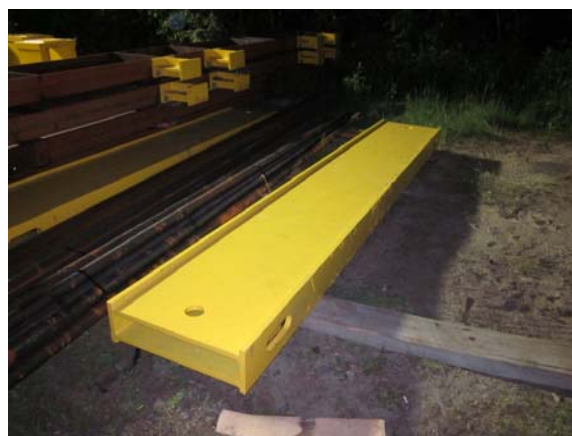
**Figure 9 – Lifting beams in staging area on site**

The threaded rod passed through the jacking seat and jack, between the approach span framing and bracing, and down below the counterweight to the counterweight-lifting beam. Two lifting beams were designed to lift the counterweight from below the counterweight. The lifting beam would be pulled up against the counterweight, picking up the counterweight in the process. The shape of each beam was a slender rectangular box section. The ends were left open for access. The top and bottom flanges were slotted with 9" long oversized slotted holes for the threaded rods to pass through. The slotted holes allowed for field adjustments. Timber was placed on the top flange of the lifting beams to bear against the bottom of the counterweight. The bottom of the counterweight was slightly irregular and of questionable integrity. The sacrificial timber was utilized to essentially crush under the jacking load, deform to the contours of the counterweight, and then finally provide a uniform surface for the lifting beam to bear against the bottom of the counterweight. An assumed concrete compressive strength of 2,500 psi was used to determine the required bearing area on the concrete since the actual strength was unknown.

The lifting beams were built-up rectangular box sections with a total depth of 2'-2". The flange plates were 1" x 8" top and bottom, and overhung the edge of the web sections slightly. The two web plates were 1" x 24" spaced 6" apart. The flange plates and web plates were welded together at the slight overhang with continuous fillet welds. (See Figure 9)

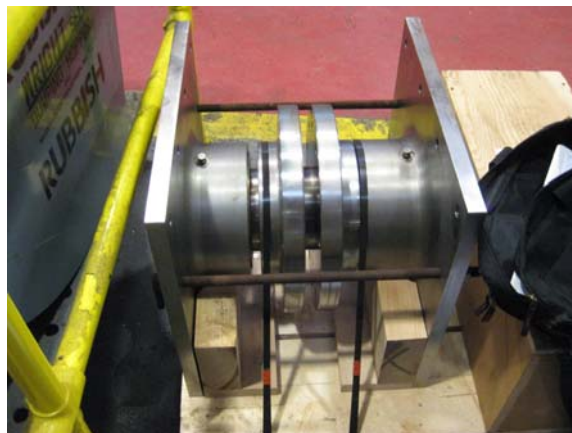
**Figure 11 – Assembled counterweight trunnion in the shop**

The original counterweight trunnions were found to be slightly undersized per the current AREMA specifications and the hanger bearing bushings were overloaded. It also became evident that there was likely load sharing which was not ideal. With a three-girder design the center bearing should take a little over 60% of the load, based on a 2-span continuous beam model, and the outboard bearing would share the remaining load. It is difficult to have ideal load sharing on the counterweight trunnions, and ensuring this condition requires careful alignment. Considering that the existing alignment and loading was suspect, the team decided to make all the counterweight trunnions the same. Because the bearing loads are very high, and the space for shafting limited, an 85 ksi, 6 1/2" diameter, counterweight trunnion was specified with UNS C95400 35 ksi bronze bushings. By using a constant diameter trunnion, the shoulders were removed from the shaft design to reduce stress concentrations and the shaft is retained by keeper plates attached to the ends of the bearings. Figure 10 shows the design

drawings of the assembled bearing through the bascule web looking down at the top of the counterweight. Figure 11 shows the assembled bearing in the shop.

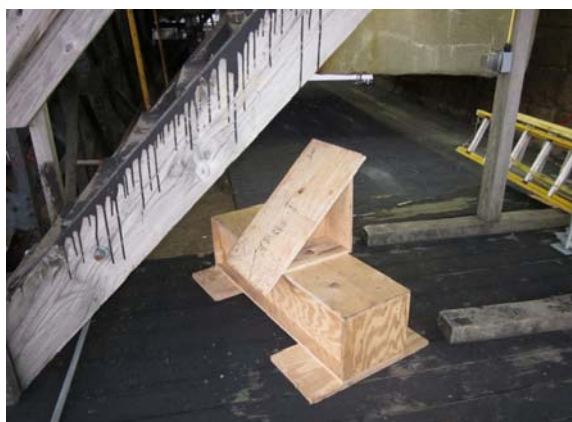
**Figure 12 – Mock up chock assembly in the field**

Site preparations by the MBCR were essential to be able to perform the work in the allotted track outage without incurring financial penalties. To expedite the construction time the MBCR team created a wooden mock-up of the chock and chock beam. The MBCR fit the mock-up in the prescribed locations dictated in the design to identify any possible issues during the repair. The MBCR identified exact locations of existing rivets that could be removed and replaced with H.S. bolts in the bascule girders and approach girders prior to the outage. They also were able to determine additional interferences not discernible from the original drawing set. The MBCR removed and replaced existing rivets in the top flange of the bascule girders and bottom flange of the approach girders where the chock and chock beam would need to be installed. There were also rivets removed and replaced with H.S. bolts on the top flange of the approach girders where the jacking beam pairs were to sit.

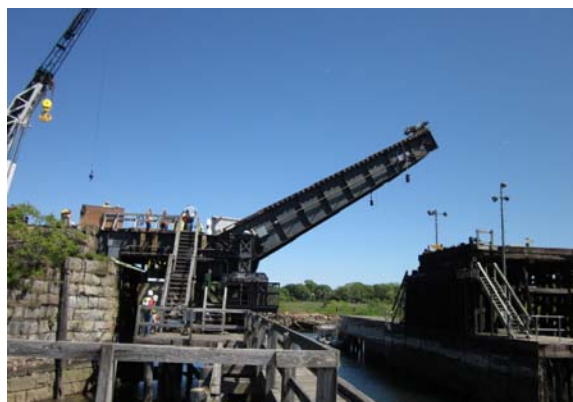
**Figure 14 – Bridge halfway open with the brakes applied**

On Day 2 the team prepared the bridge for installation of the chock assemblies. The bridge was opened to the approximate angle the plans designated and the brakes applied (See Figure 14). The crew could access the counterweight once the span was partially opened. The ties above the counterweight were shifted to allow for direct access down to the counterweight. Through this access the crew could lower down the chock assemblies and replacement pins before the access was occupied by the jacking system.

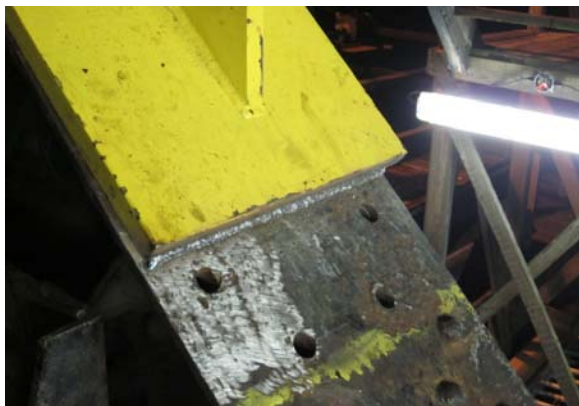
**Figure 15 – Chock assembly engaging the bascule girder and approach**

The bolts were removed from the bottom of the approach span girders and top flange of the bascule girders to receive the chock assemblies (See Figure 15). The outboard approach girders each had angle struts that connected from the bottom flange of the girders to the base of the towers. The existing struts were to be temporarily removed for the project since they would interfere with the installation of the chock beam assemblies. Upon removal of the northern strut at the approach span flange of the connection it was uncovered the bottom flange was about 80% rusted out. The flange of this approach girder had to be repaired in the field so that the chock beam would bear on the bottom flange properly. Once the struts were removed and flange repaired, the chock installation could proceed.

The crew first moved the center chock into place. The chock was lowered through the opening in the ties over the counterweight. Prior to the outage the crew marked on the top of the bascule girders where the chocks were to be placed. The center chock was then roughly placed in the predefined location. The connections of the chock assemblies to the girders were designed to reuse the bolt locations on the girders that they bear against. It became evident in the field the number of required bolts to connect the chock assemblies were not available on the center bascule girder. In lieu of bolting, the crew field welded a 5/16" fillet along the width of the flange and chock (See Figure 15).

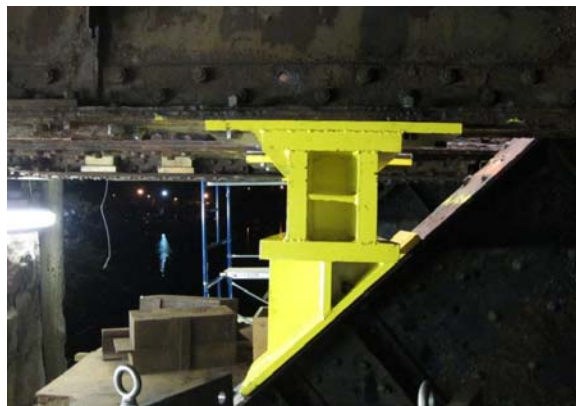
**Figure 16 – Chock assembly engaging the bascule girder and approach girders**

The same procedure was followed when installing the chock assemblies for the two outside bascule girders. The method of securing the chocks to the bascule girder by fillet weld became the preferred method for all three-chock assemblies. The time saved by securing the chocks in such a manner would be lost later when removing the welds during the de-jacking process. The chock assemblies were only securely fastened to the top of the bascule girders. The connection interface at the bottom of the approach girders was much more forgiving than the bascule girders. The chocks were bolted to the bottom flange of the approach girders, reusing the existing bolt holes.

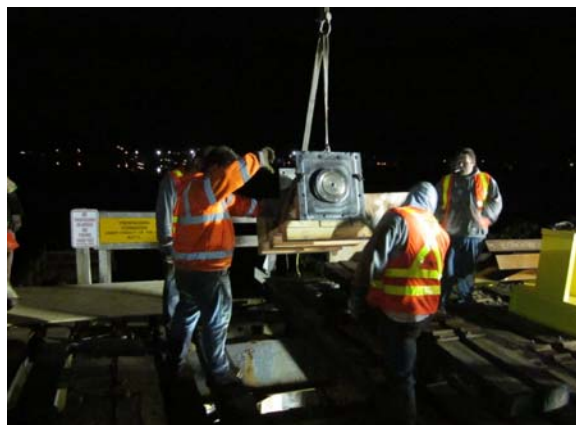
**Figure 17 – Bearing assemblies being lowered to the counterweight**

Once all three chocks were securely in place the crew staged the three replacement pin assemblies below the deck on the counterweight while the access above was still open (See Figure 17).

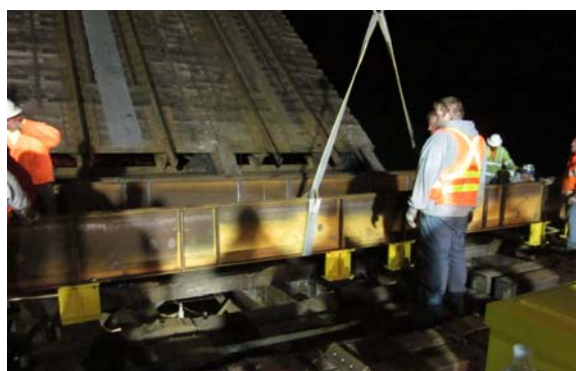
**Figure 18 – Jacking beams being lowered onto the approach girders**

The next step was to install the jacking beams. The jacking beam pairs were installed transversely across the top of the approach girders. Each beam location was already marked off with its rivets removed. The crew placed each jacking beam in the required locations and bolted each beam to the top of each of the six the approach girders (See Figure 18). The beams were installed on the top flange of the approach girders and shimmed. The end diaphragms for each beam pair were installed after each beam pair was set.

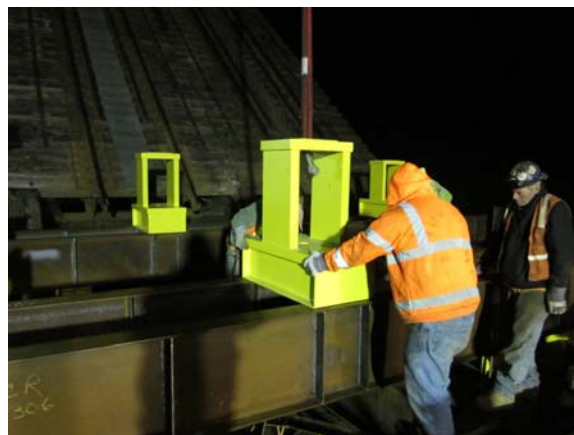
**Figure 19 – Jacking seat being installed**

As Day 3 began, all the jacking beams were installed on top of the approach span girders; the crew began to stage the lifting beams below the counterweight on the platform. The next step was installation of the jacking seats. The jacking seats were set across each beam of the jacking beam pair (See Figure 19). There were four jacking seats to be installed. The location of jack seats had to be set so that the threaded rod could be passed through the jacks, bridge framing, around the edge of the counterweight, and through the lifting beam slotted holes. The jacking seats were shimmed

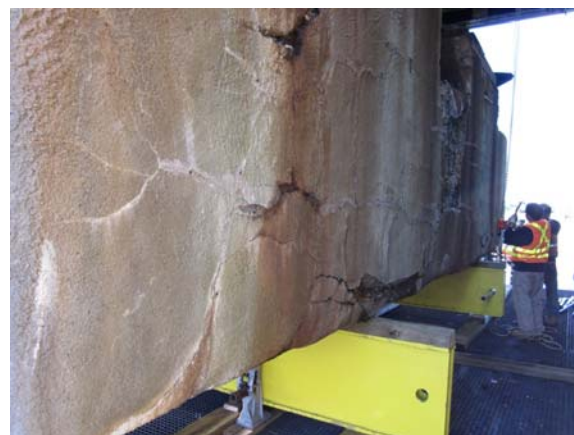
**Figure 20 – Lifting beams being installed under the counterweight**

Once the jacking seats were in place the crew began to move the lifting beams into position under the counterweight (See Figure 20). The underside of the counterweight was irregular thus a timber bearing beams were placed between the lifting beam and counterweight. The lifting beams were lightly jacked against the bottom of the counterweight to await placement of the threaded rods.

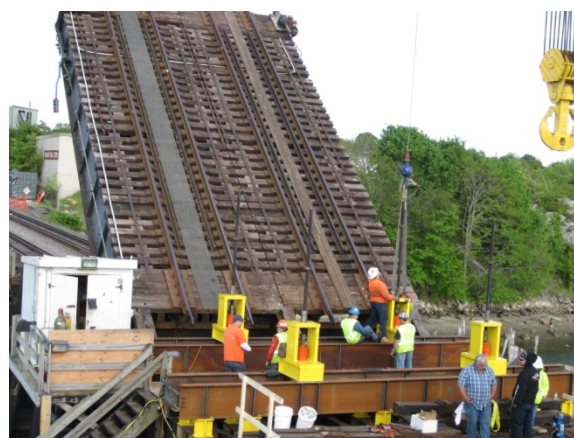
**Figure 21 – Installation of the threaded rods**

The threaded rods were installed after the lifting beams were moved close to their final position. Each threaded rod was 16'-0" long. There were two thread rods used at each jack. The thread rods were coupled together with threaded couplings just above the counterweight. After installation of the threaded rods the lifting beams and jack seats could be set to their final locations and the final preparations prior to jacking could begin. (See Figures 20 and 21)

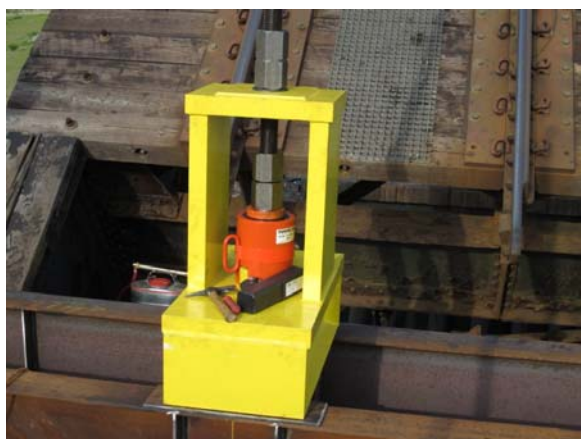
Figure 22 – Complete jacking assembly

The crew began jacking the span around midnight of Day 3 going into Day 4. The counterweight was jacked one corner at a time at 1/4" increments. Once the jacking began, the looseness and flexibility of the structure was tightened up as the counterweight load was being removed from the bascule girder and the chocks began to take the load. As the counterweight load was removed from the bascule girder, the bascule span was almost entirely span heavy. The pressure exerted by this imbalance was passed through the chocks to the chock beams and through the approach

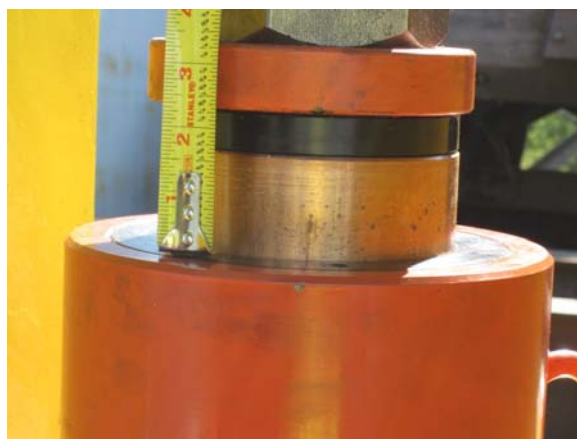
girders. It quickly became evident that the dial indicators were unable to provide any useful information due to the flexibility of the structure and racking of the structure from the failed counterweight trunnion. One of the indicators showed the counterweight was lifted 0.2" without any clearance developing in the bearings.

Due to the failed pin on the north side of the counterweight the counterweight was tilted. The total lift of each jacked varied because of this and ranged from 1 7/8" to 2 1/2" (See Figure 23). The completion of jacking was determined by inserting a feeler gauge around the counterweight trunnion pin and steel hub at the hangers. It was an iterative process of adjusting the jacks at each corner to get this condition at each of the trunnion pins. As the crew lifted one side of the counterweight, the opposite side of the counterweight would lower since the counterweight pivoted about the lifting beams, which were inboard of the outboard hanger bearings. The north side of the counterweight at the failed pin side had sagged significantly and was lifted to be as level as possible with the south side; the counterweight was lifted until the center and south pins just touched to top of their bushings.

Figure 23 – Hollow Jack after jacking
