**HEAVY MOVABLE STRUCTURES, INC.  
THIRTEENTH BIENNIAL SYMPOSIUM**

**Bridge Number 7  
Identifying and Correcting the Errant  
Roll of a Scherzer Rolling Lift Bridge for  
the Norfolk Southern Railroad**

Herbert Protin, P.E.  
Pete Davis, P.E.  
Mickey Harrison, P.E.  
Paul van Hagen, P.E.  
Giancarlo Schiano, E.I.T.  
HDR Engineering, Inc.

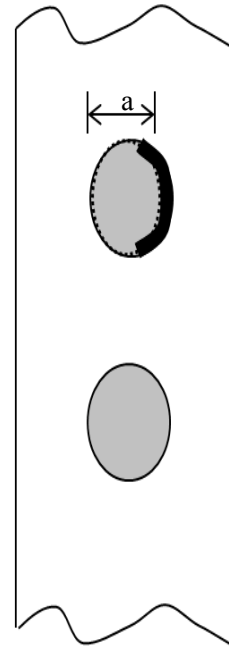
Pintle No.	North Track	South Track
	"a" Pintle Width (inches)	"a" Pintle Width (inches)
1	7.500	7.375
2	7.375	7.000
3	7.000	7.375
4	7.250	7.000
5	7.250	6.750
6	7.250	6.875
7	7.250	7.000
8	7.250	7.000
9	7.250	7.125
10	7.250	7.250
11	7.250	7.250
12	7.000	7.250
13	7.000	7.250
14	7.250	7.125
15	7.875	7.875

Note: Pintle width is measure across top of pintle

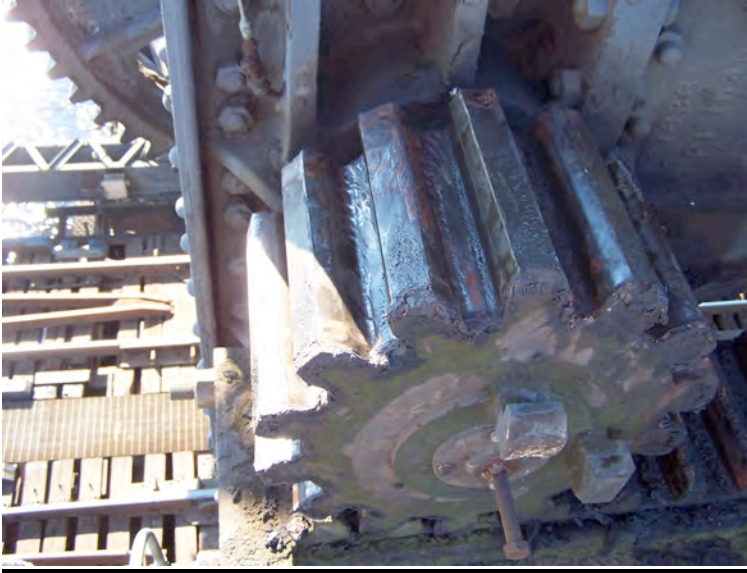
**Photo No. 17:** View looking at North pinion with the bridge in the closed position.

In general, the operating machinery (direct drive, no differential gear set) is worn. This gear wear results in one pinion generally doing more work than the other pinion. The balance condition of the movable span is unknown; however, it is reasonable to assume that the bridge is span heavy. This assumption is based upon the gear wear patterns for the closing side of the rack gears.

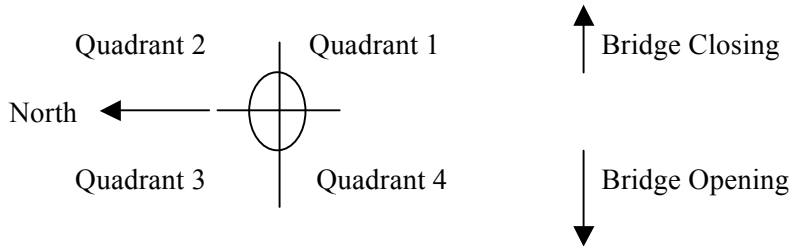
**Figure 2: Pintle Quadrant Layout**

The elevation of the flat tracks indicated that the movable span had a tendency to move to the south, or roll downhill. The overall wear pattern on the pintles was located on the south side. If the span was attempting to move downhill, then the pintle wear would be on the north side of the pintles. Based upon the location of the wear, the flat track elevation was discounted as the primary cause of the observed pintle wear. If you look at the pintle as having four quadrants (See Figure 2). As the bridge closes the tendency would be for the span to roll down hill moving the center of the socket into Quadrant.1 (SE). This would cause wear in the Quadrant 3. This didn't match the wear pattern observed in the field.

The south rack gear wear indicated that the south pinion gear was doing most of the work during the opening sequence and the north pinion was doing most of the work during the closing sequence. Since the pinion was mounted on the movable span, a clockwise rotation was induced during opening. This rotational motion would have moved the center of the socket into Quadrant 3 which would have caused wear in Quadrant 1. This was in part the wear observed in the field. However, during the closing sequence the clockwise rotation caused by driving the north pinion would have moved the center of the socket into pintle Quadrant 1. This would have caused wear in Quadrant 3. This didn't match the wear observed in the field.

It was concluded that the pintle wear was the result of an induced rotation in the movable span during opening and closing operations. Since the south tread plate radius was larger than the north tread plate radius the south tread plate would have traveled a greater distance during opening and closing. This means the bridge would have experienced a clockwise rotation during opening and a counterclockwise rotation during closing. During opening the center of the socket would have moved into Quadrant 3 which would have caused wear in Quadrant 1. During closing the center of the socket would have moved into Quadrant 2 causing wear in Quadrant 4. This combination of wear in Quadrant 1 and Quadrant 4 closely matched the wear pattern observed in the field. The interference between the pintle and socket as the bridge opened/closed was approximately 0.16 inches.

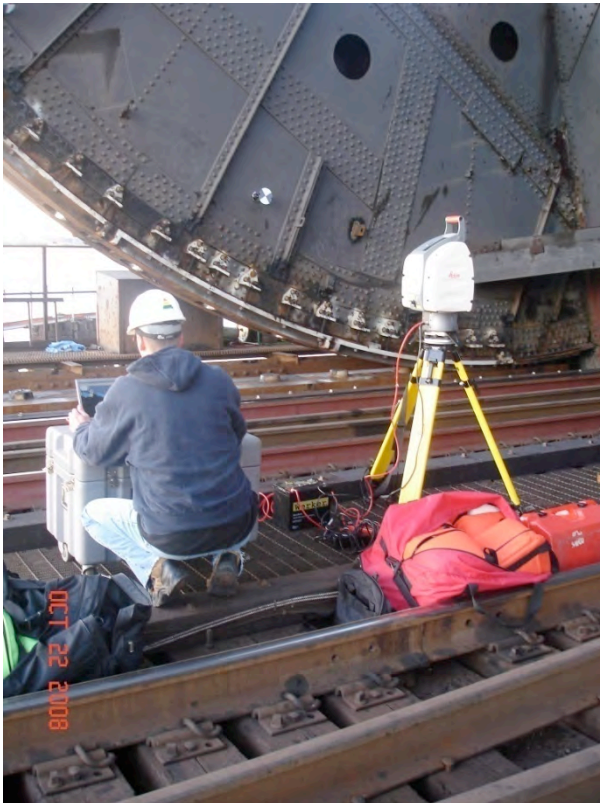
**Photo No. 20:** Laser survey of the segmental girders.

The Contractor used a 3-D laser survey to locate a comprehensive set of points and surfaces on the bridge during a 4-hour bridge outage. The survey required three separate set-up locations in order to capture all the data necessary on both sides of each track girder (See Photo nos. 20 and 21). It was critical that the bridge remain in one position, unmoved, during the survey in order to obtain a direct relationship between the inner and outer faces of each track girder (the open position was selected to allow river traffic to pass during the survey).

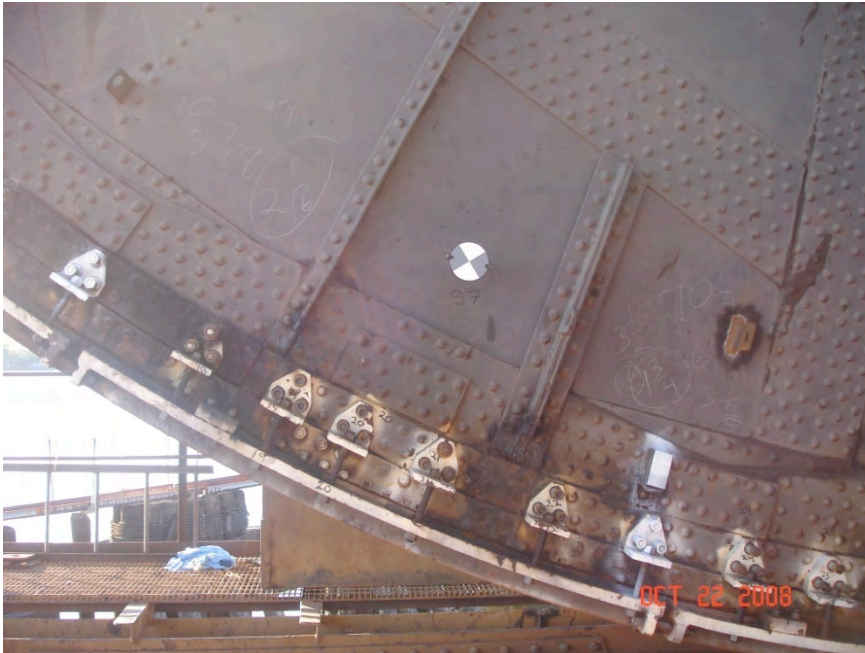
**Photo No. 21:** Survey Targets set up on the  
North face of the South Segmental Girder

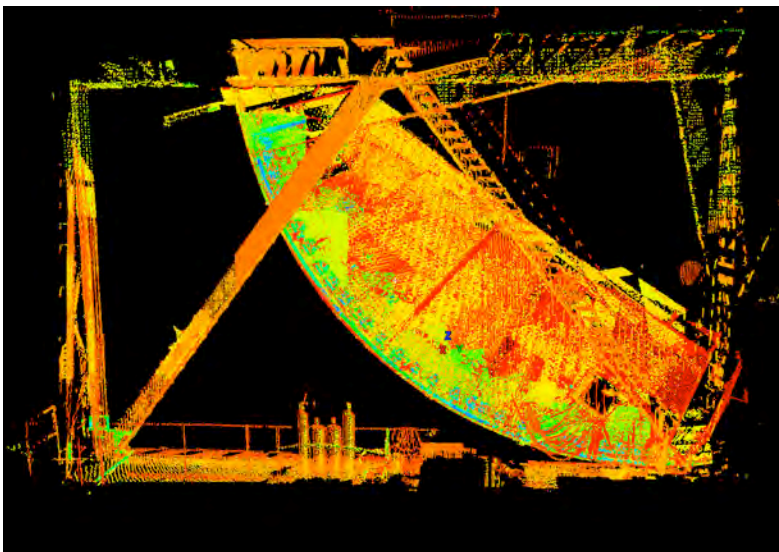
**Photo No. 22:** 3-D Laser Survey –  
Elevation of Track Girder

The survey data indicated that the bascule girders were not centered on the flat tracks nor parallel to the flat tracks and that the web plates were not straight. Berding Surveying extracted the critical data that was used to develop detailed shop drawings and translated the data to CAD format. The critical data included the location of every rivet and bolt to be used in connection of the new steel plates (See Photo No. 23), the location of the face of the web plates at which new flange angle would be bolted, the location of the flat track and the center of each pintle, and the location of the center of roll. This information was used to aid in the development of detailed shop drawings, however correction of the data was necessary in order to use it for fabrication of the tread plates and connection angles.

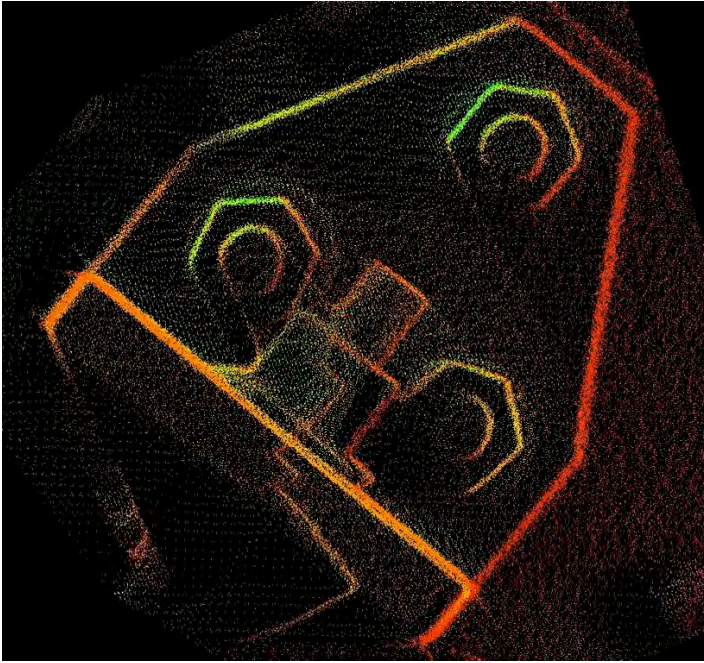
**Photo No. 23:** 3-D Laser Survey – Survey of Bolt Heads

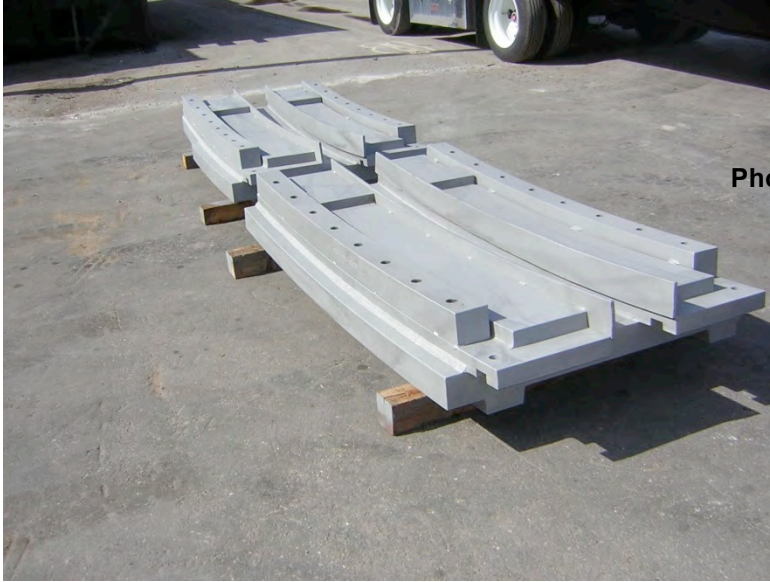
**Photo No. 24:** New tread plate segments.

Using this information the contractor fabricated and installed the flange angles and shims prior to the bridge outage, and fabricated the first segment to be installed in the bridge outage (See Photo nos. 24 to 26).

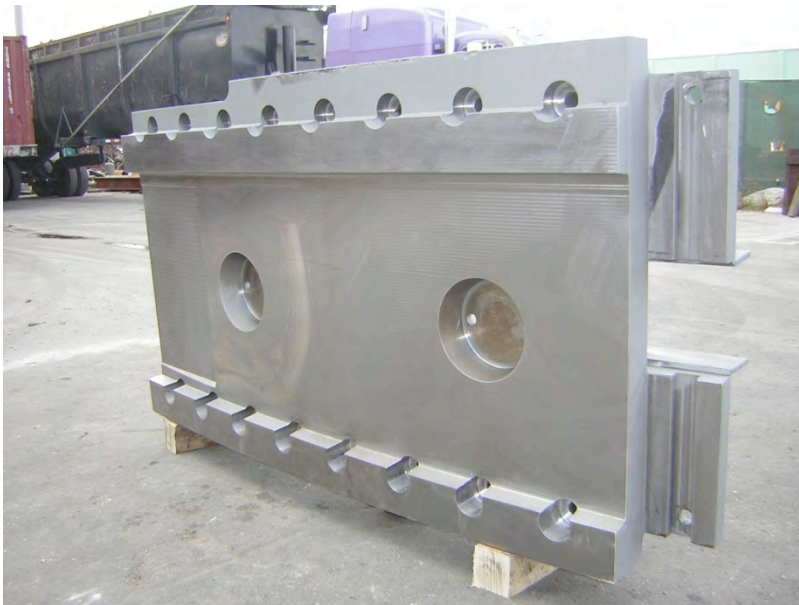
**Photo No. 25:** View of bottom of tread plate segment. Note circular sockets to match existing pintles, interlocking tongue and groove connections between the segments. Also note that the locations of the holes for bolted connections to flange angles are different on the two sides of the tread plate.

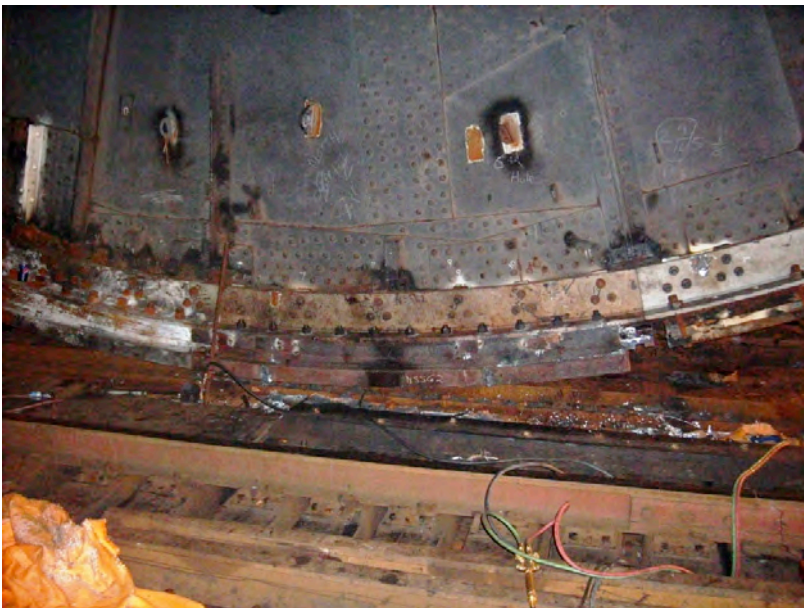
**Photo No. 29:**  
Installation of  
Segment 2.
