**HEAVY MOVABLE STRUCTURES, INC.
THIRTEENTH BIENNIAL SYMPOSIUM**

**Rehabilitation of Historic Components at
the Bridge of Lions**

Steven Shaup, PE
TranSystems
Fort Lauderdale, Florida

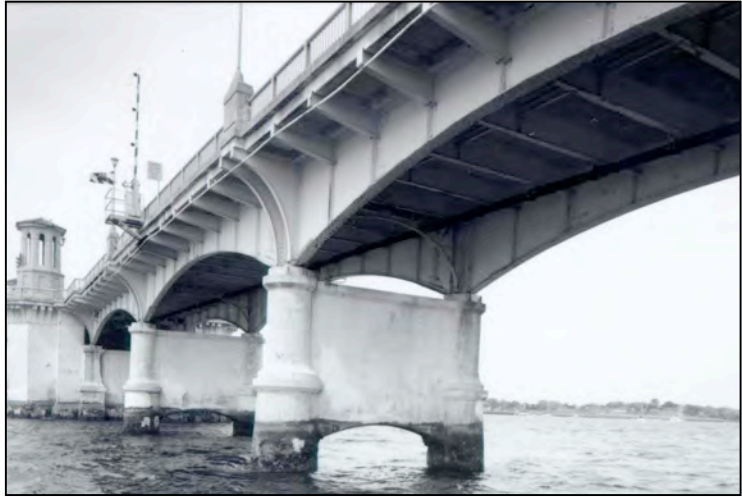
Figure 0 - Original haunched girder-floorbeam approach spans.

The existing haunched girders that comprised the approach spans needed to be reused in order to retain the No Adverse Effect determination. See Figure 10. The plan for the superstructure on the approach spans was to reuse the existing girders in a capacity that required them to maintain some structural function. For any historic rehabilitation, it is important for historic components to continue to serve, at least partially, a structural function. These girders were placed in line with the decorative ends to the piers as they had been on the original substructure to maintain the bridge's appearance. During construction, the girders were removed from the bridge and sent to a shop for wholesale repairs to areas of section loss. Where areas of section loss were found, the areas were cut out and replaced with new material welded into place. The repaired girders were metalized and painted to extend their life as long as possible. The primary load carrying members of the approach spans consist of a brand new system of girders and floorbeams that are completely hidden within the profiles of the reused steel girders. The floorbeams frame into the reused steel girders at the piers, where additional steel plate and angles have been installed to allow for proper load transfer.

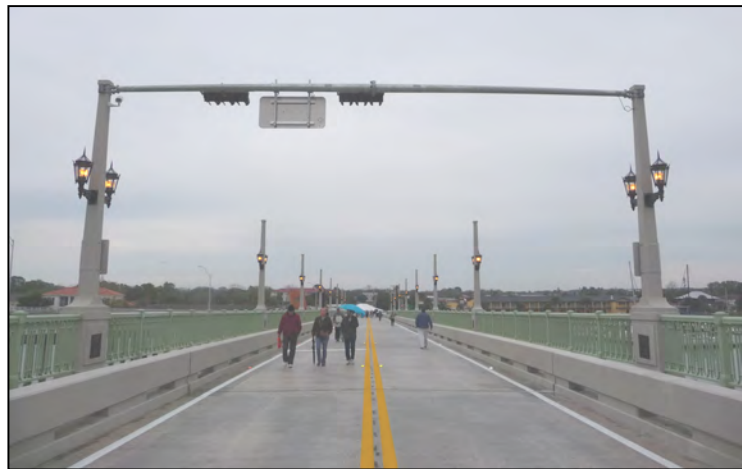
Figure 0 - New bridge cross section. Note corral railing at curbline that separates roadway from sidewalks.

Because the girders were to be removed as part of the reconstruction of the approach spans, it was decided to increase the roadway width from 22-feet to 25-feet and install a plain, low profile traffic barrier between the roadway and the sidewalks. A TL-4 approved corral-type rail was used. The approach span sidewalks were kept at 5-feet wide, with the exception of the bascule span, which was reduced to 3-feet in order to accommodate the additional roadway width. Installation of the traffic barrier improved motorist and pedestrian safety and allowed the original ornate pedestrian railings to be replicated. The pedestrian railings were replicated from the original design plans, but with the railings designed with structural steel instead of cast iron and the height modified to meet current railing height requirements. See Figure 11.

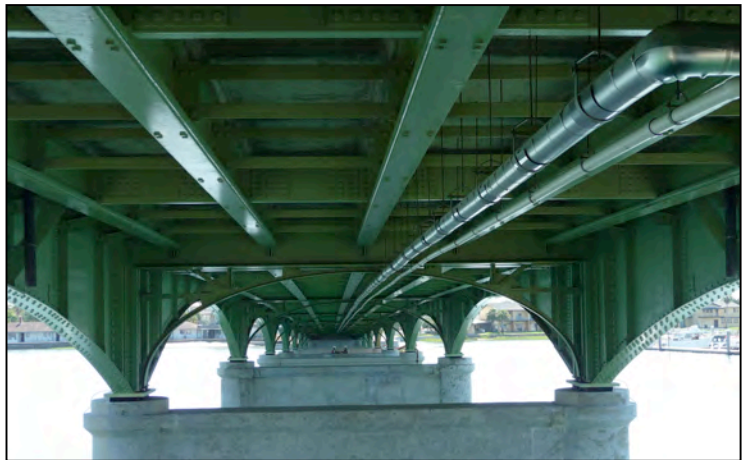
Figure 0 - New approach span framing. Note existing haunched girders re-used, modified to provide bearing support for the floorbeams over each pier.

The original steel girders consisted primarily of continuous steel girders with half spans at each end, which in the original configuration placed the joints at every other midspan. With the new support structure consisting of multiple girders and floorbeams at each pier location, the haunched girders were

modified in order to locate the joints at more conventional locations above piers. The rehabilitated approach spans now provide two and three span continuous units. See Figure 12.

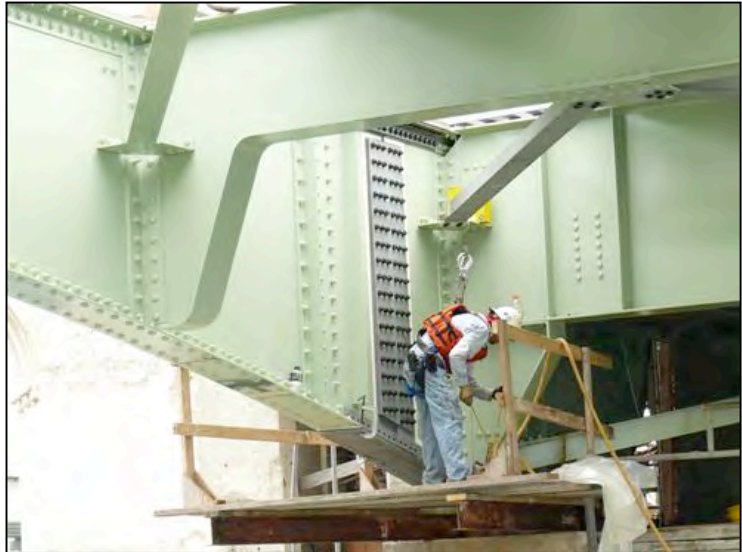
Figure 0 - New bascule span during construction. Note built up construction to left side of splice and built up welded construction to right and welded built up plate girder floorbeams.

Because of the significance of the appearance of the bridge, the new bascule span used built up construction using dome head direct tension indicator (DTI) bolts that would mimic rivet heads, oriented so that the round heads were on the exterior faces of the bascule girders and on the undersides of the flanges as much as possible. The built up section was only required for the portion of the span visible when the bridge was down, so the heel portions of the bascule girders were of welded plate girder construction. See Figure 14.

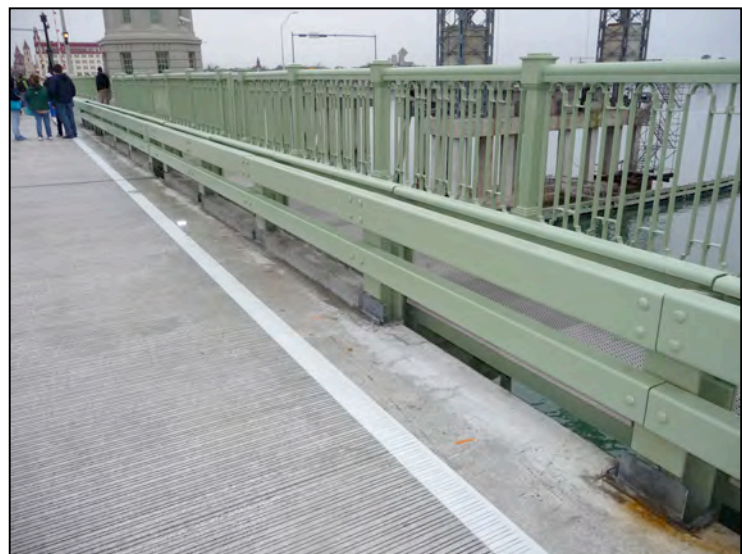
Figure 0 - New bascule span traffic barrier.

The traffic railing was maintained across the bascule span using steel and mimicking the design of the Illinois side-mounted rail, which had the same height as the corral rail. See Figure 15. The pedestrian railing was of the same design as the approaches.

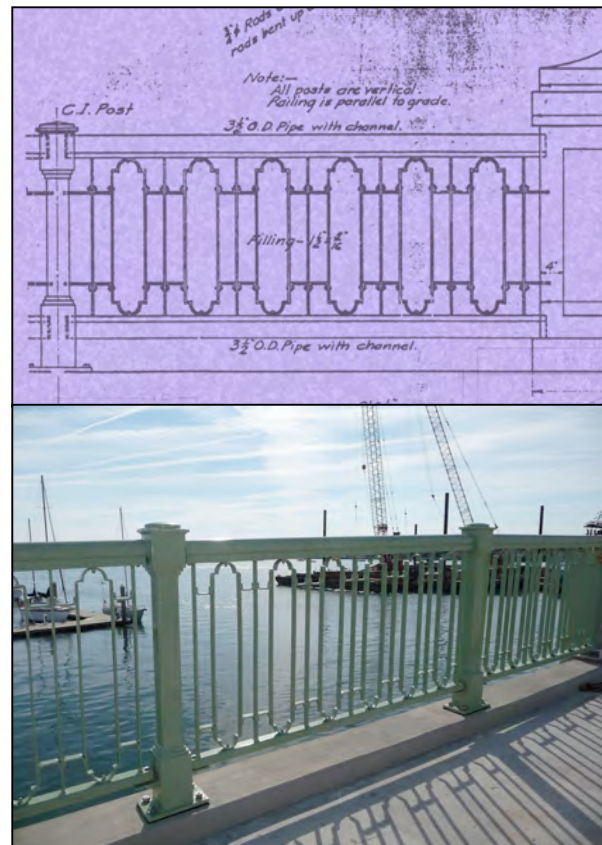
Figure 0 - Railing design from original plans at top; new railing with adjusted height at bottom. Note that height change has little impact on railing appearance.

Railings that were sufficient for pedestrians and bicyclists were required by the FDOT. As such, the original 44-inch high rails were replicated but at 54-inches high to meet this requirement. The original design plans were used to detail the railing, with some modifications required where original shapes were no longer available or modern steel shapes could be used with no impact to the railing's appearance. For example, the original horizontal rails used tubes and bars bent into a C-shape. The sizes that were shown in the original plans were not used anymore, but current sizes of pipe and a small standard channel shape were available that had no impact on the appearance of the railing. To accommodate the taller railing that was required, it was possible to stretch the railing, but the modification did not significantly alter the railing's appearance from the original. See Figure 22.

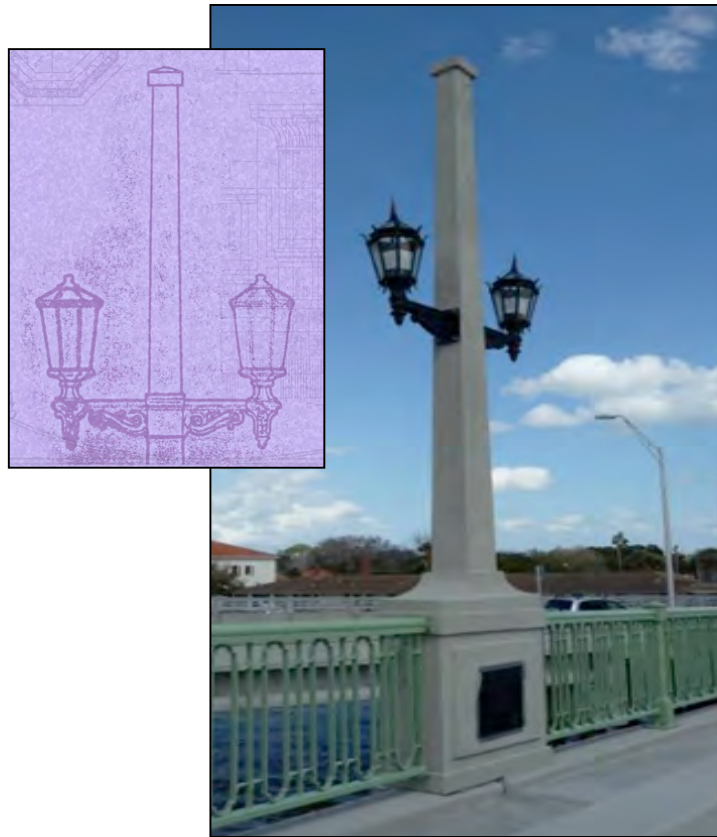
Figure 0 - Original design drawings detail for roadway lighting at left; replicated lighting at right.

The roadway lighting had long been removed from the bridge. Fortunately, the original specifications for the luminaires had been preserved and kept at the Historical Society and it was possible to replicate the

luminaires. The concrete pole used to support the pairs of luminaires in the original design was replicated by making use of precast concrete poles that were positioned vertically on the concrete pedestals using precast leveling nuts. See Figure 23.

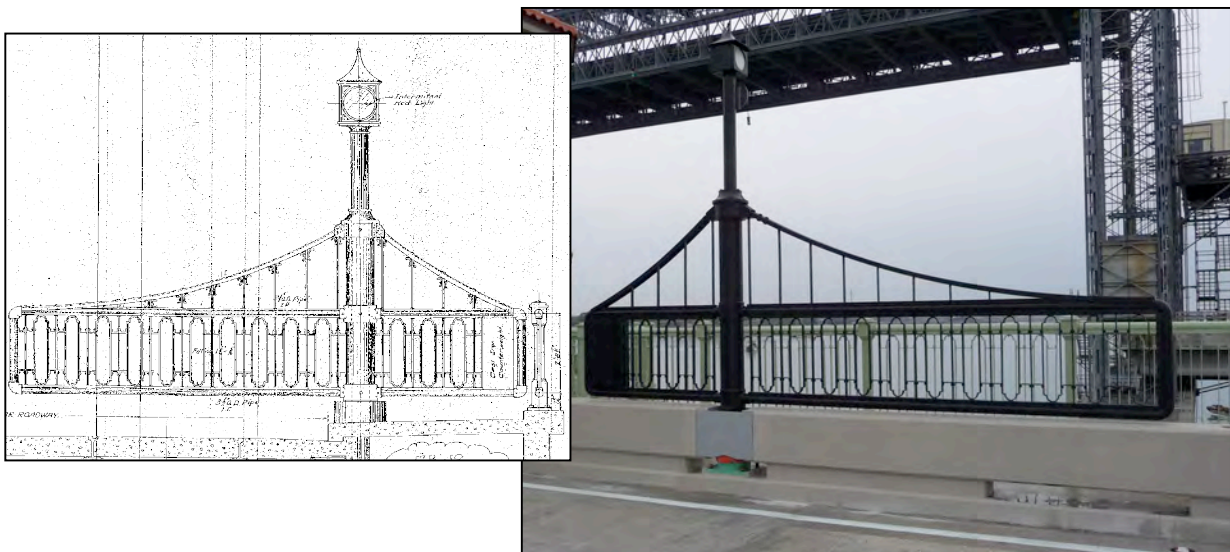
Figure 0 - Original gate details at left; replicated gate at right.

The bridge traffic control devices were far less than what is required today. The traffic was controlled by a pair of wrought iron gates that swung from mounts at the curblin. Modern traffic control devices were installed on the bridge for safety reasons, but as part of the restoration of the bridge, these ornate gates were replicated using original design drawings supplemented by original design photos. As was done with the pedestrian railings, the round tube and C-shape horizontals were replicated using stock sized steel pipe and standard steel channels. The original traffic gates were located at the curb level, but the placement of the traffic barrier at the curblin required the gate to be located at the top of the traffic barrier. This change was found to be acceptable because safety considerations outweighed the benefits of having the railing any lower. See Figure 24.

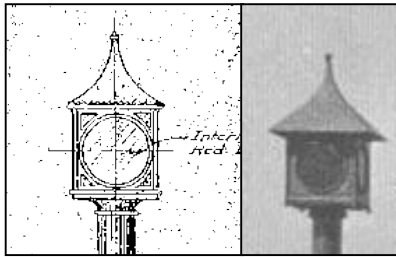
The light fixtures atop each post were found to differ between the original design drawings and the photos. The 1927 design drawings were originally used to replicate the fixture, but the design was

Figure 0 - Original design traffic gate head lamp detail at left; constructed lamp at right.

modified once the photos were examined and the differences made known. The size of the post and the fixture were determined by scaling various dimensions from available photographs. See Figure 25.

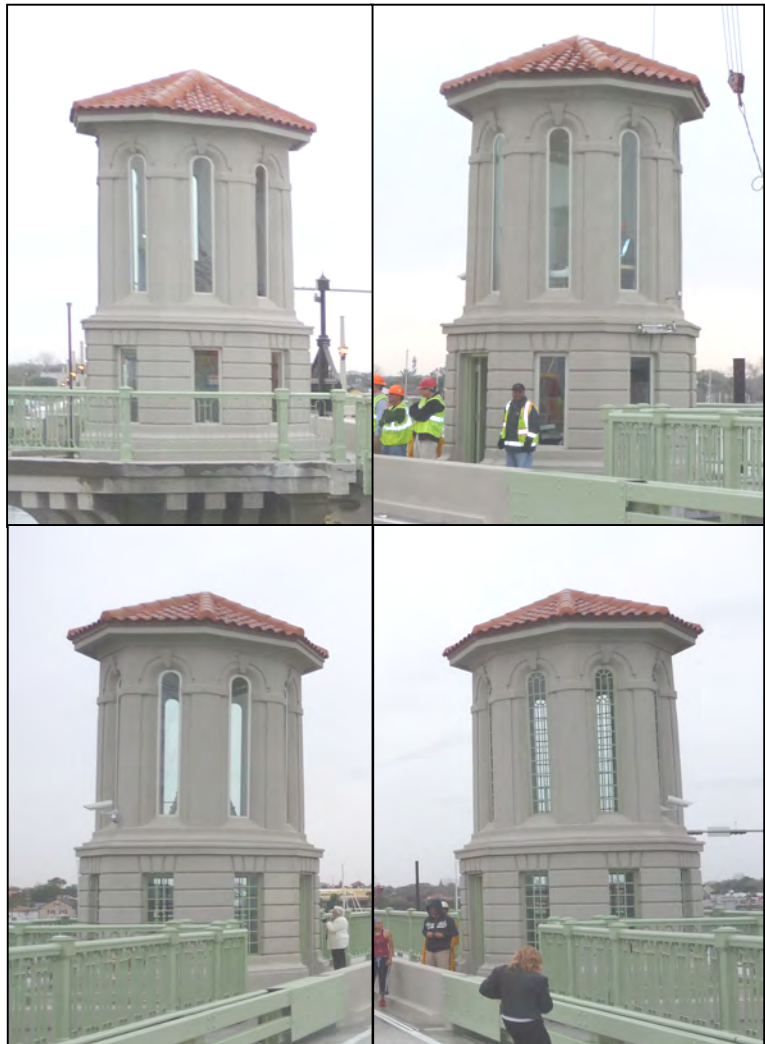
Figure 0 - Restored bascule pier towers. Clockwise from top left: NE tower, SE tower (tender house), SW tower, NW tower.

In order to restore the towers as much as possible and provide enclosed spaces that would be more maintenance-friendly, all openings had windows installed. Where the openings previously had windows installed, the windows were detailed to match the multi-pane appearance using single pane windows with adhesive strips to replicate the multipane appearance and meet current requirements for windows meeting Florida's windstorm criteria.

Where the openings were previously open to the elements, single clear windows were installed to differentiate historically open locations from those that had multi-pane windows. This is an appropriate practice for historic structures where it is undesirable to create a "fake" history by showing things that were not part of the original structure. See Figure 26.

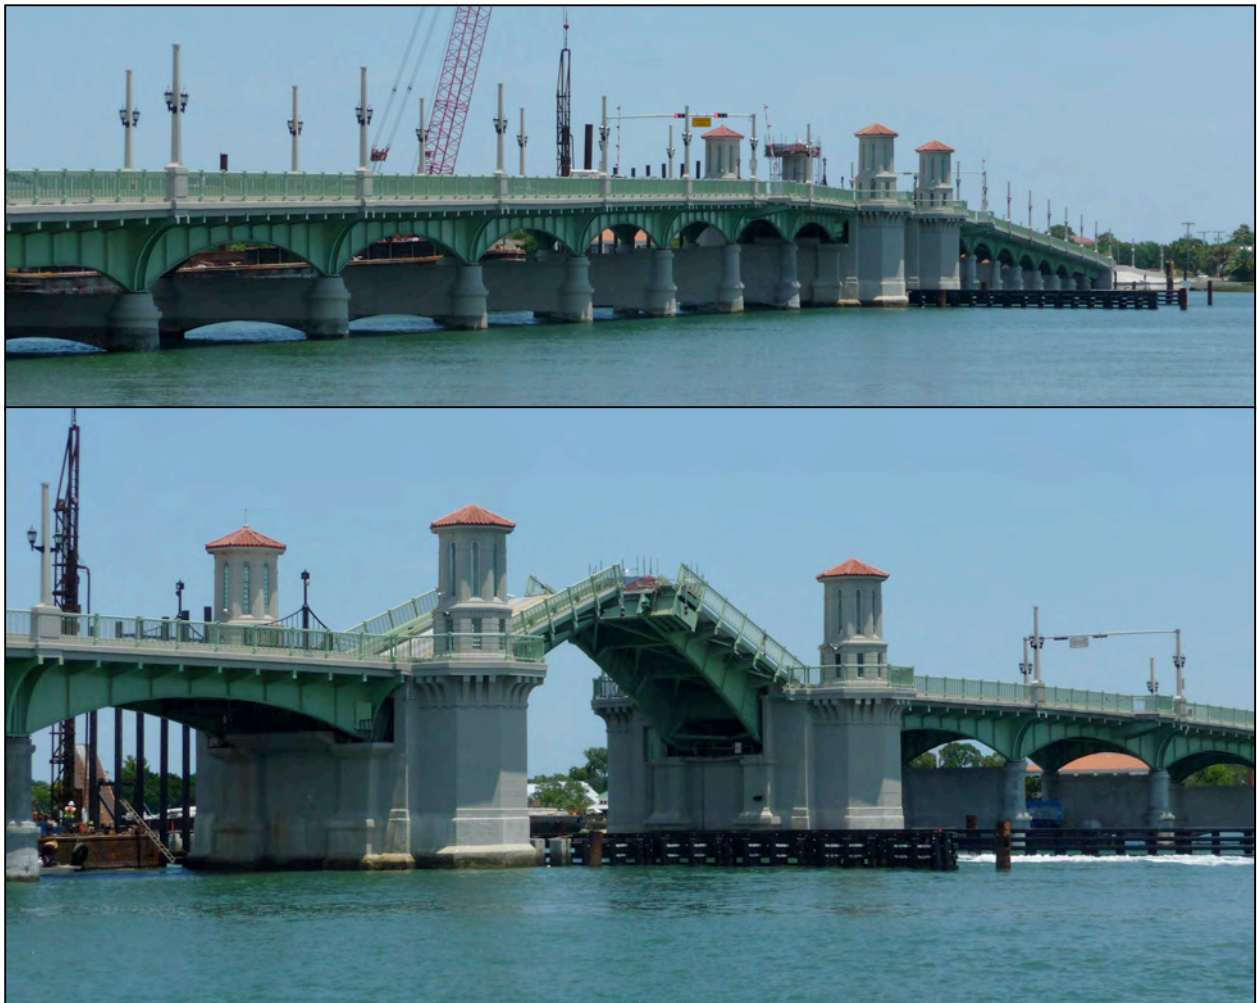
Figure 0 - Views of the completed bridge with the steel painted original green.

There was some question as to the color of the original paint on the bridge. Over the years, the bridge had been painted numerous times, and at the time of design the steel had been painted a light tan color. Review of records at the historical society and careful removal of the layers of paint on existing steel indicated that the original bridge was painted a light grayish green color. This was confirmed by a local resident who was present at the grand opening of the original bridge and had part of the old railing in their possession. The resident confirmed that the color was accurate. See Figure 27.
