**HEAVY MOVABLE STRUCTURES, INC.
THIRTEENTH BIENNIAL SYMPOSIUM**

**Rehabilitation of Bridge Street Bridge
Preserving a Nineteenth Century Historic
Bascule Lift Span**

Paul van Hagen, PE and Herbert Protin, PE

HDR Engineering, Inc.

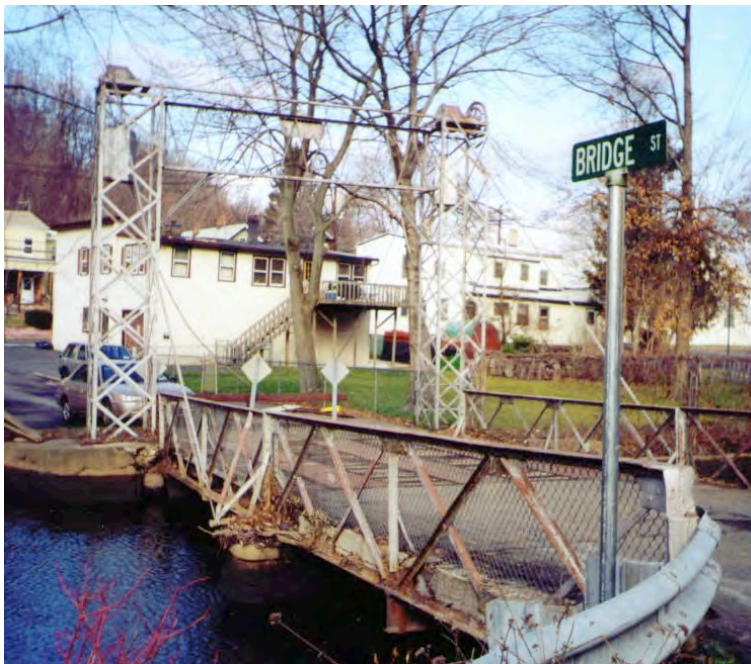
FIGURE 1: Bridge Street Bridge prior to rehabilitation

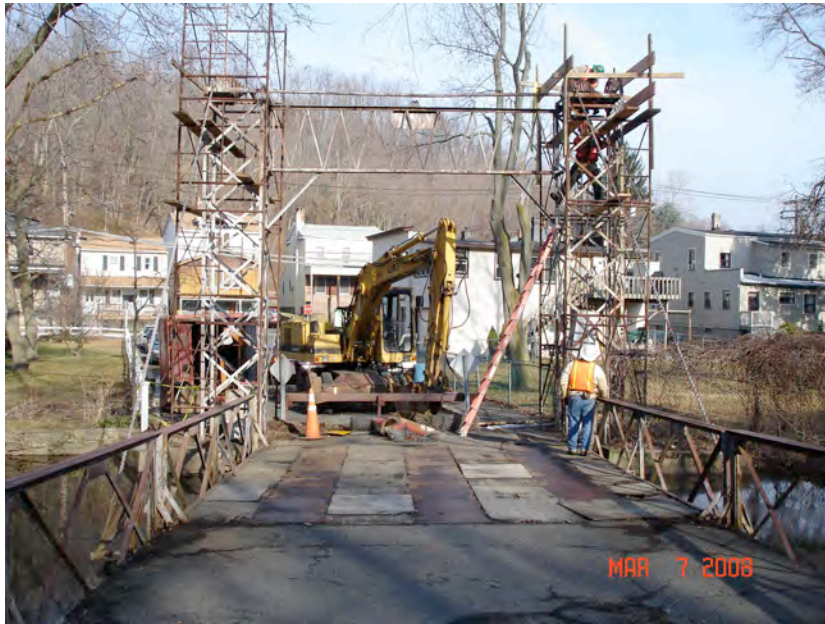
FIGURE 6: Demolition of steel towers

The first step was to remove the steel towers (see Figure 6), including all machinery and counterweights, all carefully stored for delivery to the Contractor's yard for restoration later. Pieces to be reused were all marked and photographed. On the second day the Contractor cut the counterweight chain at the Northwest Tower Leg (see Figure 7). Since the chain is a historic element that was to be reused in the reconstruction of the bridge, the Contractor was informed that he would have to restore the chain to its original condition.

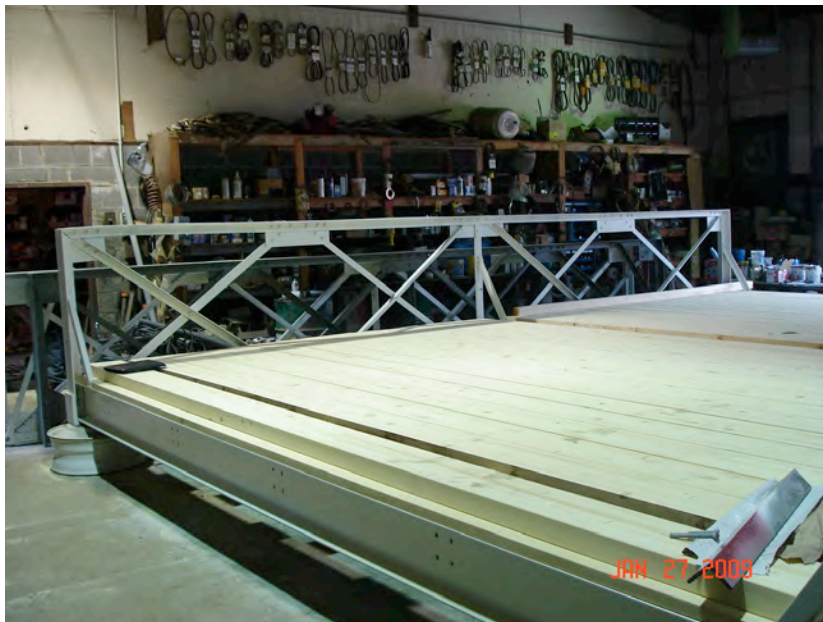
The contract called for IPE hardwood decking and stringers. The contractor was not able to procure the member sizes specified in the desired species, and so the client agreed to modify the contract requirements to provide timber more readily available in the sizes required. The timber to be used was Alaskan Yellow Cedar, a relatively rare, but hard, durable timber, with excellent resistance to deterioration especially suitable to the marine environment (see Figure 13). The timber properties were not as specified for IPE and so the number and arrangement of the timbers beams was modified.

FIGURE 13: New timber deck and rehabilitated steel framing erected in shop

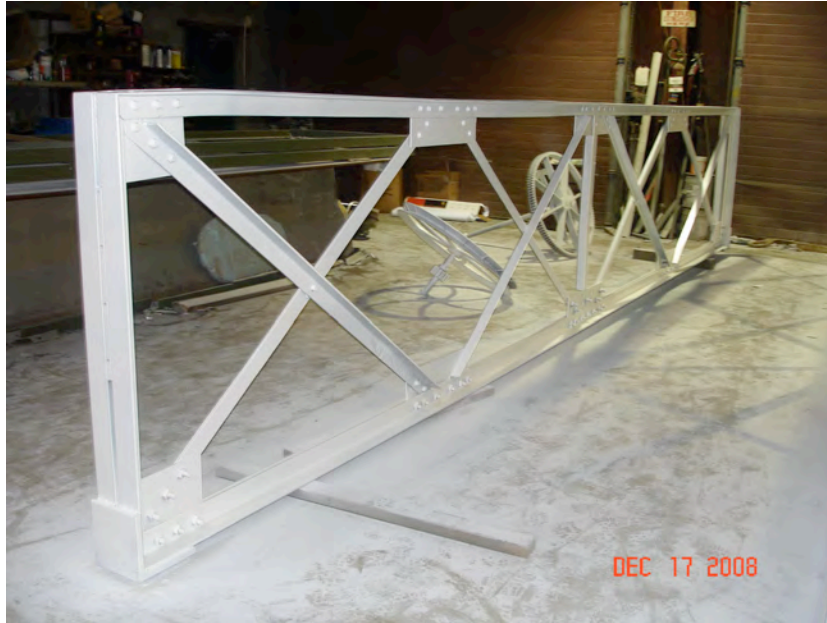
A thorough field inspection was performed during demolition to measure existing pieces to be replaced, and to determine what had been there, in some cases using existing rivet hole locations to determine the configuration of replacement pieces that had long since disappeared. The extent of the repairs to the steel elements required careful detailing to be consistent with existing bridge elements. Truss members such as angles, structural tees and plates were measured and replaced exactly in kind (see Figure 16). Several angles to be replaced were of a size that is no longer rolled, and so were replaced with metric size angles that more closely matched the original pieces. For this effort, seven new sheets of steel details were produced.

FIGURE 16: View of rehabilitated truss after prime coat was applied in the shop. Note shafts and gearing in the background.

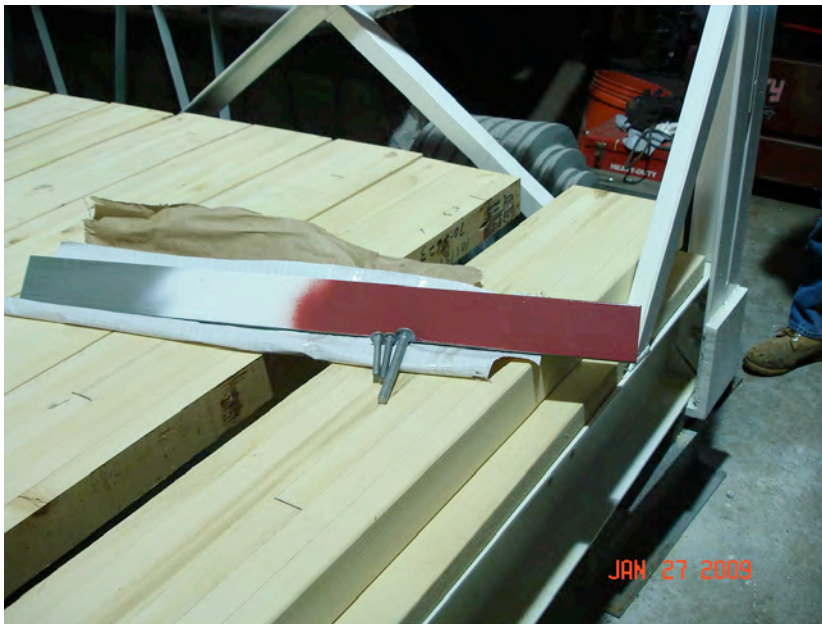
The color of the bridge prior to construction was silver, but this was not the original paint color. Under the silver coat, and still very well intact in many areas, was found the original lead paint coatings. The client and others noted the importance of painting this structure in keeping with its natural surroundings and using a color that it had been in the past. Local agencies including the village government and the historic society were contacted to determine and agree upon the color the bridge would be painted. Eventually the bridge will be painted with a color to match as closely as possible to the color that was found on the existing steel members, namely Pantone 492U which is a brick red semi-gloss epoxy paint system (see Figure 18).

FIGURE 18: Paint sample for approved three coat system. Note rehabilitated sheave assembly in the background.

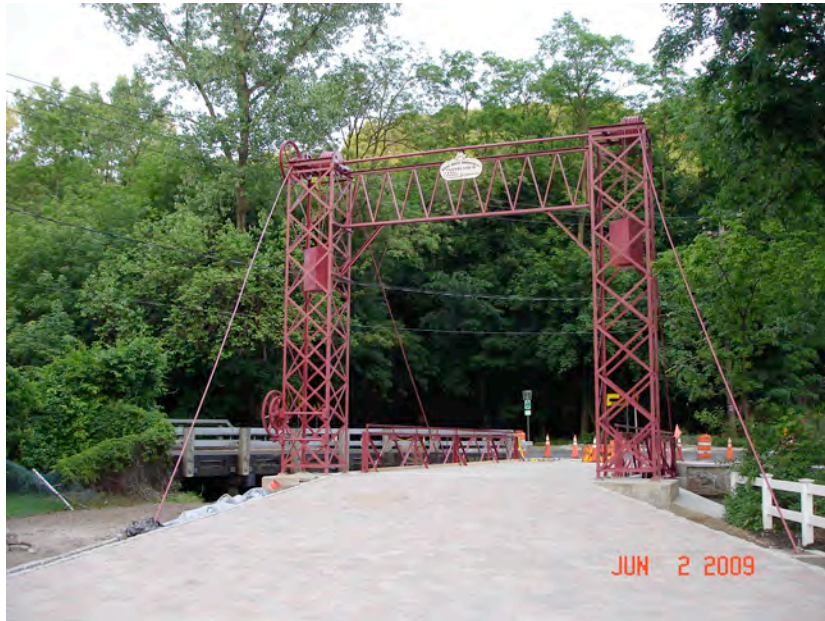
FIGURE 19: Substantial completion of the Bridge Street Bridge. Note the paving blocks used for the north approach

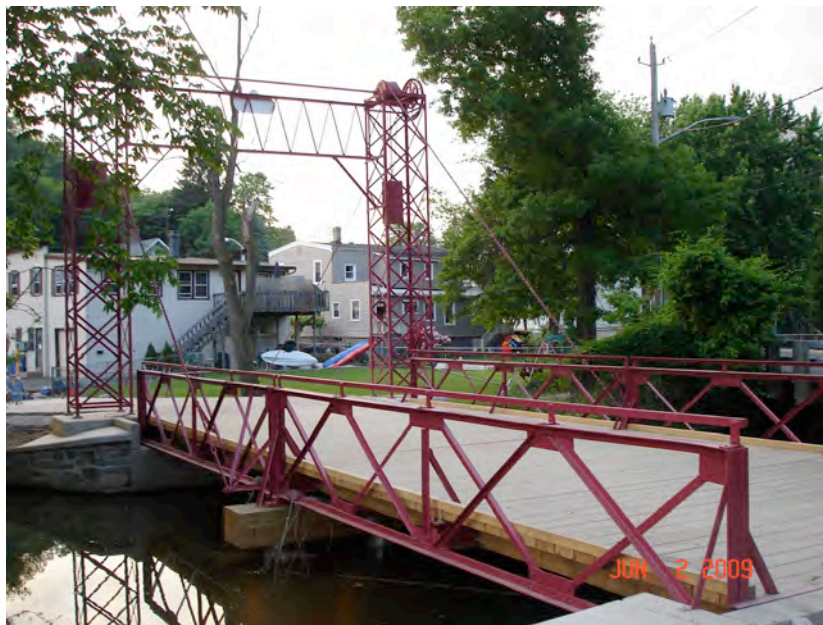
FIGURE 20: Bridge Street Bridge looking northeast. Similar view to Figure 1
