Emergency Repair of the I-695 Drawbridge over Curtis Creek

By:
Scott Reynolds, PE
Hardesty & Hanover, LLP

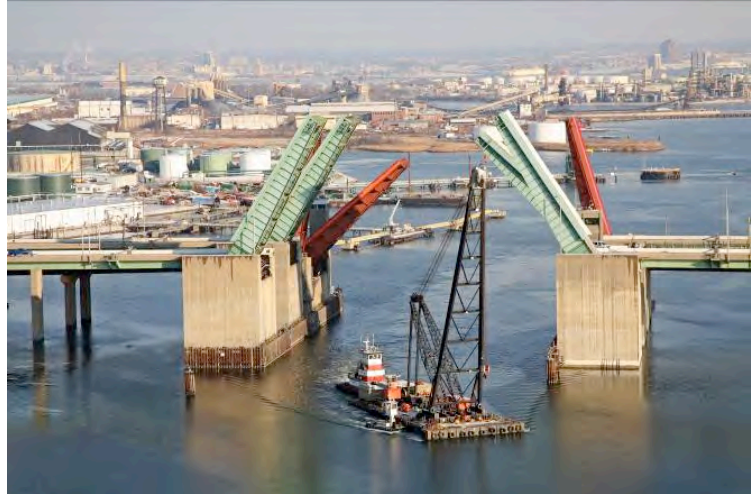
Mid-day on June 29, 2009 the northwest leaf of the parallel double leaf bascule bridges on I-695 in Baltimore, MD malfunctioned resulting in the leaf stopping during closing operations at an angle of approximately 15 degrees from the seated position.

Under a pre-existing agreement with the Maryland Transportation Authority (MDTA), Hardesty & Hanover, LLP (H&H) had an engineering team on site to observe each scheduled operation of the bascule bridges to assist the operators in diagnosing and addressing any concerns that may develop. Consequently, an H&H engineer was on-site, and coincidentally on the northwest leaf, at the time the malfunction occurred. It was immediately evident that a failure had occurred within the primary reduction gearing. Due to limited access to the interior of the differential gear box, it was not possible to assess the specific component(s) beyond identifying that the differential mechanism itself was not functioning properly as evidenced by the input shaft and both first and second intermediate shafts rotating, while the output shafts remained stationary.

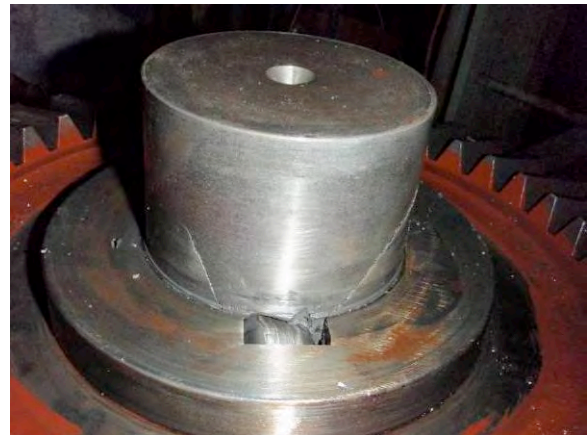
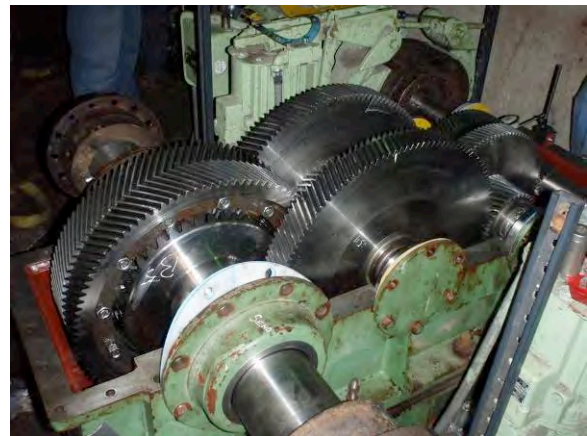
The parts identified to be replaced included both bevel gears, bevel gear keys, output shafts, differential bronze bushing and all reducer shaft bearings. The new bevel gears were identified to have two areas of improvement to increase the torque capacity required for operations. The first modification was to increase the interference fit between the bevel gear hub and shaft. The second modification was to extend the bevel gear hub to provide a larger bearing area for the new key.

Based on the successful performance of the temporary repairs within the northwest leaf, it was determined to install the new parts in the differentials on the northeast and southwest leaves, and to perform a temporary repair on the southeast leaf. This work was completed within the scheduled six week closure and reduced speed operation of all leaves was restored.

A second navigation closure of one week duration was then scheduled for 17th of September to complete the permanent repair on the southeast leaf differential.

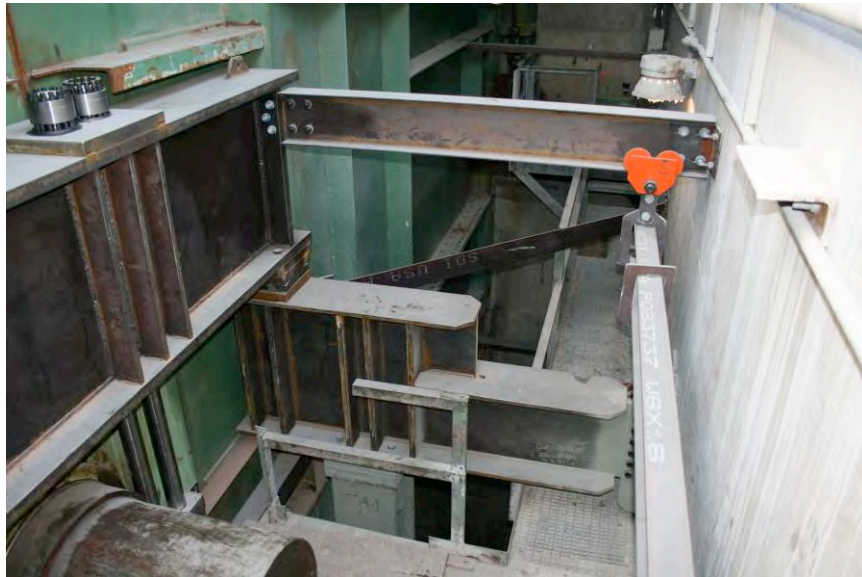
Considerable effort was invested in developing the specific mechanism for raising the bridge off of the trunnion bearings. Experiences with similar projects had typically utilized the jacking frame to support hydraulic jacks for pushing the bridge into the air. The dimensions of the jacks that would be required to accomplish lifting the 2.6M LB of each leaf would not have been easily accommodated within the framework of a

small interchangeable jacking frame assembly such as was required for this application. Therefore, a method to lift the bridge up, rather than pushing the bridge up, was determined to be more easily constructed and less costly to fabricate and erect. With the selection of CM&W to perform the machinery work, an added benefit was their ability to fabricate structural steel for the jacking system. This allowed for collaboration with the fabricator during design and detailing of the structural steel to ensure materials,

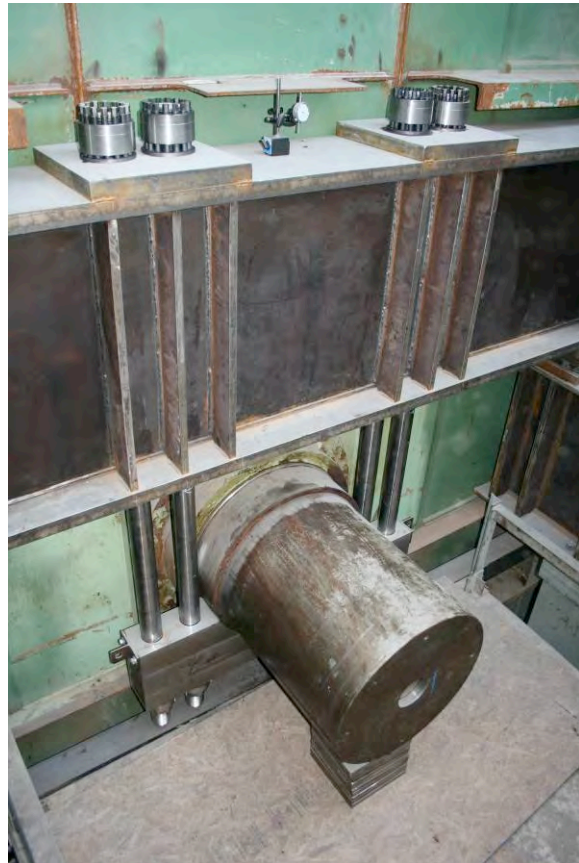
The entire concept of lifting the bridge from above rested on the feasibility of design and manufacturing a trunnion saddle. This component of the system needed to be compact enough to fit under the trunnion shaft and between the trunnion bearing and the bascule girder web, but large enough to accommodate the hanger rods and support nuts. The shape of the saddle was also critical since it had to fit tightly and uniformly around the bottom half of the trunnion shaft. The trunnion shafts were thoroughly cleaned and their diameters measured. All eight trunnion shafts were found to have similar enough diameters that custom saddle designs were not necessary. One saddle radius was specified that could be used at any trunnion shaft. The saddles were analyzed using a simplified hand calculation and verified with a detailed 3D finite element computer model. While the hand calculation was valid for basic stress design, the computer model was used to investigate problems that may arise due to poor fit between the saddle and the shaft. It was determined that a smaller saddle radius was more beneficial than a larger one. This finding was used to develop a single saddle design that could be used at each trunnion. This refined analysis and detailing allowed for only four saddles to be fabricated instead of 8, saving fabrication cost and lead time. The saddles were manufactured by Camforge of West Virginia as forgings from ASTM A668 Class M material, with a 125ksi yield strength. Numerous tests were required to verify the material and final forging including MT, UT, tensile strength, and macro-etch test. The final

dimensions of the saddle were achieved by milling the inside diameter and boring the holes for the hanger rods.

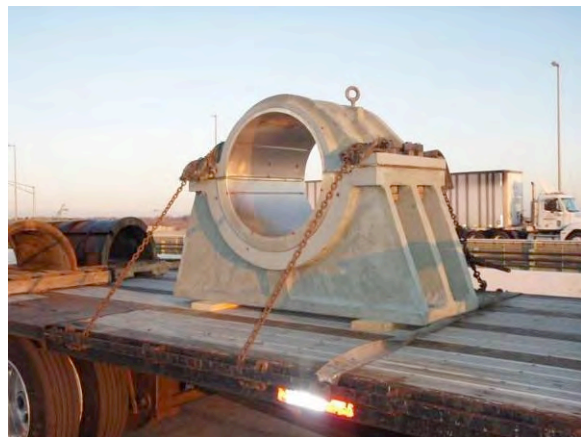
Another detail changed from the original was the bearing housing cap to bushing connection. The bushing was originally secured to the housing cap through two keys 90 degrees apart. The rehabilitation design eliminated the two keys and replaced them with countersunk cap screws. The old keyways in the cap were filled with a metal epoxy filler to eliminate any voids.

The final bushing bores were rough machined pending final measurements of the shaft diameters after the field machining was completed. Once the shafts were complete, the shafts were measured in nine locations along the length and around the circumference of the journal and sent to the machine shop to start the final bore machining. An ANSI RC6 fit was specified for the new trunnion bearings.
