# HEAVY MOVABLE STRUCTURES, INC. 13<sup>th</sup> BIENNIAL SYMPOSIUM

# Heavy Duty Riveted Bridge Deck AASHTO H20 Loading and Fatigue Testing

Kenneth P. Apperson, PE - Ohio Gratings Inc. Dr. Craig C. Menzemer, PhD, University of Akron

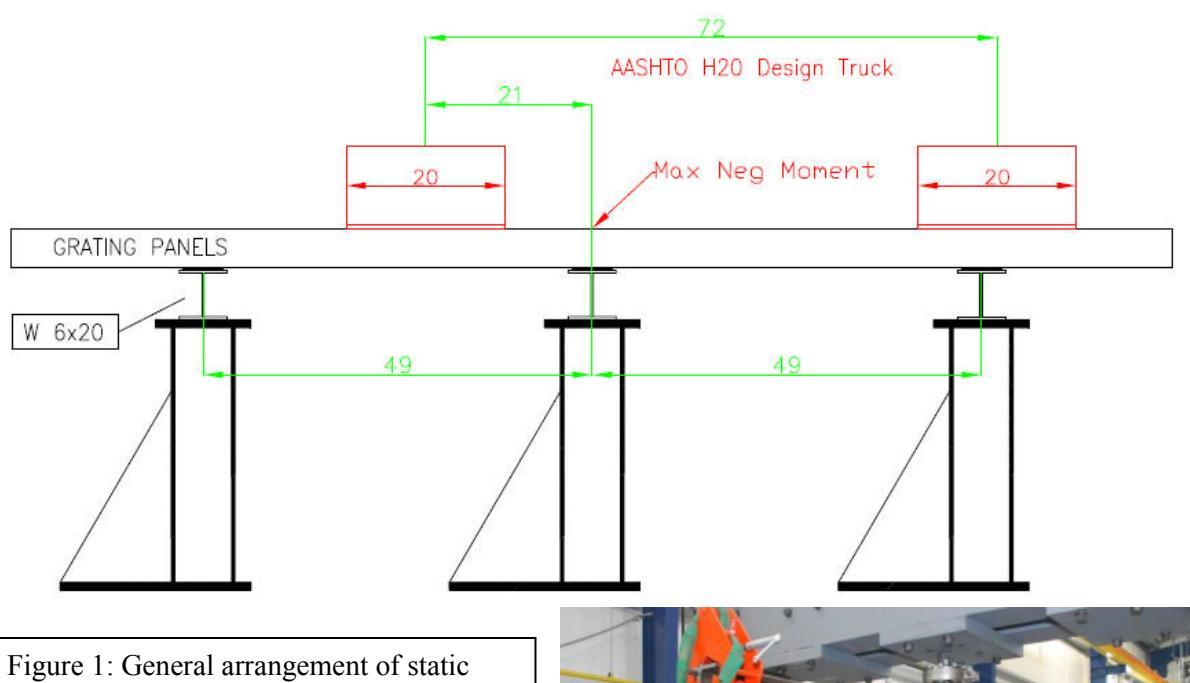
Figure 1: General arrangement of static test set-up for 37R5 Lite 5" x <sup>1</sup>/<sub>4</sub>" deck

Figure 1 and the photo below show the general arrangement for the static test set-up for testing of the two span continuous riveted steel bridge deck. Support spacing was 49 inches center to center of stringers. A spreader beam was utilized and loads were placed 72 inches apart to simulate a design truck axle located to provide the maximum negative bending response. Twenty inch long sections of steel "I" beam with reinforcement plates and a 10 in wide flange were used to provide the AASHTO tire patch for an H20 loading. High durometer rubber pads were placed between the short sections of each "I" beam and the deck to act like a "tire"

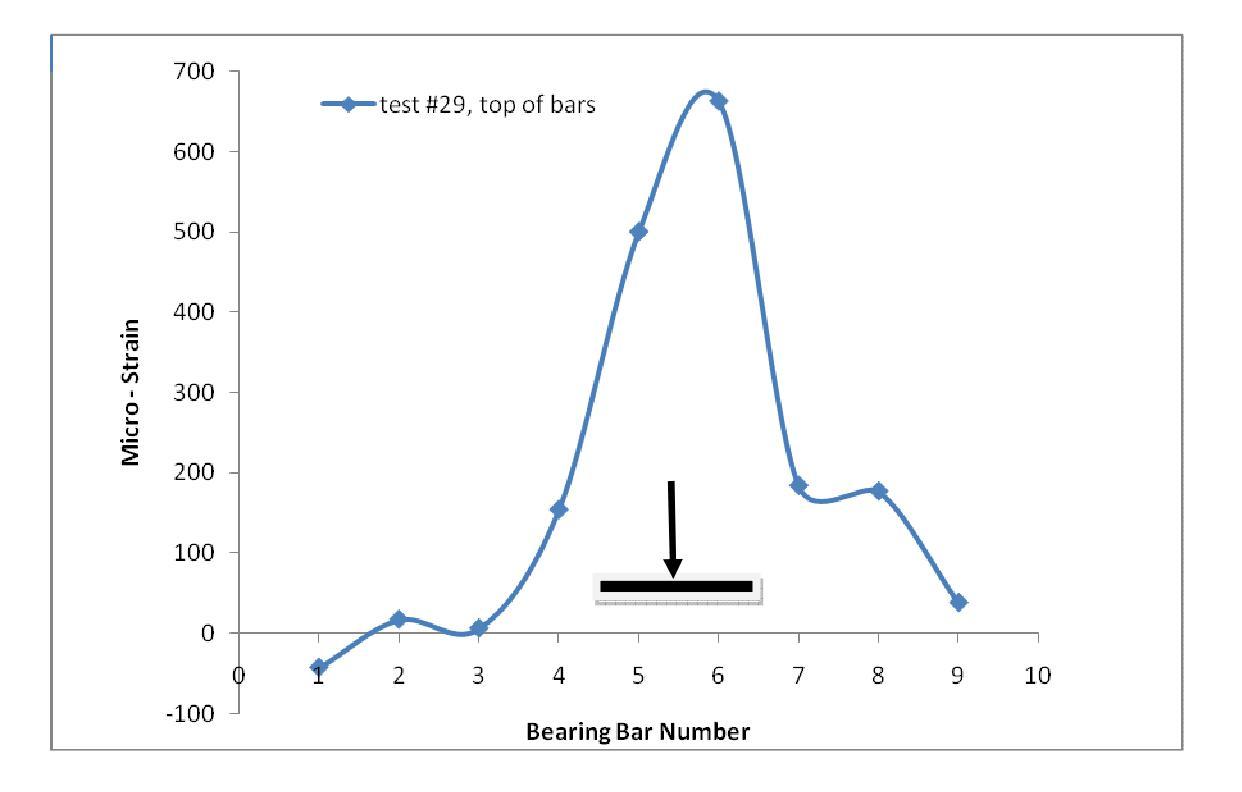
Figure 2: Longitudinal strain distribution across the top of bearing bars in the negative moment region. The 10 inch dimension of the loading plate was centered over bars 5 and 6.

Figure 2 shows the longitudinal strain distribution for the bearing bars acting along the negative moment region of the continuous span. Each of the strains plotted in Figure 2 is from a gage mounted 0.25 in from the top of the bar, oriented in the longitudinal direction. The distribution of strain shown represents an axle load of about 41,600 lbs,

representing a fully loaded H20 truck with 30% impact applied to the wheel loads. The diagram shown in Figure 2 shows the location of the load with respect to each tire patch, centered over bearing bars 5 and 6 near the center of the panel width. From the response shown in Figure 2, it is apparent that most of the resistance is supplied by the bearing bars located directly under the load. The bearing bars adjacent to those under the load participate in the resistance, but to a much smaller extent.

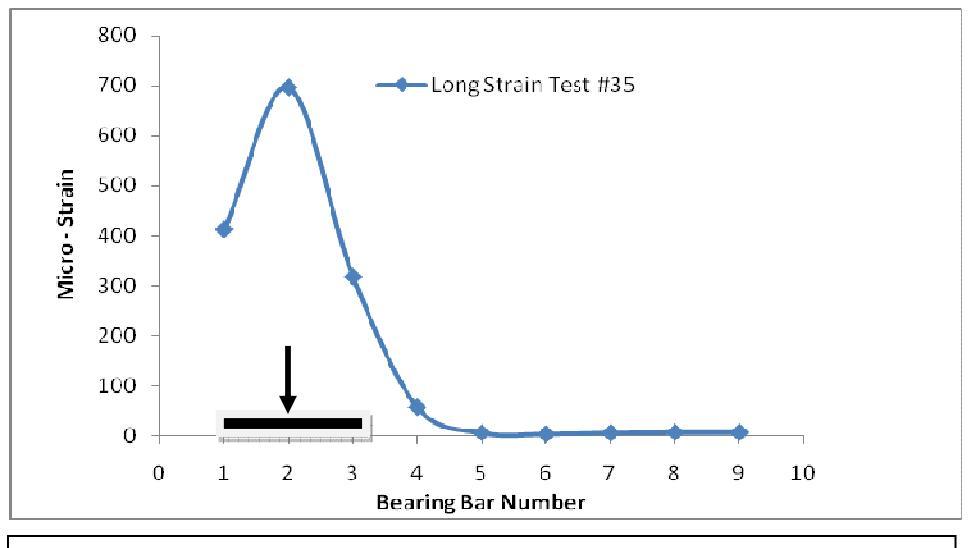
Figure 3: Longitudinal strain under the maximum negative moment with the load applied at the edge of a panel.

Figure 3 shows the longitudinal strain near the top of the bearing bars in the negative moment region when the loading is applied at the edge of adjacent panels. As before, the strains were measured using gages 0.25 inches from the top of the bar oriented in the longitudinal direction. The load was again applied to produce the maximum negative moment. The strain distribution was taken under a load of about 41,600 lbs. With the load applied at the edge of the panel, the maximum response is from the three bearing bars directly under the simulated tire patch.
