**HEAVY MOVABLE STRUCTURES, INC.  
ELEVENTH BIENNIAL SYMPOSIUM**

**In Place Machining of Trunnion Journals  
On Bascule Bridge Rehabilitation**

## Wappoo Creek Bridge

## Wrightsville Beach Bridge

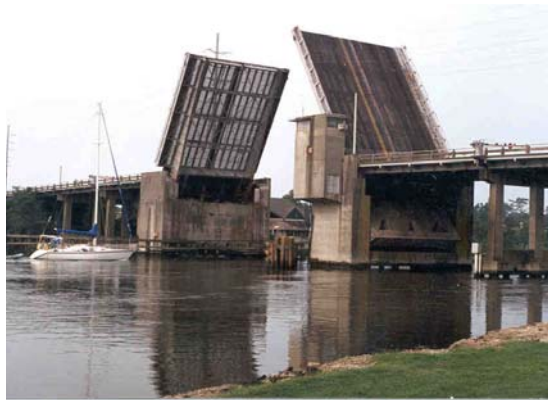
PHOTO 1: General view of Wappoo Creek Bridge prior to reconstruction

Operation of the bridge did not indicate any adverse conditions to the trunnions except excessive clearances were measured. The trunnion bearings as were not disassembled as part of inspection.

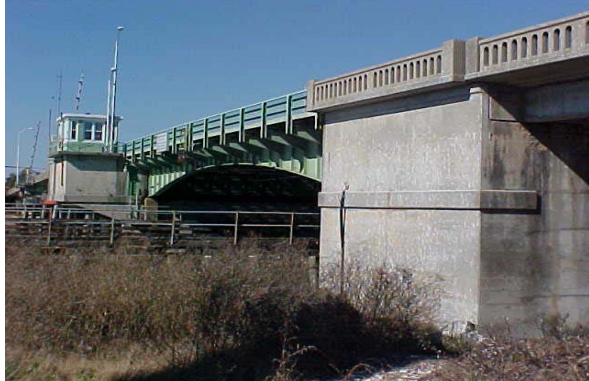
PHOTO 5: General view of Wrightsville Beach Bridge over the Intracoastal Waterway.
