# HEAVY MOVABLE STRUCTURES, INC. ELEVENTH BIENNIAL SYMPOSIUM

# CHALLENGES OF A DESIGN-BUILD BASCULE BRIDGE REHABILITATION

Caleb Linn PCL Civil Constructors, Inc.

The NE 14<sup>th</sup> Street Causeway (Figure 1) is a four lane, two span hydraulic bascule bridge carrying traffic over the Atlantic Intracoastal Waterway in Pompano Beach, Florida. In March of 2005, the Florida

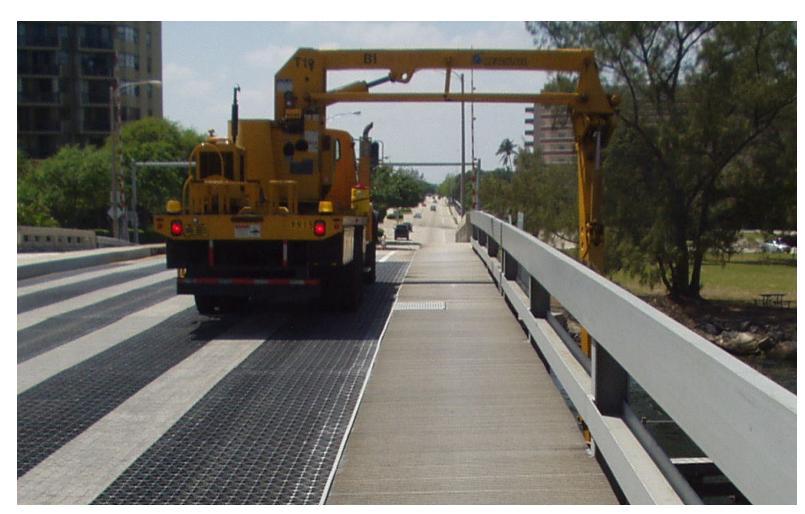
With a preliminary design complete, the team performed a field verification of existing conditions by the use of a snooper truck provided by the Department during a six hour inspection (Figure 3). In the teams review of project documents, two areas of concern were highlighted: the floor beam to main girder connection and the sidewalk bracket to main girder connection. During the inspection, the team concentrated on these areas to determine an appropriate scope of rehabilitation. As the owner did not allow destructive testing of structural members, it was difficult to ascertain the extent

Figure 3. A snooper truck is utilized to inspect connections.

of deterioration located beneath the plates and angles connecting the members to the main girder. The design was completed based on the visual inspection of the members.

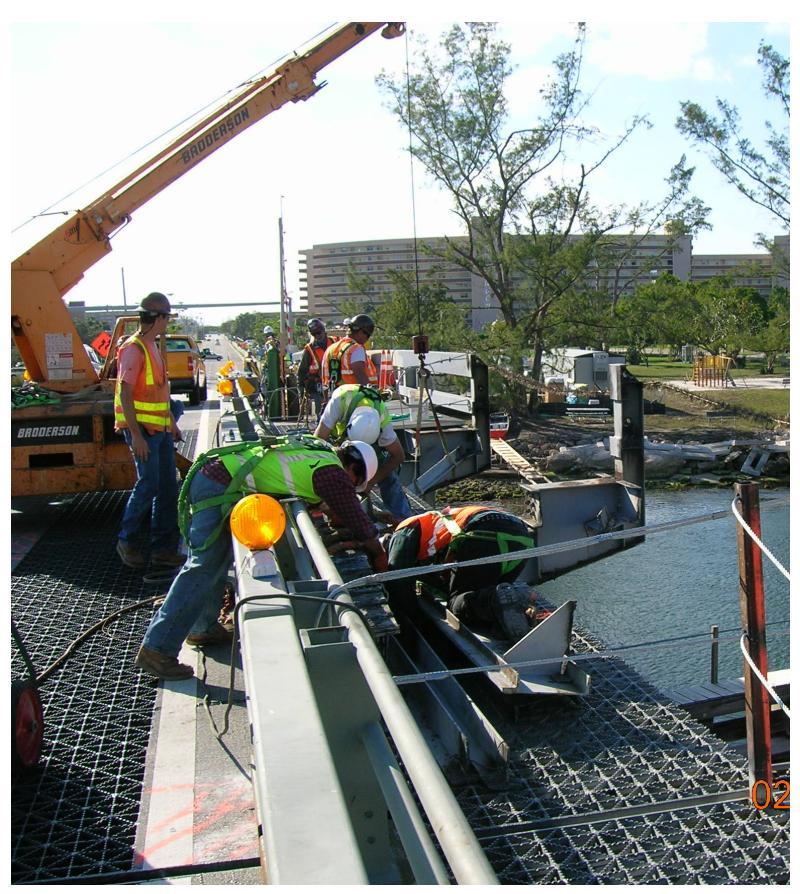
Figure 8. Ironworkers anchor down pieces of steel removed from the bascule span to maintain longitudinal balance of the span.

Along with anchoring the steel to the span, vehicular traffic had to be protected from the temporary weight; therefore the steel would have to be placed behind the temporary traffic barrier in a 5 ft. wide area (Figure 8).

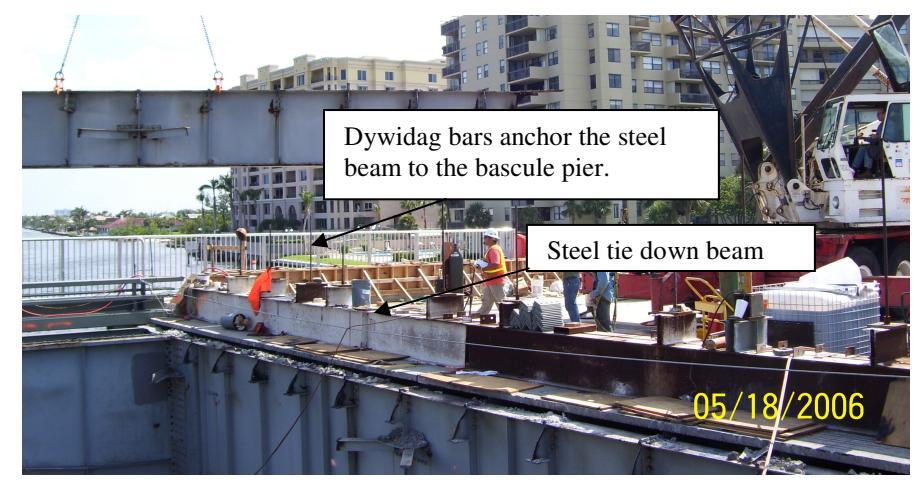
Figure 9. Existing steel is removed. The tie anchors the span in the down position.

known, the tie down system was designed for the structure and, once in place, balancing of the span would not be a concern (Figure 9).

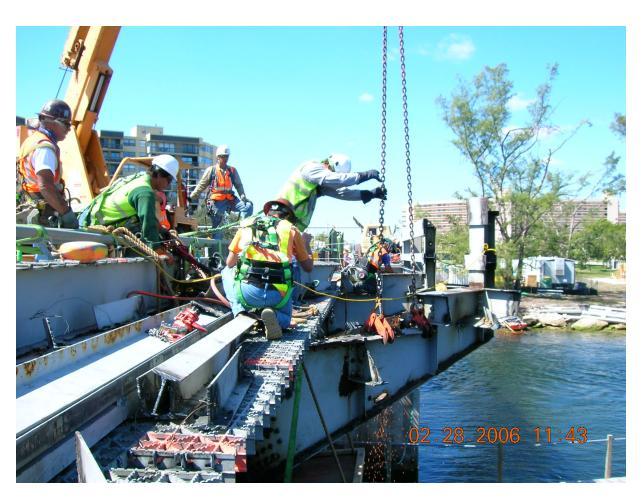
Figure 13. The team removes the first sidewalk bracket.

Upon arrival of the first steel delivery and completion of the temporary steel barrier, the team began demolishing the existing sidewalk components on the north span. The first existing sidewalk bracket was removed on Feb. 28, 2006 (Figure 13). After removing the bracket, an ironworker pointed out severe deterioration (100% section loss) on the main girder, which had been hidden by connection plates (Figure 14a and 14b). The superintendent requested the Project Engineer and Project Manager to examine the deterioration to determine if there was cause for concern. Because the point of deterioration was located where the fracture critical floor beam framed into the main girder, PCL contacted the owner (FDOT) and the Engineer of Record (H&H) to request an investigation into the extent of deterioration. The

group conducted multiple visual inspections revealing flexing of the girder web and severe deterioration on the fracture critical weld connecting the floor beam to the main girder. As a result of the investigation, the bridge was immediately closed to vehicular traffic to ensure the safety of the public was not compromised.

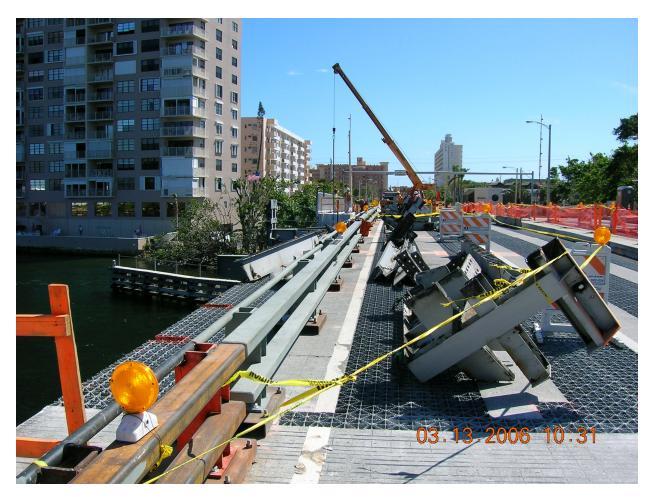
- Modifying the schedule to remove the entire sidewalk components at once meant anchoring down a large quantity of temporary weight to the span, on both the north and south (Figure 15). This temporary weight would have to be removed, or relocated behind temporary barriers before reopening the bridge, which would be challenging due to the minimal space.
- 2) To remove the temporary weight from the spans, the new steel would need to be installed to maintain the balance. The new brackets could not be reinstalled until a repair procedure was created and the material procured.
- 3) The schedule for steel delivery did not require steel for the south to be delivered until March 20, 2006. This steel included the temporary traffic barrier required for the removal of the existing material.

Figure 15. Existing sidewalk components placed on roadway for temporary weight.

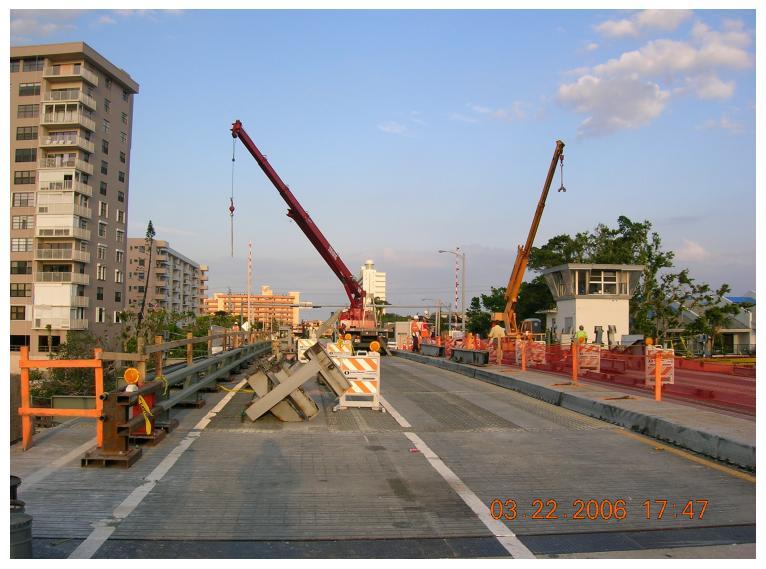
Figure 16. An additional crane is brought to the site to allow work on the north and south simultaneously.

The next milestone was to set a date which to have all sidewalk bracket locations inspected and repair plate material procured and installed. Based on material delivery, the team set a date of March 28, 2006 to have the north and south main girder remediation completed to allow reopening of the bridge to traffic by March 29, 2006. The team new this would be challenging as it meant double the scope of work (removing and replacing both the north and south sidewalks) would be completed in the amount of time originally slated to reconstruct only one side. To accomplish this task, an additional crane was brought to site (Figure 16) to allow work on each side simultaneously. The ironworkers were split in to two teams to work on each

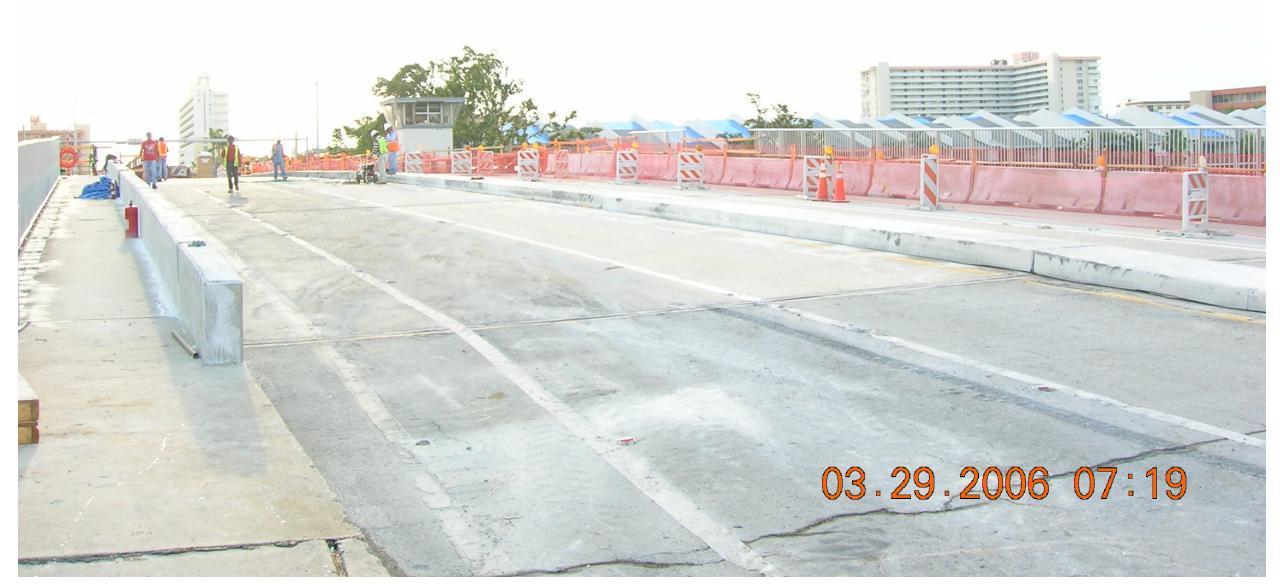
side, and worked extended shifts to make up for the smaller crew size. The team was able to complete the required repairs by March 28, 2006, and the bridge was safely reopened to vehicular traffic on March 29, 2006 (Figure 17).

Figure 17. The roadway is cleared for the reopening of the bridge on March 29, 2006.

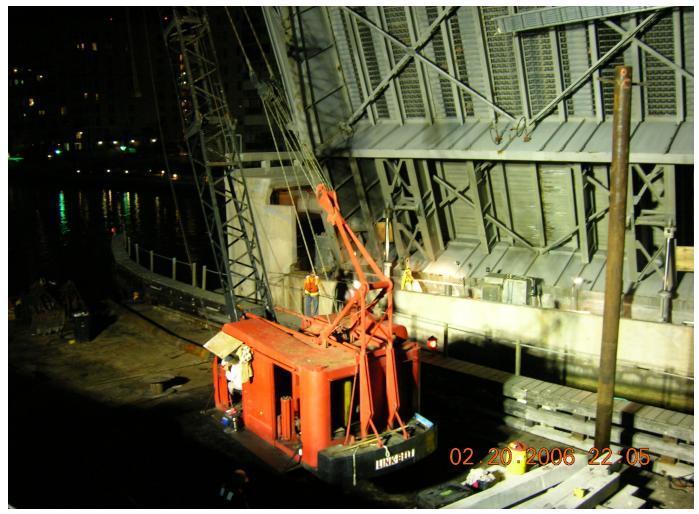
Figure 18. The barge is positioned to allow removal of two cylinders on the west span.

The first four cylinders (two from each span) were schedule to be removed Feb. 20, 2006 during a one night closure. During this one night closure, a crane on barge was brought to sight to remove the cylinders (Figure 18). To allow the cylinder removal to occur within one night, the cylinders were disconnected and un-pinned prior to the night closure. This allowed the team to remove four cylinders, two from each span, in only five hours.

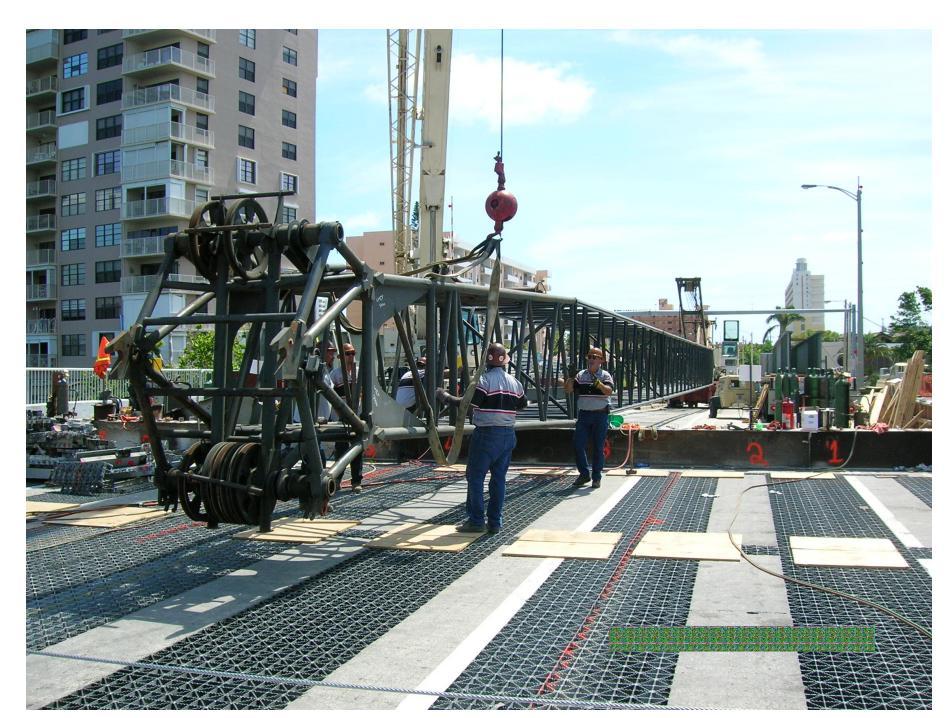
Figure 24. The last piece of crane boom is connected on the east span of the bridge.

The crane was set up and the tie down installed by the end of the second day (Figure 24). The team began removing the first piece of grating that night (Figure 25). The team worked through construction one bay at a time. In order to keep the force on the tie down below its capacity, the new steel was constructed after each bay was demolished (Figure 26). During the reconstruction of the roadway steel, various unforeseen conditions had to be dealt with. In order to expedite resolving these issues, Hardesty and Hanover made site visits whenever

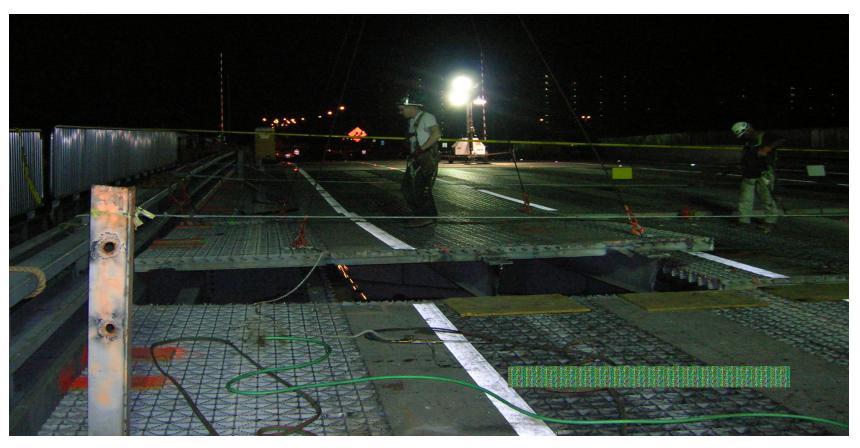
Figure 25. The first piece of deck grating is removed the second night.

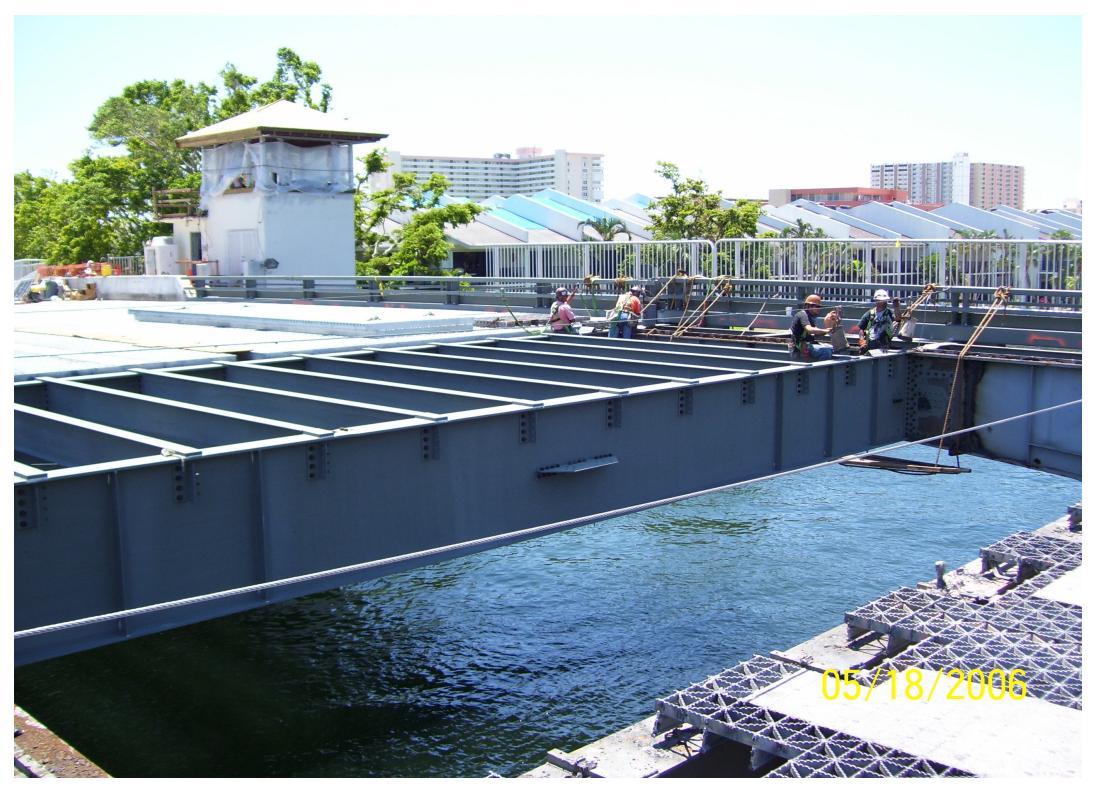
Figure 26. Bay 1 steel is erected after bay 2 was demolished.
