HEAVY MOVABLE STRUCTURES, INC. THIRTEENTH BIENNIAL SYMPOSIUM

Link Arm Repair and Counterweight Hanger Fatigue Strengthening for Long Island's South Shore Bascule Bridges

Ronald Kudla, P.E. NYSDOT Director of Bridge Maintenance for Region 10

> Dennis Biegel, P.E. STV Incorporated

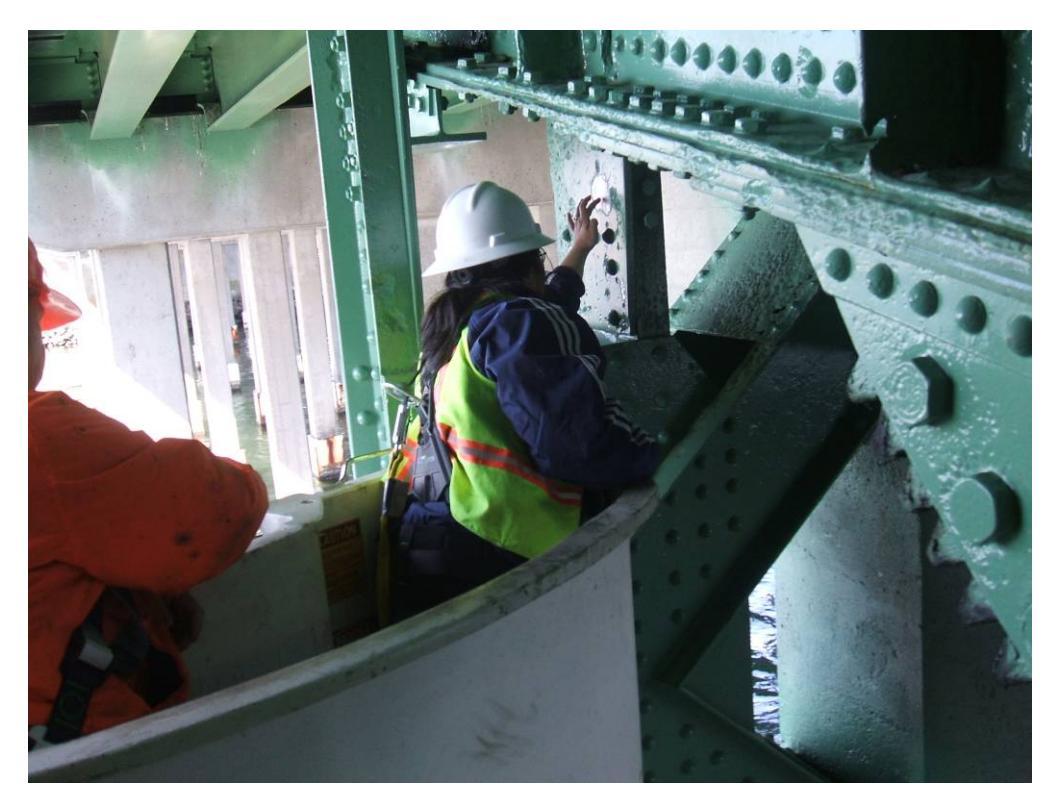
It was also noted during a site visit that the Loop Parkway bascule does not rotate open and closed perfectly vertically, resulting in rubbing contact at the flower boxes. This suggested the possibility of outof-plane bending of the counterweight hanger plates, which are historically fatigue-prone elements. One uncovered nuance to the counterweight hanger bending stresses are that the bearings tend to go out of round as the bridge ages and the bridge develop a 'nested' position. This keeps the bending stresses in the hangers at their maximum load throughout travel instead of dropping off as soon as starting friction is overcome and the much lower running friction values dominate. This possibility prompted the Region to have strain gages installed on the hangers and record strain readings through a series of test operations. The results of this testing was compiled and analyzed by another consultant. Their conclusion was that the hangers had reached the end of their service life.

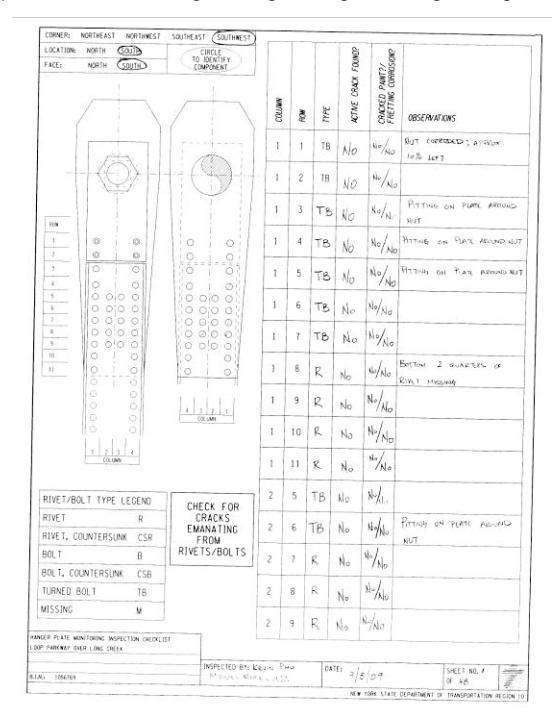
The earlier report issued by another consultant which concluded that the hanger plates had reached the end of their expected fatigue life dictated that some form of remedial action be taken. The extreme solution of replacing the hanger plates was not seriously considered. Overall, the Loop Parkway over Long Creek structure is nearing the end of its useful service life and the cost of replacing the hangers entirely was not viewed as a prudent investment. Under the assumption that this structure would be programmed by NYSDOT for replacement in a ten to twenty year time frame, a strengthening of the hangers was determined to be the preferred option.

A requirement of any repair work was that roadway traffic be completely removed from the bridge during the work. This would facilitate the extensive field drilling and reaming operations that would be required as part of almost any repair option.

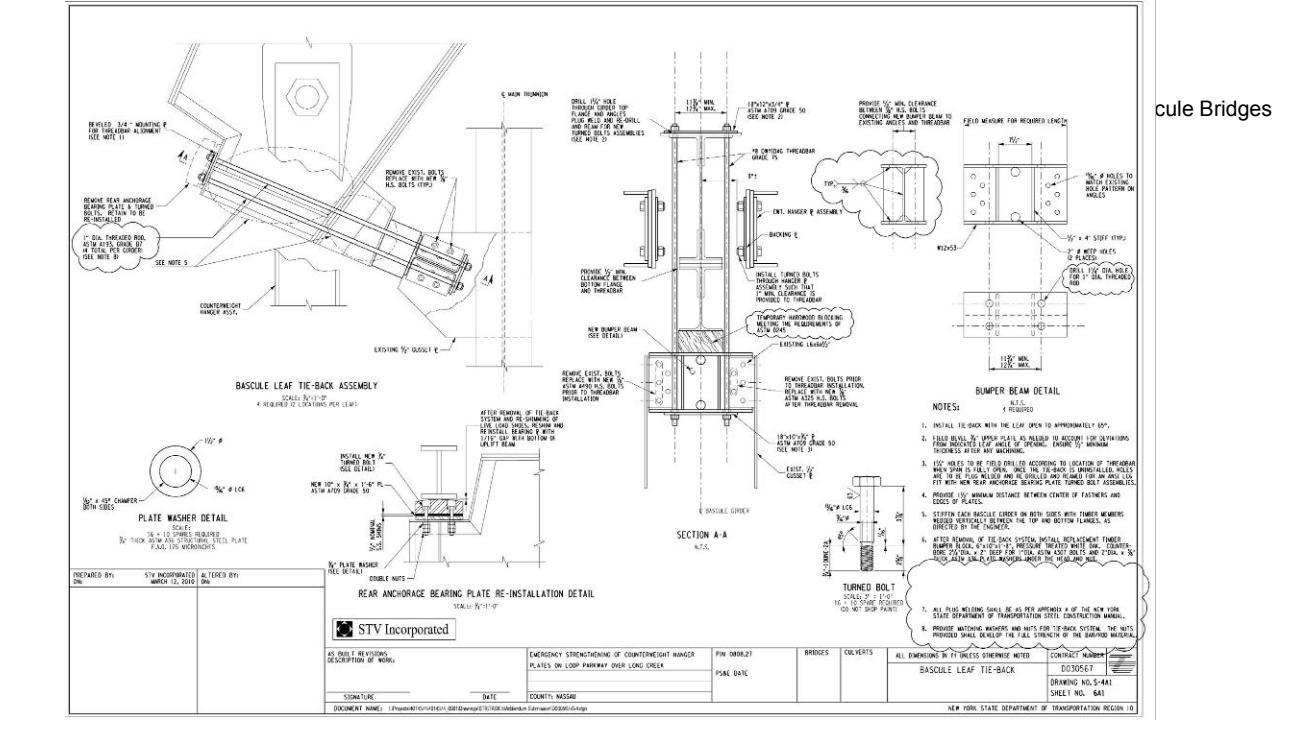
Perhaps the key question the design team faced early in the process was that of how much dead load the repair would relieve from the existing hangers. The STV team and the Region's staff initially investigated the possibility of having a repair almost completely support the weight of the counterweight with minimal contribution from the existing hanger plates. Such a system would entirely bypass fatigue sensitive areas of the existing hangers and would place the load through members with no cyclic loading history. This approach would restore much of the hanger system's original service life capacity. The method of support envisioned for the counterweight involved using a series of synchronized twenty ton jacks from the bascule pier. After considerable study, this proved to be extremely problematic. The issue was that under certain wind cases, uplift at the rear trunnion columns was possible. A number of solutions were considered, including parking a series of fully loaded cement trucks on the flanking spans during the work to replace the dead load from the counterweight.

This issue caused the design team to "take a step back" and take a fresh look at the strengthening. The result was a change to the philosophical approach to the problem. Given the anticipated remaining service life of the structure, there was no good justification for providing another half century or so of fatigue life for the hangers. Instead, the repair could transmit only a small, nominal amount of counterweight dead load and serve as a "back-up" to the existing hanger plates should they begin to develop fatigue cracks.
