## HEAVY MOVABLE STRUCTURES, INC. 16<sup>th</sup> BIENNIAL SYMPOSIUM

# Main Street Bridge Vessel Impact, Analysis and Repairs

Mario R. Palumbo, P.Eng, The St. Lawrence Seaway Management Corporation David Marcic, PE, Hardesty & Hanover, LLP

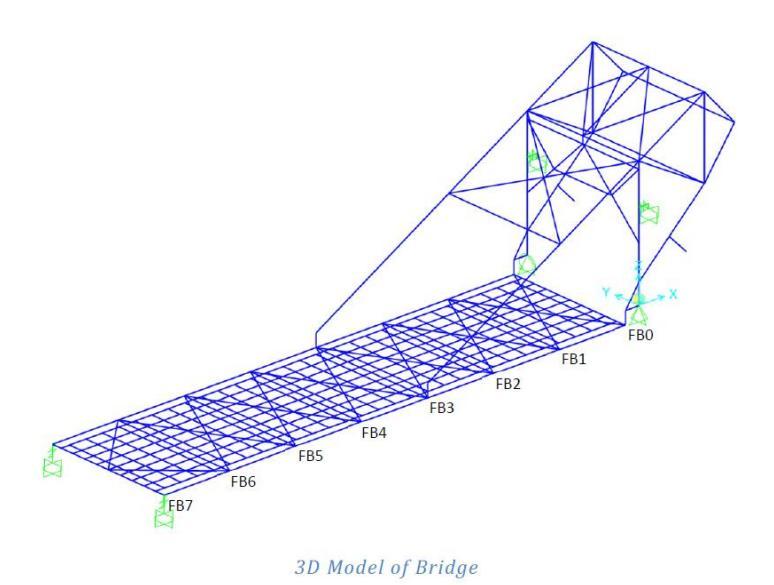
The purpose of this analysis is to evaluate the structural adequacy of the bridge under various loading conditions including dead, live, wind, and seismic loads. The analysis included the following: a live load rating of main floor system members for standard trucks as determined by CAN/CSA-S6-06 Bridge Code, and a wind and seismic evaluation of all members. Results of the analysis were used to determine bridge deficiencies, and provide recommendations for retrofit or repair.

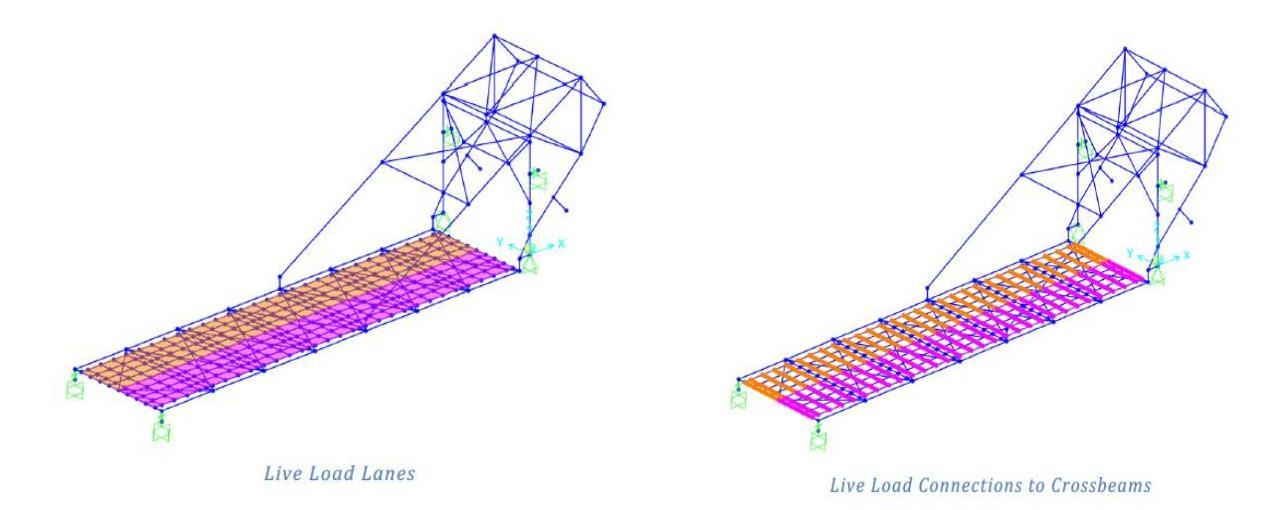
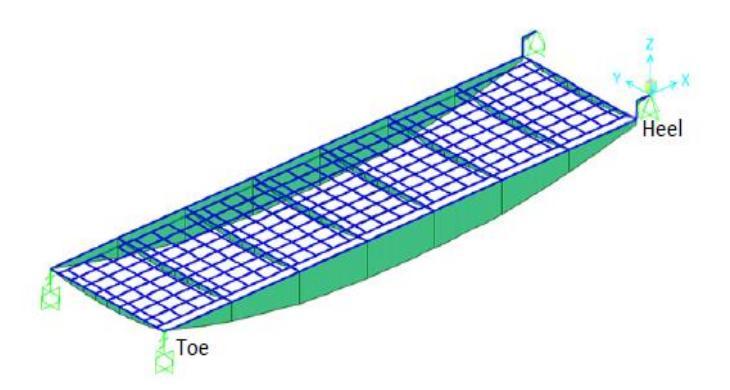
Bascule Girder Live Load Moment Diagram

For Bridge 19, it was determined that all main members including bascule girders, floor beams, stringers and crossbeams have a live load rating factor, F, greater than 1.0, and are therefore sufficient for use by normal highway traffic.

It was recommended that continued routine inspections of the bridge be performed and section loss and deterioration recorded, to be used for future load rating updates.

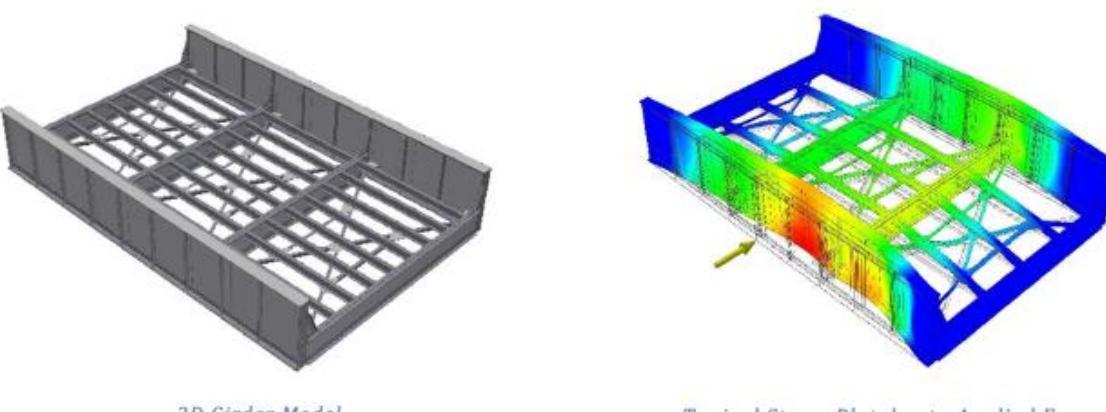
3D Girder Model

Based on the damage that was observed during the inspection, the theoretical force that just slightly overstressed the bracing in Bay 1 and 2 was 800kN (175 kips) which represents a reasonable upper-bound estimate for the actual ship impact force.

This force distribution and the anticipated effects on the respective members correlate with the findings observed in the field.

Typical Stress Plot due to Applied Force

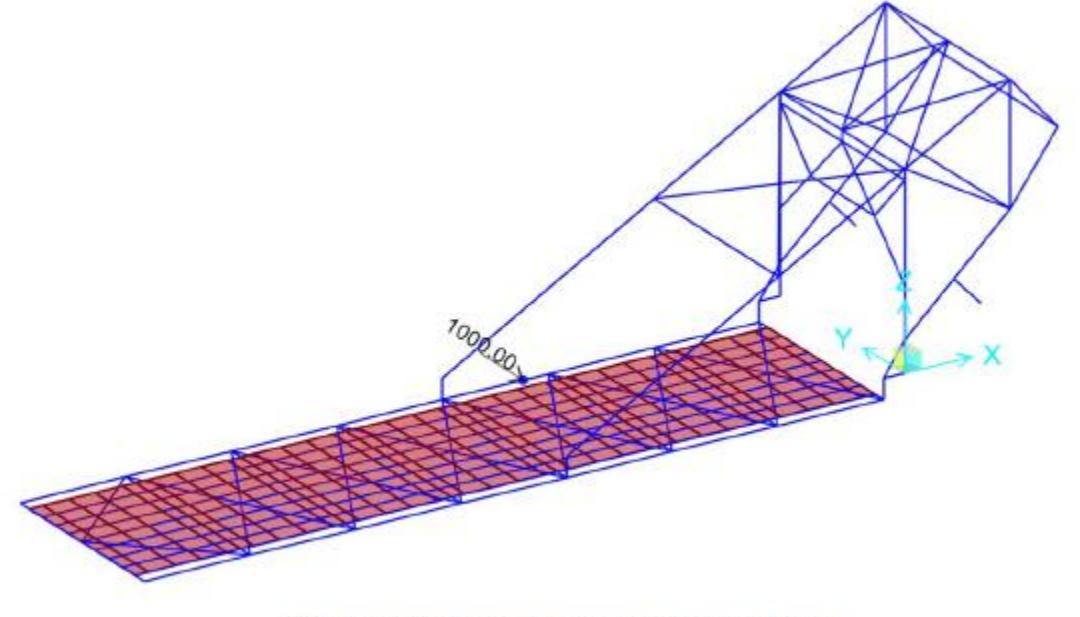
Ship Impact Force Applied to Global Model

The localized concentration of the deformation was simulated as a single concentrated force. The results of the analysis indicates that the ship impact forces would have been on the order of 5,000kN (1,000 kips) or greater.

When this impact force was applied to the global model it revealed that many of the bridge members, including bracing, floor beams and stringers would have also been damaged as a result of the impact. However, these findings do not correlate with the damage that was observed by the in-depth field inspection. These conflicting findings indicate that there was more force distribution and dampening in the structure than what the 3D analytical model displayed.

A large portion of the energy from the impact was likely dampened during the deformation of the girder and therefore not distributed throughout the structure as is predicted by the model.

Straightening the bascule girders is not required for strength purposes and if left in its current condition will not have any negative long term residual effects. It was recommended that the local damage to the bascule girders be repaired, as well as replacement of bottom lateral bracing between the heel floor beam FB0 and floor beam FB3. I

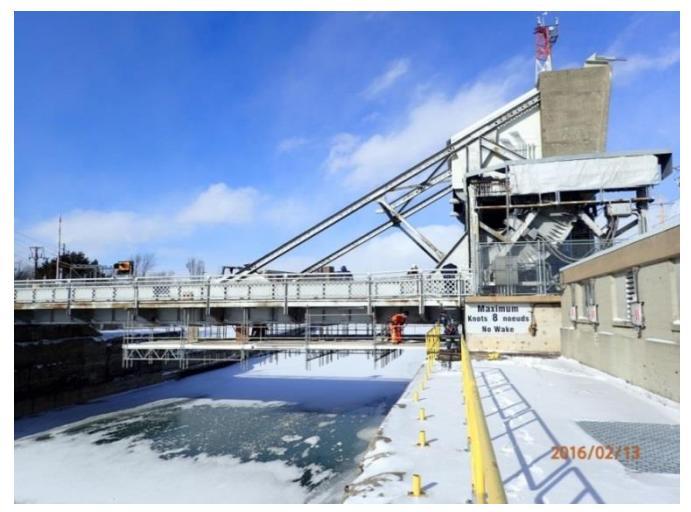
Scaffolding Installed

Scaffolding under the bridge deck was first installed to gain access to all the damaged areas. The majority of the repair work involved removing a section of the North main girder. In order to maintain the North girder as a tension member, the bridge overhead counterweight was jacked to have it act as a simply supported structure, and top and bottom of the girder was jacked in compression and tension respectively.

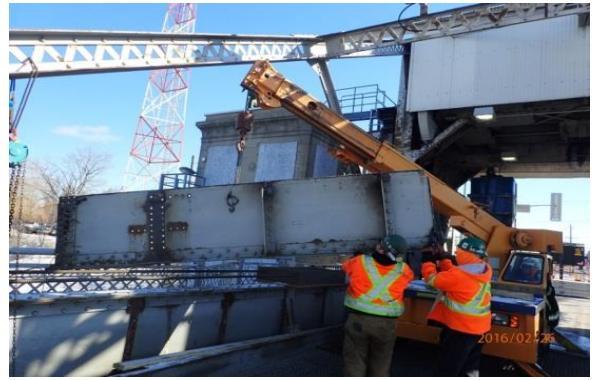
Top view of bridge with section of North girder removed.

Two 4-inch diameter holes were cut at each corner and the girder section was cut and removed in two pieces.

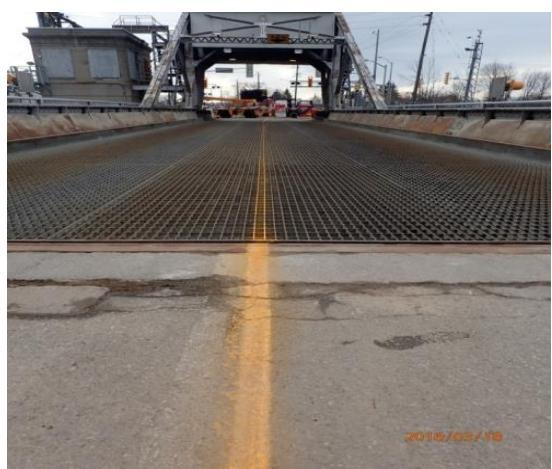
Road Line Repainted

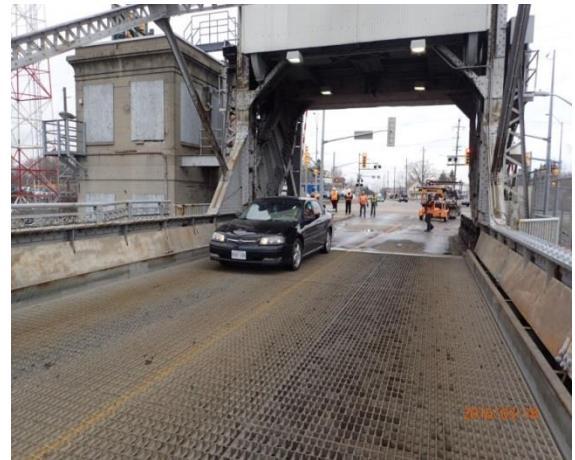
First Vehicle to Cross the Bridge After Repairs
