HEAVY MOVABLE STRUCTURES, INC. SIXTEENTH BIENNIAL SYMPOSIUM

Mechanical Rehabilitation of the Houghton-Hancock Vertical Lift Bridge

Andrew M. Brodsky, P. E. Reid C. Hoffman, P.E. Modjeski and Masters, Inc.

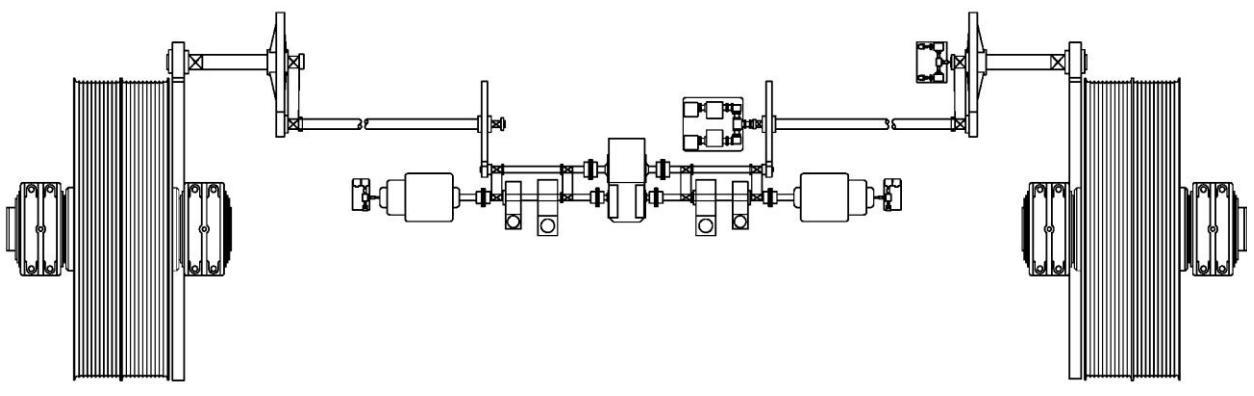
Figure 3: General Machinery Layout

To achieve good load sharing with the existing machinery configuration two possible options were explored. The first option was to alter the engagement (center distance) of the final pinion with the rack in order to increase or decrease the backlash at the final tooth mesh. Any movement of the final pinion would also affect the previous gear sets because the existing gearing is mounted in union style plain journal bearing housings. Adjustment to the engagement of the final pinions was ruled out because it

replacement of the subsequent open gearing was considered during the preliminary design, but the configuration of the existing motor and machinery brakes, along with the costs associated ruled out this option. The solution to allow indexing between corners utilizes a new indexing coupling on one primary reducer output shaft (per tower). This new indexing coupling was a custom double engagement gear coupling with a shrink disc on one side to allow for infinite adjustability of the corner to corner indexing of the machinery. A new shaft was also included in the design to use with the new shaft indexing coupling. The new indexing coupling was included as part of the advanced material procurement contract with pilot-bores in each coupling half. The general contractor for the main construction contract was responsible for measurement of the exiting components to provide final bore dimensions to the coupling manufacturer for final machining of the couplings.

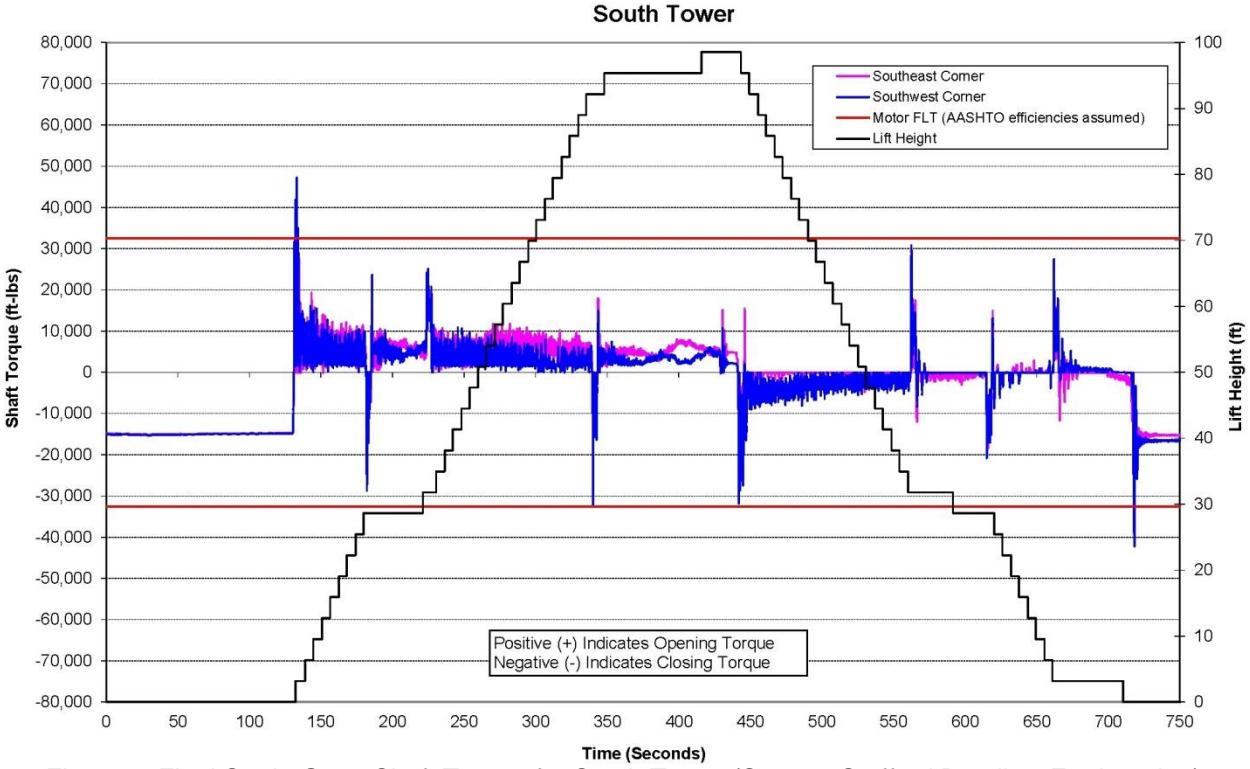
At the start of the construction contract the lift span was approximately 11,500 pounds span heavy per tower with a significant transverse imbalance biased towards the east side of the lift span. The bridge has had a history of trouble seating on both the pier seats and intermediate seats. This construction contract included work to address the balance condition of the lift span, machinery indexing, live load shimming and poor seating characteristics of the bridge. The contract required the final balance condition of the bridge to be between 4,000 and 6,000 pounds span heavy per tower. Additionally the machinery indexing adjustments required a final maximum torque split of 60 percent to 40 percent at the final balance condition.

Final Bridge Balance Condition (Fully Seated at Lower Seats)				
	East Corner	West Corner	Split	Total Imbalance
North Tower	2,317 lbs	3,149 lbs	42%/58%	5,466 lbs
South Tower	2,357 lbs	2,989 lbs	44%/56%	5,345 lbs

Figure 5: Final Strain Gage Shaft Torque for South Tower (Source: Stafford Bandlow Engineering)

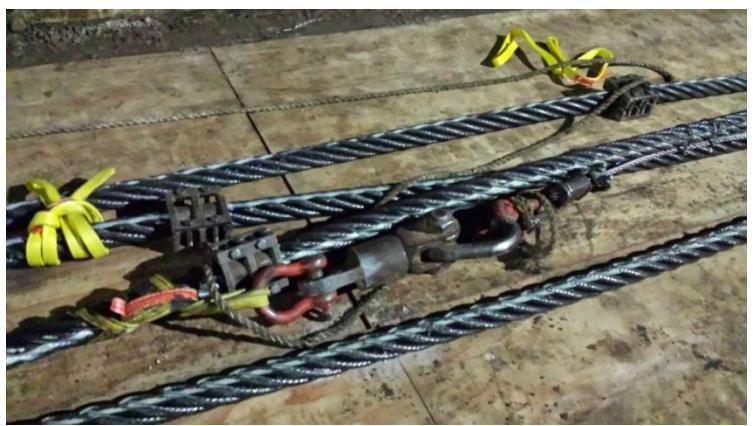
Photo 10: Tugger Connection to New Wire Ropes for Rope

shutdowns. One for unloading of the existing wire ropes, and one for reloading of the new wire ropes after making the lift span side connection. The recommended procedure also included a single lane closure for removal of the existing wire ropes one at a time after cutting the rope above the counterweight side block socket. A temporary tugger line connected to an air tugger was to be used to lower each existing counterweight rope down to the roadway level. A similar procedure was recommended for hoisting the new counterweight ropes over the sheave to make the counterweight side connection. The recommended procedure only required the bridge to be closed to vehicular and snowmobile traffic for two overnight periods and allowed the remaining rope removal and installation work to be completed with only short vehicular traffic interruptions.

ZTI elected to use a procedure for wire rope removal and installation similar to the recommended procedure provided in the Contract Plans, but did not cut each counterweight rope on the counterweight side. An air tugger mounted to a truck was used to lower the existing ropes and hoist the new ropes from the top of the lift span deck. An auxiliary air tugger was mounted in the machinery room to assist with control of the rope over the sheave on the counterweight side of the sheave. Each existing counterweight rope was attached to the tugger line with a double choked nylon strap. Fabricated "cable stop clamps"
