HEAVY MOVABLE STRUCTURES, INC.
12TH BIENNIAL SYMPOSIUM

REPLACEMENT OF SPHEROIDAL TRUNNION BUSHING
ALFORD STREET (STATE ROUTE 99) OVER MYSTIC RIVER

Edward M. Long, P.E.
Hardesty & Hanover, LLP

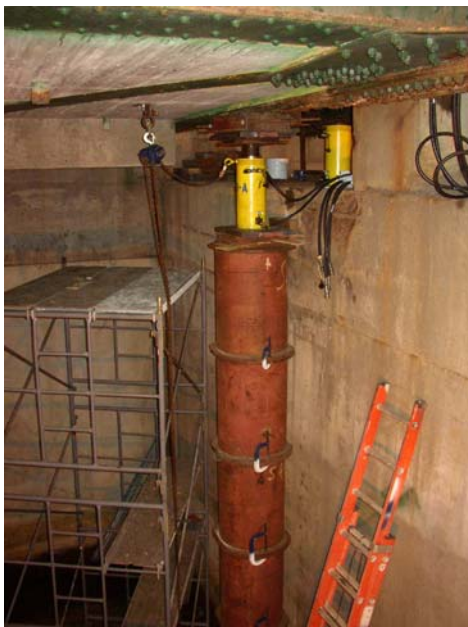
The first step in the replacement operation is to remove the trunnion cap, to expose the spheroidal bushing, and jack the bridge sufficiently to expose the full outside diameter of the bushing for measurement (a minimum of 3/8 inch is required to clear the outside diameter of the micrometer and mandrel). The jacking point for lifting the bridge is the timber bumper block located on the bottom flange of the main girder. A 200-ton jack was used to elevate the 650-ton leaf.

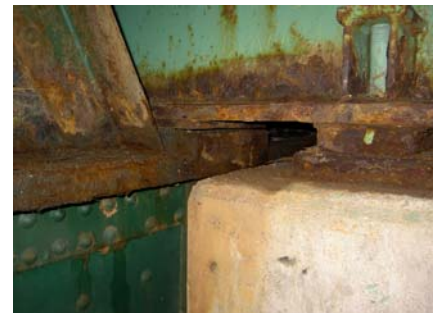
Typical of Hopkins Trunnion Bascules, the bridge is equipped with sliding lock bars at the draw crack, forward live load shoes and rear main girder shoes. The rear main girder shoes are located directly below the crossbeam that supports the deck over counterweight. The original design clearance for the rear main girder shoe and strike plate, located on the bottom flange of the crossbeam is 1/32 of an inch. This minimal clearance requires a steel shim plate be installed between the forward live load shoe and strike plate,

rotating the span around the trunnion, and increasing the clearance at the rear main girder shoe. A shim plate of 1/2 inch thickness

increases the clearance to approximately 3/8 inch. The shim plate also raises the toe of the leaf at the draw crack approximately 3-1/2 inches.

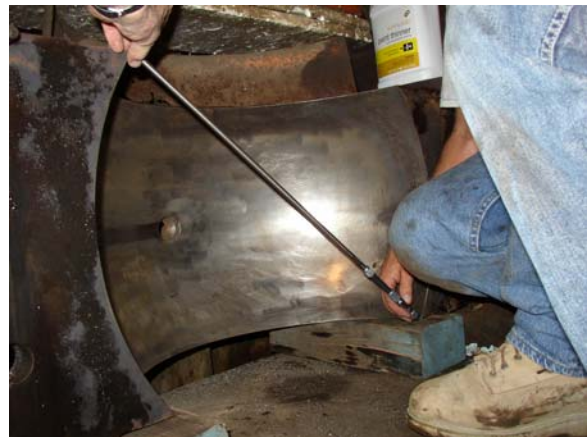
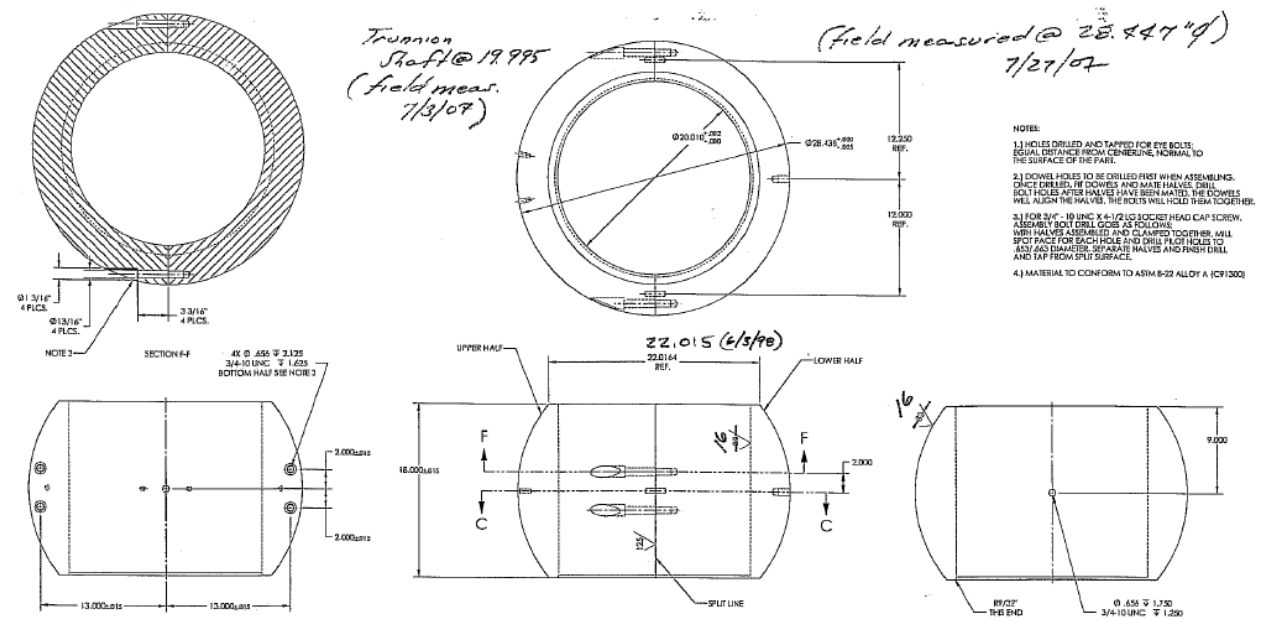
Tribology Tech Lube T-1000 was placed in the bottom half of the trunnion bearing while the bushing was elevated for measuring. After reassembly, lubricant was poured through the boss in the top cap and into the drill hole in the bushing formerly occupied by the lock screw. It was anticipated that some of this oil lubricant would disperse along the interface of the bushing and the casting, and spill out and reach the lower half of the trunnion assembly during operations

for navigation. The on-call maintenance contractor was directed to refill the makeshift oil reservoir every other day.

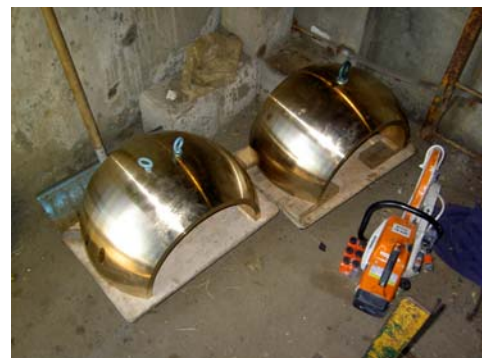
Jacking the span, to relieve dead load from the bushing, was the first step. A ½ inch steel shim was again placed between the live load shoe and the strike plate, and two small 20-ton jacks placed in a temporary jacking frame located at the draw crack. These jacks would permit making small adjustments to span alignment, simplifying removal of the old bushing, and

installation of the new bushing, without damage to the bushing or the bearing assembly.
