Replacing the Counterweight Trunnion Bearings in a Strauss Bascule Bridge Burnside Bridge Reconstruction Project – Multnomah County, Oregon

Jon Henrichsen, P.E., Chuck Maggio, P.E., Ed Wortman, P.E., Tye Aldana, P.E.

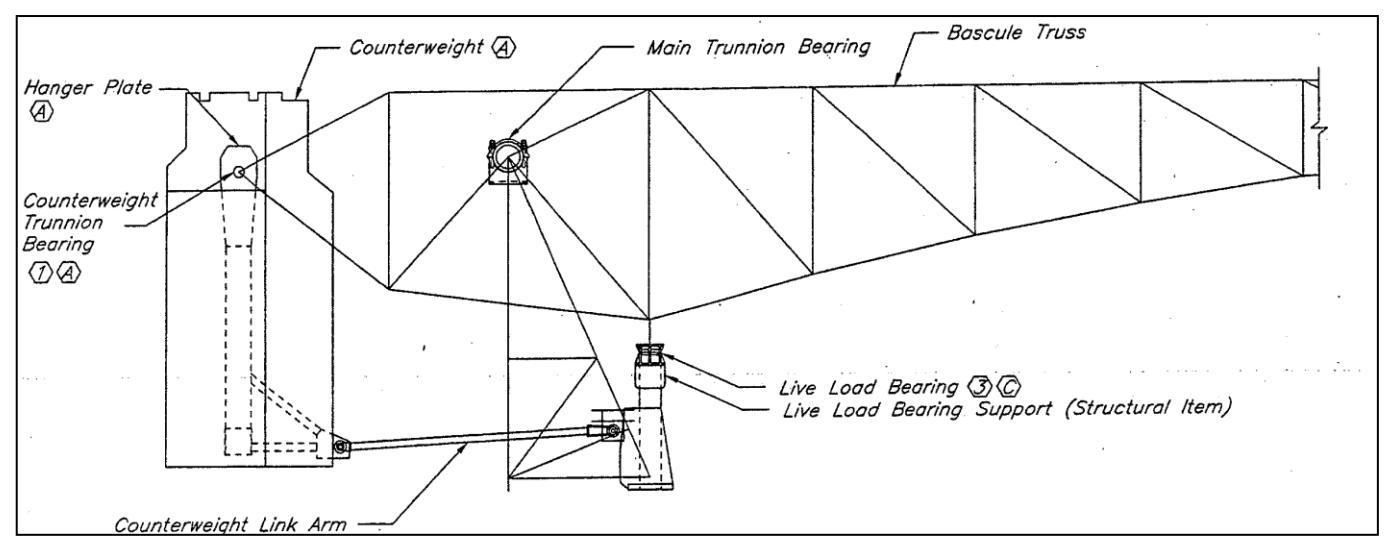
Figure 1: Elevation of Burnside Bascule Span

The east leaf of the Burnside Bridge had been operating at about half the speed of the west leaf since at least the late 1990's, possibly before. Because of the unique configuration of the Strauss trunnion style bridge, a number of elements were identified as being the likely source of the slow movement. They are labeled in Figure 1 and/or listed below.
