**HEAVY MOVABLE STRUCTURES, INC.
SIXTEENTH BIENNIAL SYMPOSIUM**

**Strauss Heel Trunnion Repairs
Jacksonville Bridge**

Geoffrey L. Forest, P. E.
Modjeski and Masters, Inc.
&
Michael Collier, P. E.
Scott Bridge Company

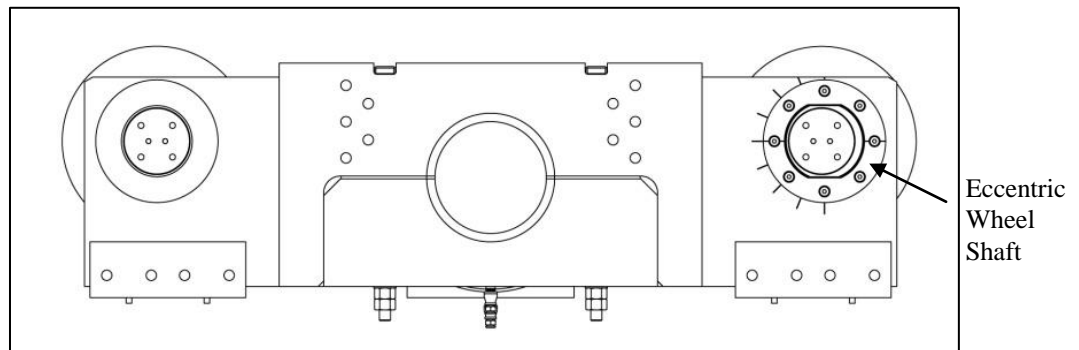
Figure 5 - OSG Lower housing the eccentric shaft

could then be placed onto the ends of the axles and keeper plates installed to hold each roller on its axle. Also, the original OSG had no provision for adjusting the engagement between the rack and pinion gearing. To accomplish this adjustment, one of the lower roller shafts was made eccentric. Rotating the shaft within the lower housing adjusted the center of the roller vertically, which dictates the vertical position of the rack gear, with respect to the pinion (see Figure 5).

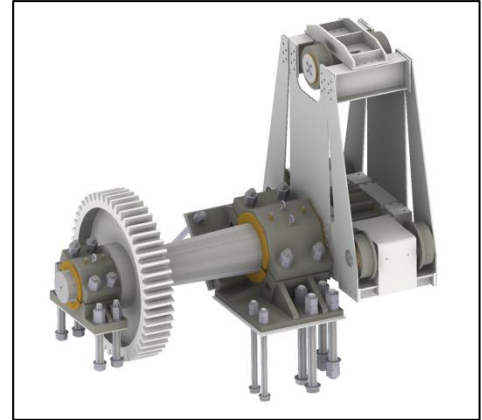
Figure 6 - General view of new components

In the end, the original operational intent of the guide assembly was retained, but maintainability and ease of adjustment and future part replacement was improved (see Figure 6).

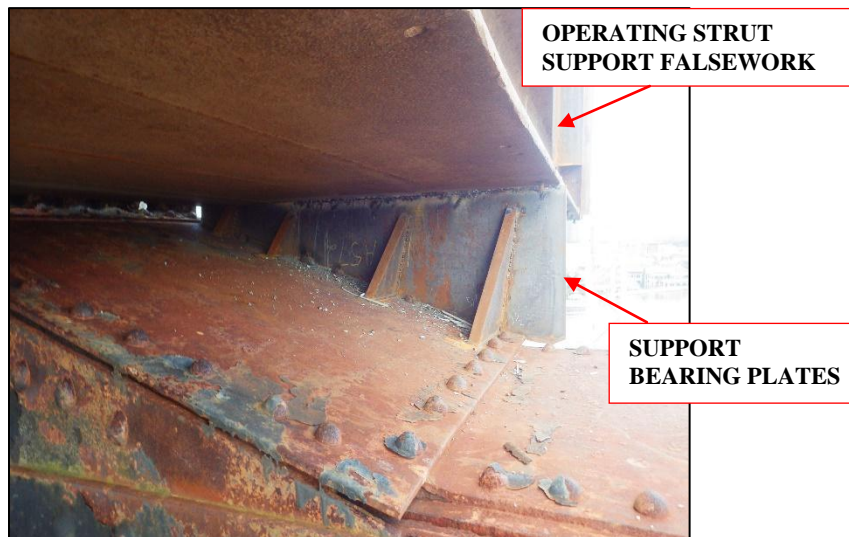
Photograph 4 - View of the bearing plates that were welded to the top of the counterweight truss to support the operating strut falsework

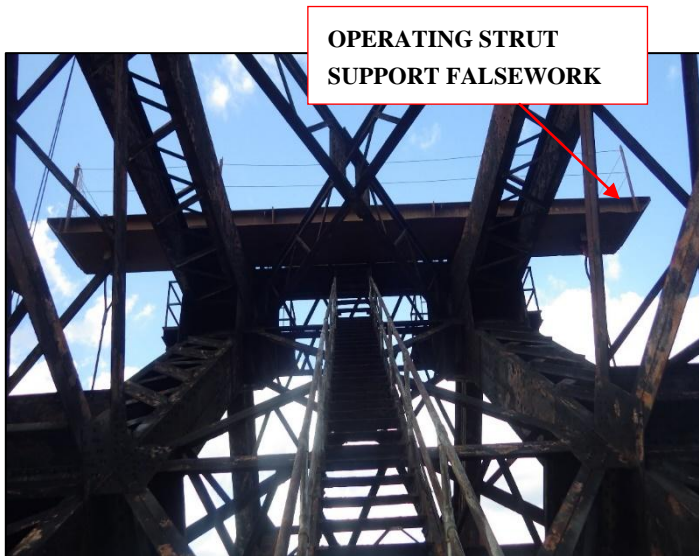
Photograph 5 - View of the falsework installed at the top of the counterweight tower to support the operating strut during the repairs.

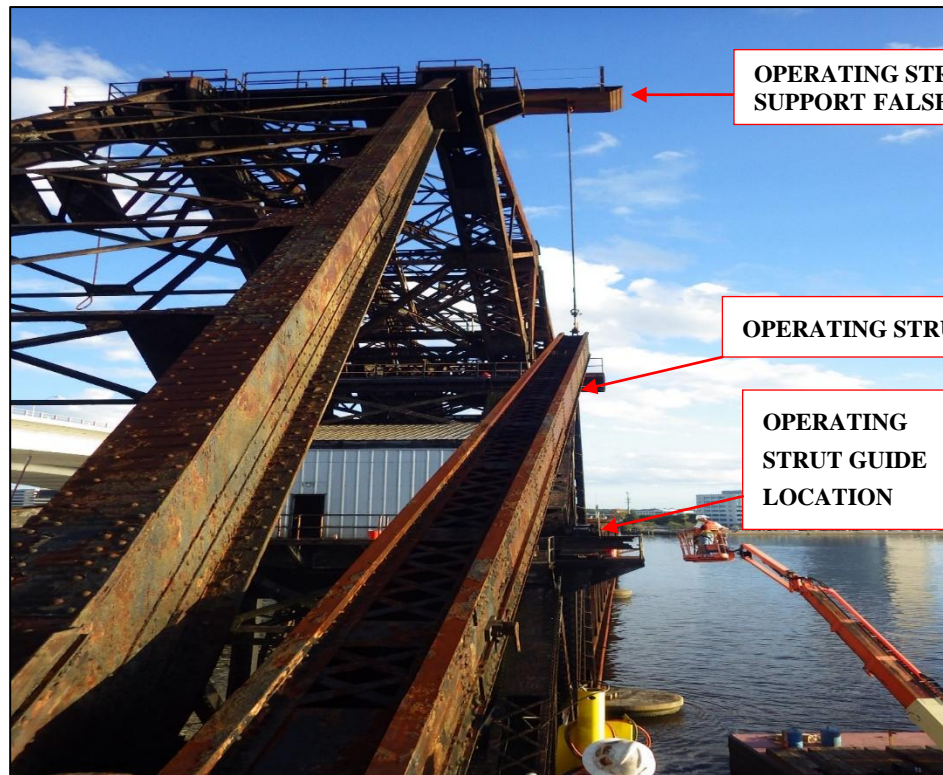
Photograph 6 - View of the operating strut hanging from the falsework

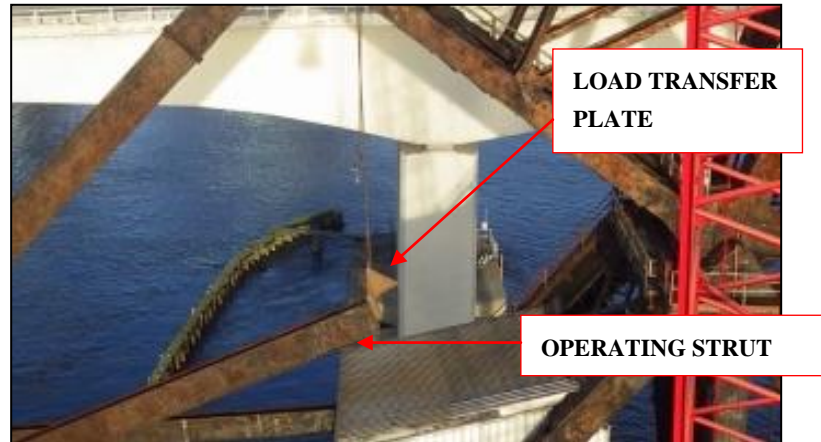
Photograph 7 - View of the load transfer plate used to support the operating strut from the falsework

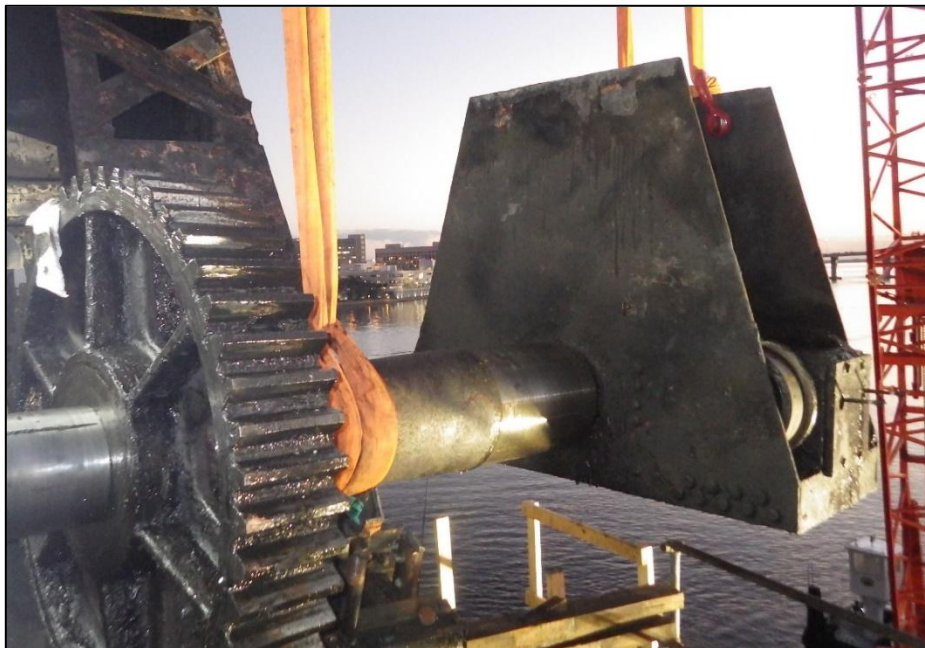
Photograph 8 - View of the existing pinion shaft being removed from the structure. Note that the carriage assembly is being removed at the same time.

The bearing caps at B1 and B2 were removed. Then, the west pinion shaft, with the OSG attached, was removed (see Photograph 8). The fact that the pinion shaft extended through the west wall of the machinery house made the rigging challenging. An overhead hoist was used inside the house to assist with lifting the shaft out of its

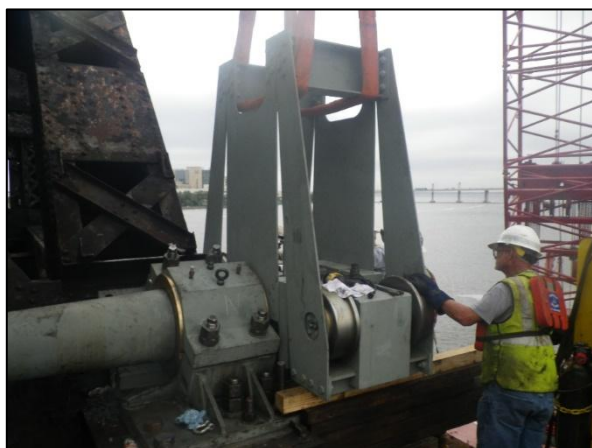
Photograph 9 - View of the top portion of the OSG being installed.

drilling and reaming of the bolt holes at B1 and B2. Only one temporary bolt was removed at a time. The new bolt would be installed prior to proceeding to the next hole, to retain alignment. During the process of shimming the B1 bearing base, the shims would not stay in place on the side of the bearing that is angled, and the space for the shims was tapered. The angle of the structure did not exactly match the angle of the newly fabricated B1 bearing. Therefore, the Project Team made the decision to use Chockfast Orange epoxy to fill the space between the bottom of the bearing base and the support structure. After all bolts were installed, the new OSG was placed onto the pinion shaft (see Photograph 9).

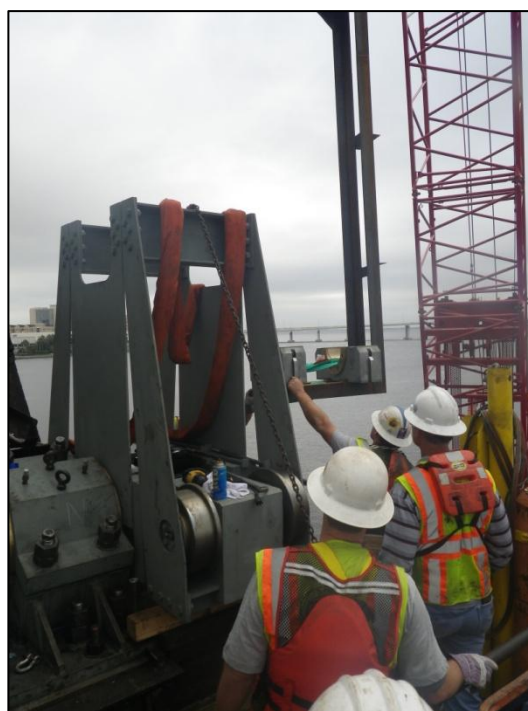
Photograph 10 - C-Hook used to place bearing caps on underside of OSG

A specially designed and fabricated c-hook was used to install the bearing caps on the underside of the OSG (see Photograph 10). These caps have a slight clearance fit on the sides and required careful placement to prevent binding during installation. The new OSG was designed so that the top section could be removed to facilitate installation of the operating strut. Once the OSG was in position, the operating strut was then lowered into position. Installation was completed by installing and adjusting the OSG upper rollers (see Photograph 11). The scheduled outage was from 8:00 a.m. on a Friday to 5:00 p.m. the following Friday. The bridge was returned to service several hours early on the last day of the outage.

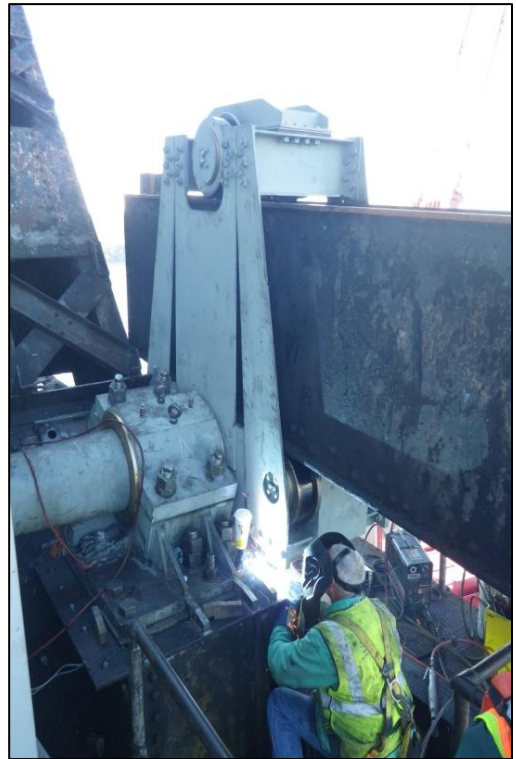
Photograph 11 - View of newly installed OSG and Bearing B1

the entire pinion assembly was replaced including the B1 Bearing, B2 Bearing, pinion shaft, G2 and OSG. The outage procedure to replace the East components was the same procedure detailed above for the West components. The outage was completed successfully within the allotted time and the bridge returned to normal operations.

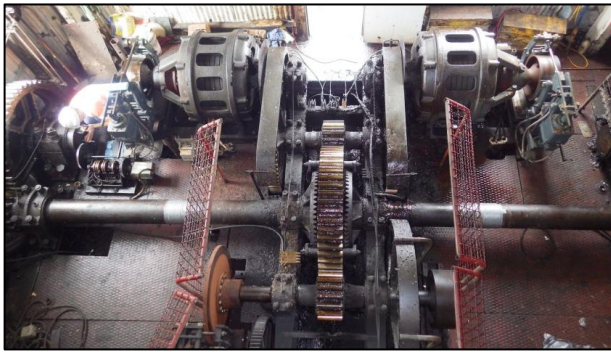
Photograph 14 - View of central differential gearing and cross shafts from above

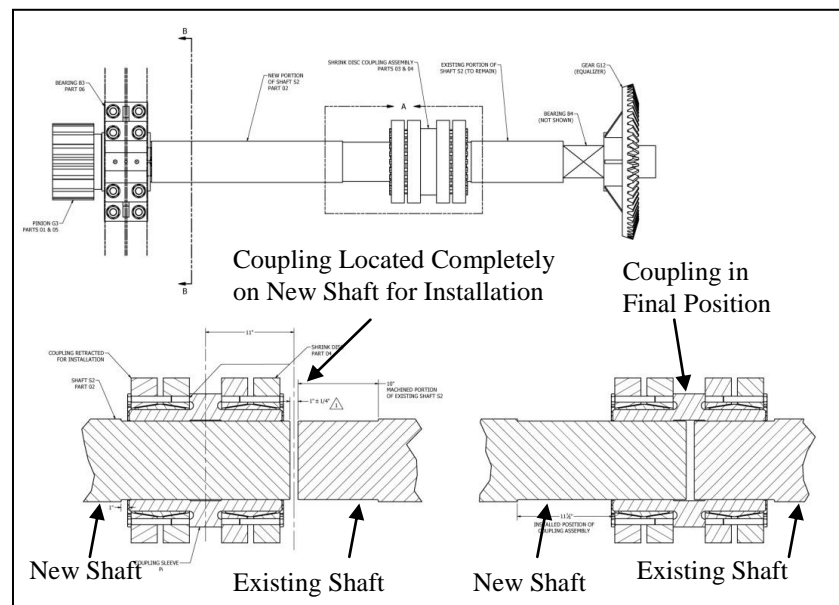
Figure 7 - New Pinion G3, shaft and coupling assembly

To avoid some of these issues, a sleeve type coupling was chosen, which would use shrink discs to attach the sleeve to the shaft. A sleeve has higher capacity to transmit bending than two flanges bolted together. And using shrink discs to mount the sleeve eliminated the need to machine keyways and install the coupling with heat. The only machining process required would be to turn down the outer surface of the cross shaft to a clean, known diameter. The new shaft and pinion could then be preassembled with the new coupling pushed completely onto the end of the shaft. Once the shaft is positioned in the machinery room, the new coupling can be moved onto the existing shaft and the shrink discs tightened to complete the splice (see Figure 7).

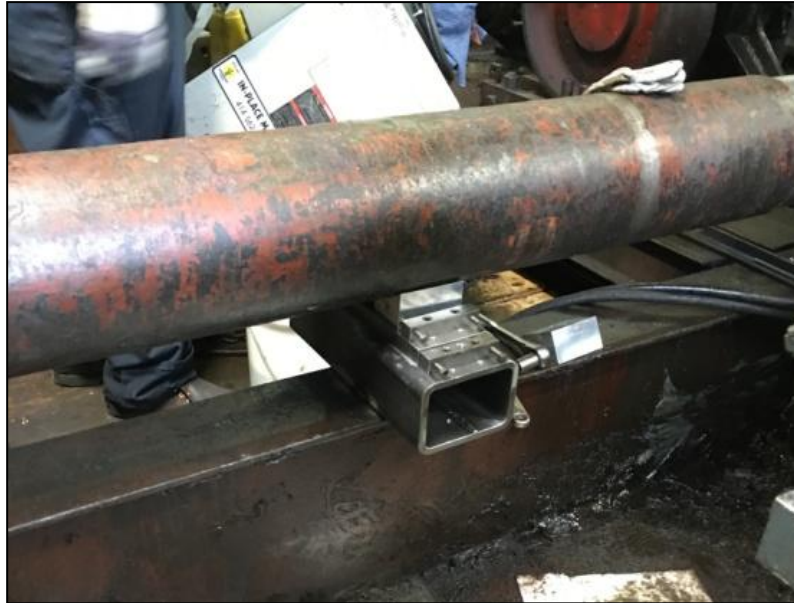
Photograph 16 - Adjustable V-block to support shaft and align the cross shafts

Once the outage was underway, crews went to work removing the West shaft. The first step was to block up between the shaft and the pre-installed supports. The fixture used was called a v-block. The v-blocks not only provided support for the shafts but also allowed for the shafts to be shifted in any direction for alignment purposes (see Photograph 16). After getting the blocking underneath the West shaft, the electric hoist was used to position the saw over the West shaft and the shaft was cut. A 13" horizontal band saw was used to make the cut (see Photograph 17).

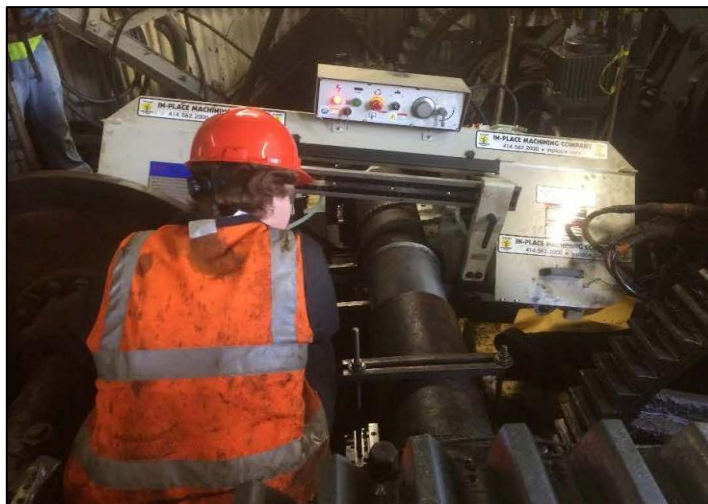
Photograph 17 - View of the 13" band saw cutting the existing cross shaft

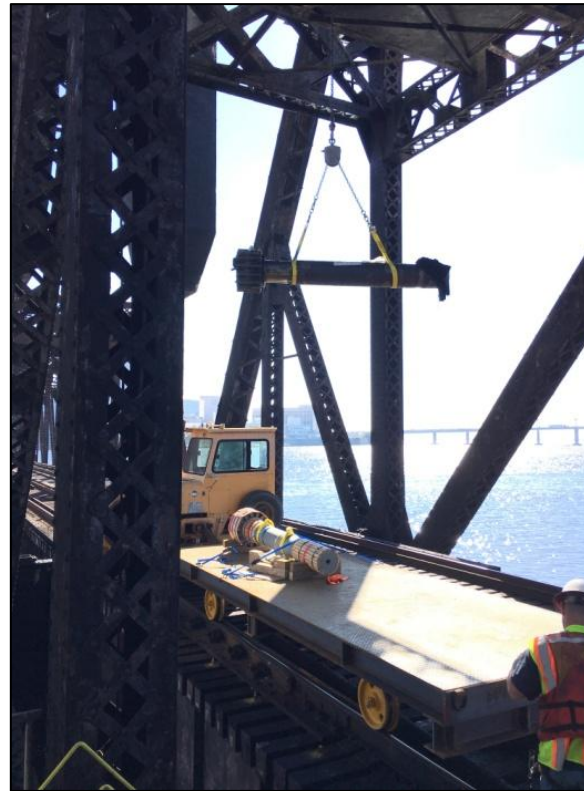
Photograph 18 - Removed pinion shaft, being lowered to rail cart

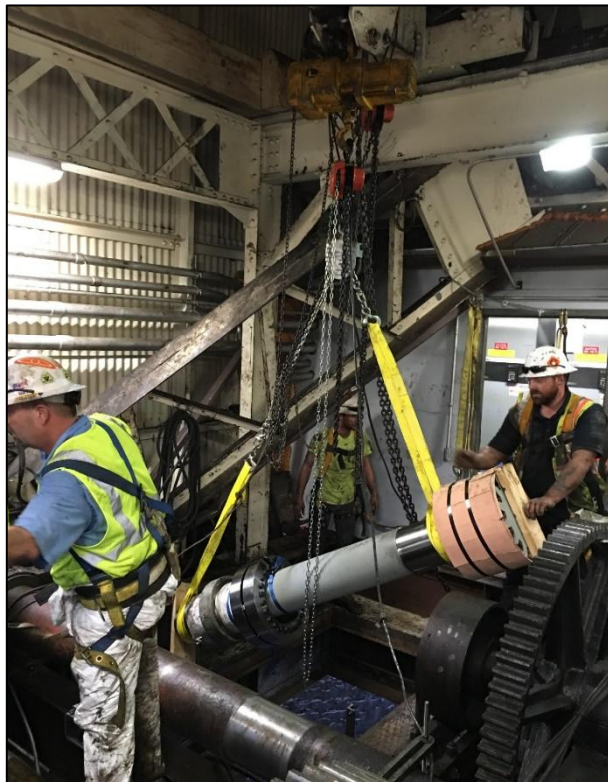
Photograph 19 - View of the new pinion shaft being raised into the machinery house. Notice that the shaft had to be out of level in order to fit through the hole in the floor

Once the existing West components were removed from the machinery house, the electric hoist was used to raise the new West B3 bearing from the track below into the house (see Photograph 19). The bearing was

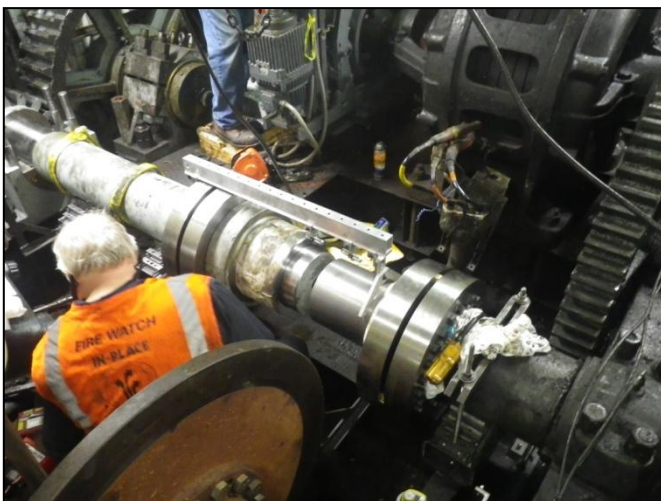
Photograph 20 - Concentricity gauge used to align two ends of Shaft S2

the G3 pinion teeth had to mesh with the G2 gear causing yet another challenge. The new shaft was set on the v-block supports. After the shaft was set, the v-block supports were then used to align the end of the new portion of Shaft S2 to the end of the existing portion of S2. The maximum allowable clearance between the coupling sleeve and the shaft was 0.0035". Therefore, the alignment of the ends of the shafts had to be correct so that the sleeve could slide from the new shaft onto the existing shaft. A concentricity gauge was used to align the shafts to less than 0.005" T.I.R. around the shaft (see Photograph 20).

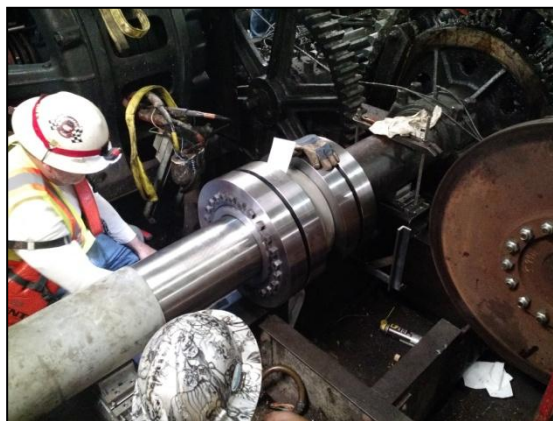
Photograph 21 - Sleeve coupling with Tollok shrink discs installed

Once the alignment was confirmed, ceramic heaters were installed around the coupling sleeve to expand the sleeve. The heat was able to expand the sleeve approximately 0.012". As soon as the sleeve had expanded, a specially fabricated hydraulic pusher was used to push the sleeve onto the new shaft. In the final position, the sleeve is positioned equally between the two shafts. Next, the two Tollok couplings were installed. In order to tighten each coupling, 24 bolts had to be tightened gradually to 361 ft-lb so the shrink disc rings were drawn together evenly (see Photograph 21). After the couplings were installed, final alignment of the shaft was performed. This alignment was confirmed by checking the mesh between G3 and G2. Finally, the crew drilled and reamed the final bolts at the B3 bearing base (see Photograph 22).

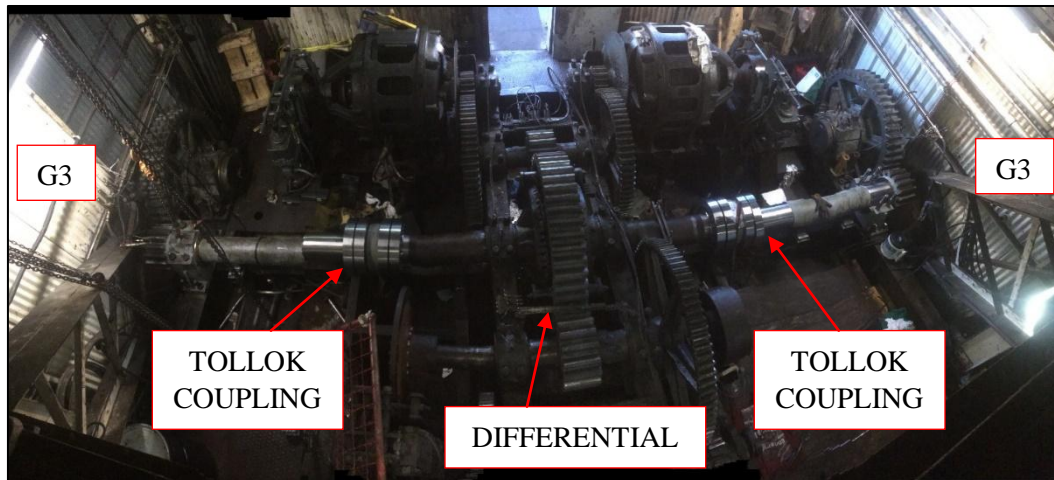
Photograph 22 - View of the machinery room after the completion of the installation of the new shaft and G3 gears

After completing the West side, crews moved over to the East side and repeated the same process, which was completed in slightly less time (see Photograph 22). The scheduled outage was from 7:00 a.m. on a Monday to 5:00 p.m. on Thursday. The bridge was returned to service at about Noon on Thursday, several hours early before the end of the outage.
