Sheridan Street Bascule Bridge Repair

**Alfred G. Banz, P.E.
Hardesty & Hanover, LLP**

TENTH BIENNIAL SYMPOSIUM

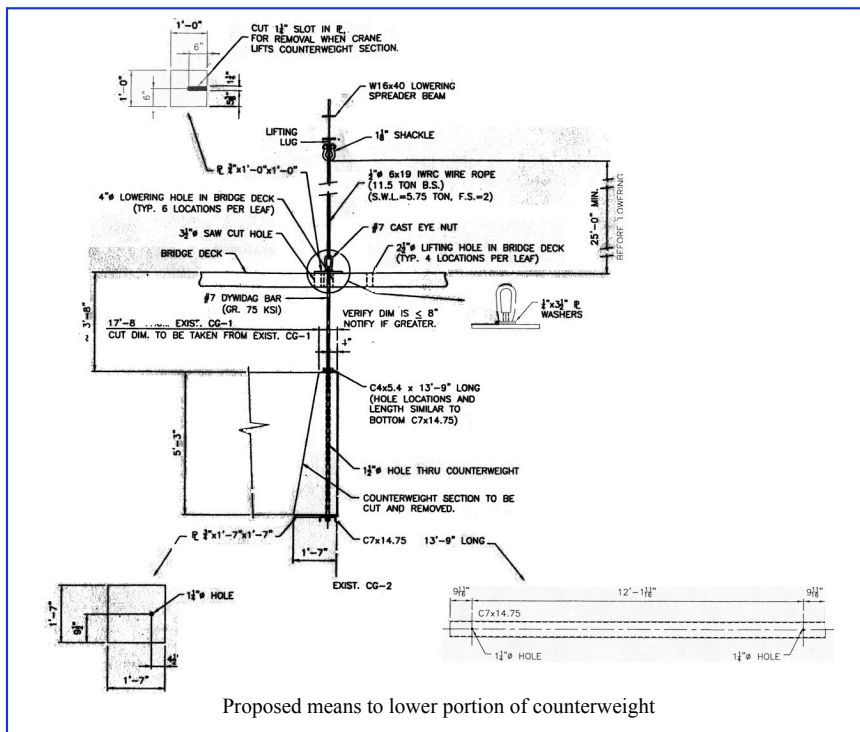
Proposed means to lower portion of counterweight

A series of holes were cored vertically through the counterweight to allow the contractor to install #7 Dywidag bars with top and bottom support channels, cast eyes nuts and grooved plates necessary to

support the weight being removed. The holes in the counterweight lined up with corresponding holes cored through the flanking span deck directly above. In addition, two vertical grooves were cut into
