# **Rehabilitation Of The Historic Bridge Of Lions**

Alan Klevens, P.E. Lichtenstein Consulting Engineers, Inc.

**TENTH BIENNIAL SYMPOSIUM**

**OCTOBER 25 - 28, 2004** The Omni Orlando Resort at ChampionsGate

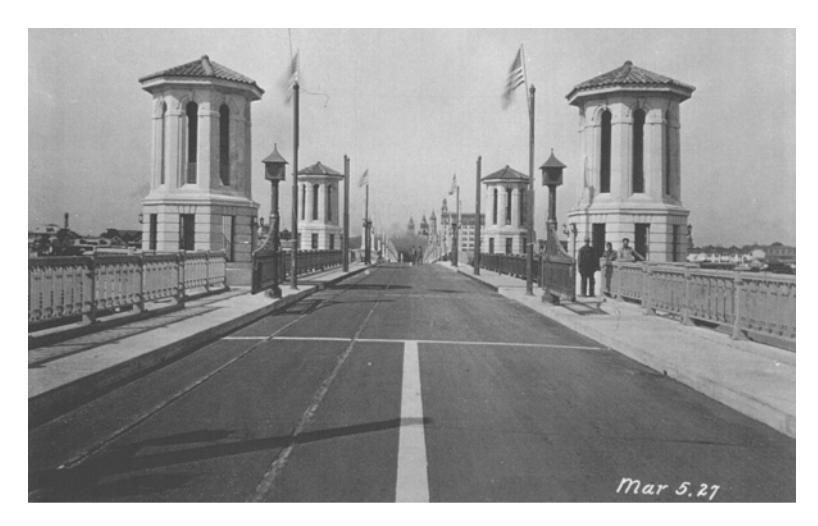
There is excellent documentation for the original traffic gates for the bascule span, and given the high level of pedestrian use of the bridge, their reproduction and reinstallation as pedestrian barriers would enhance the historic character and experience of the bridge. See Figure 4 for original construction.

Figure 4: 1927 photograph showing ornamental traffic gates, railing, and observation towers.

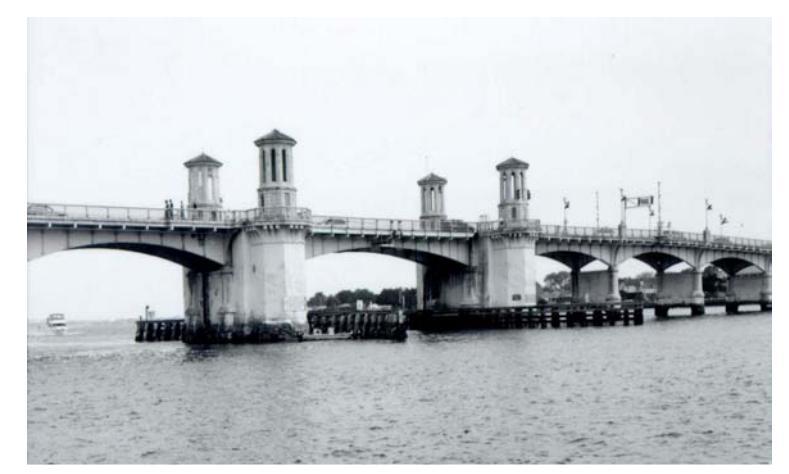
Figure 6: Elevation of existing bridge. Note arched girders and open approach pier configuration.

Because of the overall importance of the arched girders, they are being rehabilitated and reused. The girders will be removed from the site, deteriorated material replaced in kind using button head bolts, the steel painted in the shop, and then returned to the site and installed on new piers. The bridge is large enough that moving each girder outward

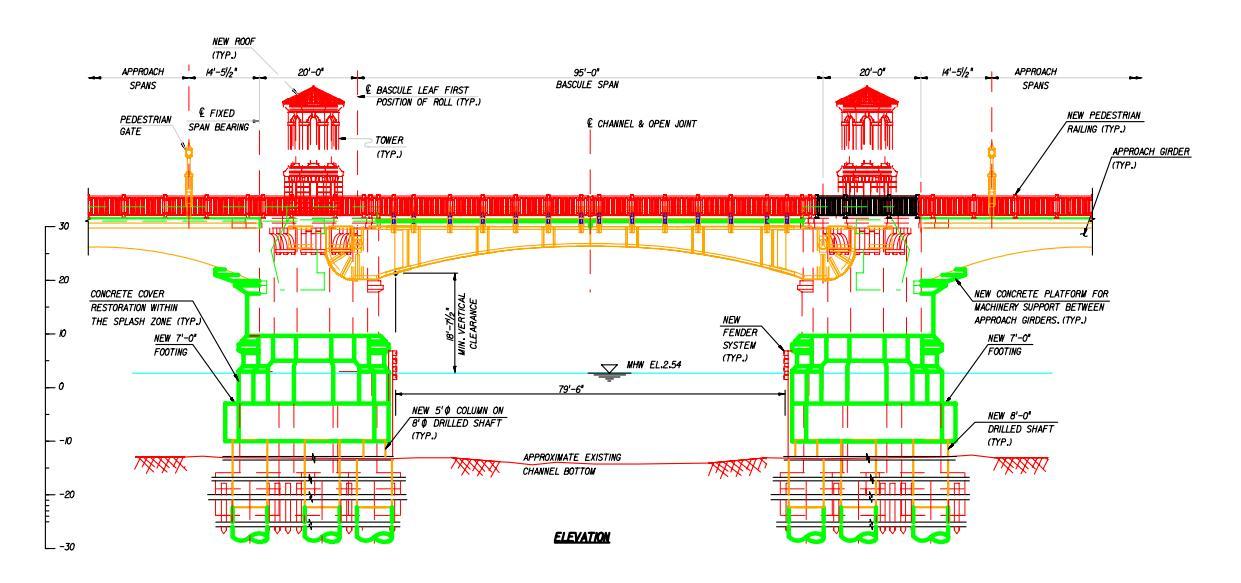
Figure 8: Elevation of rehabilitated bascule span and piers. Note new machinery platforms.

and installation of a new cantilevered concrete platform to accommodate the new span drive machinery. See Figure 8.
